# Service Bulletin

Subject:	RATTLE NOISE FROM STEERING SYSTEM	Bulletin No:	06-001/13
.s ==s.s= FROM GTEENNO GTGTEM	NATILE NOISE I NOM STEENING STOTEM	Last Issued:	08/22/2013

2011-2012 Mazda2 vehicles with VINs lower than JM1 DE 1\*\*\*\*\* 140732 (produced before December 10, 2011)

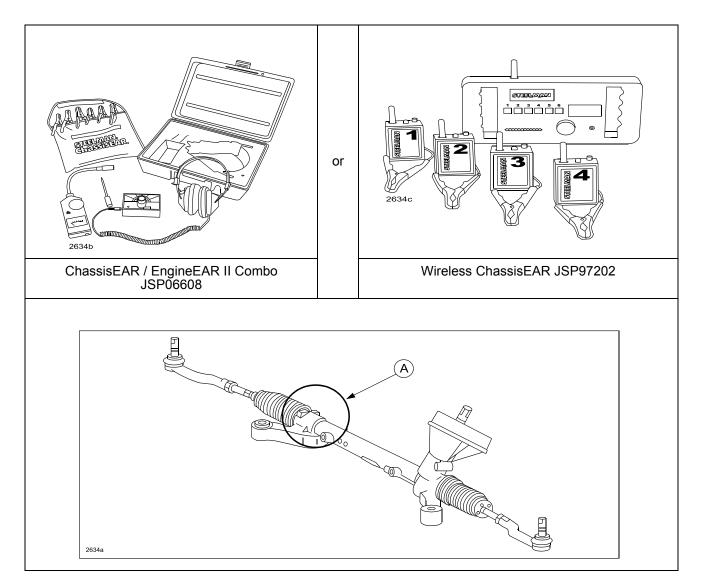
When driving straight on a rough road at approximately 6-19 mph (10-30 km/h), some vehicles may exhibit a rattle noise from the front passenger side floor.

2. Use Special Service Tool (SST) ChassisEAR / EngineEAR II Combo JSP06608 or Wireless ChassisEAR JSP97202 to confirm rattle noise is coming from the rack end bushing (A) (shown below):

- 3. If step 1-2 apply, replace the steering gear assembly according to MS3 online or Workshop Manual (section 06-13 STEERING GEAR AND LINKAGE REMOVAL/INSTALLATION).
- 4. Verify repair.
