Service Bulletin

Subject: Bulletin No: 02-004/13

STEERING WHEEL OFF CENTER WITHOUT DRIFT OR PULL

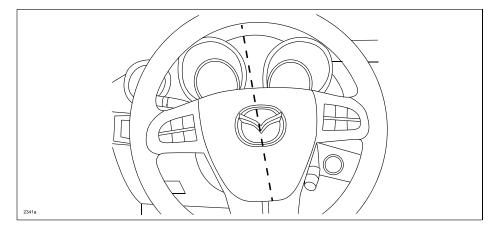
Some customers may complain that the steering wheel is off center more than 3° even when driving straight on a flat road.

Customers having this concern should have their vehicle repaired using the following repair procedure.
