Subject: REAR DOOR WILL NOT OPEN	Bulletin No: 09-023/13
	Last Issued: 08/13/2013

APPLICABLE MODEL(S)/VINS

2014 Mazda6 vehicles with VINs lower than JM1 GJ ***** 119979 (produced before April 9, 2013)

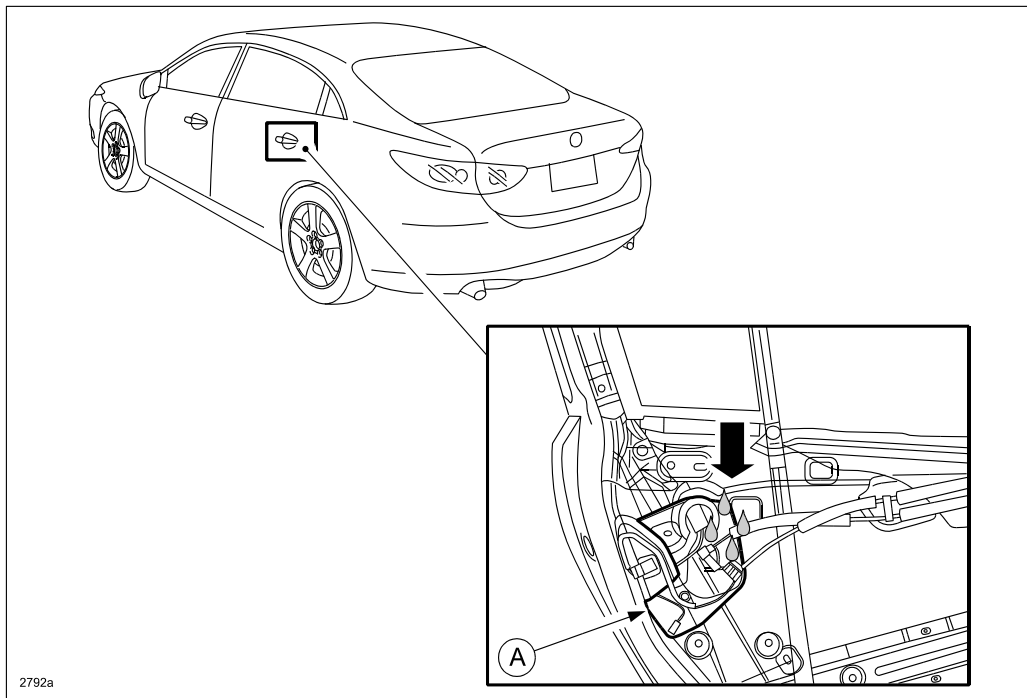
When the ambient temperature drops below 32 degrees Fahrenheit (0 degrees Celsius), especially after rain or car wash, some customers may experience a rear door(s) that will not open. This may be caused by water entering the inside of the rear door latch and lock actuator (A) and then freezing at low temperatures.

Customers having this concern should have their vehicle repaired using the following repair procedure.
