| Subject: 2013-2014 CX-5 - FRONT SEAT BACK TRIM SEAMS COMING APART - (LEATHER SEATS ONLY) | Bulletin No: 09-025/13 |
| | Last Issued: 09/30/2013 |

APPLICABLE MODEL(S)/VINS

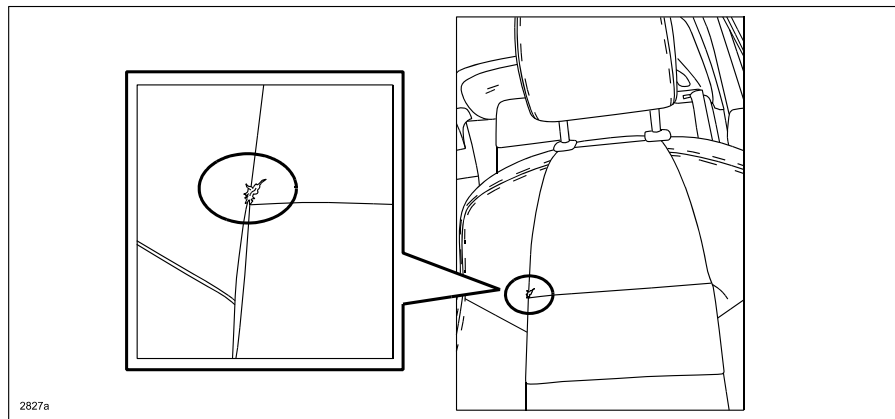
Some vehicles may exhibit a condition where the front seat back trim is coming apart at the seams. This condition is caused by insufficient sewing strength in the seams. The sewing method has been improved to eliminate this concern.

1. Verify the customer concern.
2. Replace the seat back trim with modified service parts according to the on-line instructions on MS3 or the Workshop Manual (section 09-13 FRONT SEAT BACK TRIM REMOVAL/INSTALLATION).
3. Verify the repair.
