# Service Bulletin

Subject:	DOOR TRIM ARM REST SURFACE PEELING	Bulletin No:	09-024/13
		Last Issued:	09/17/2013

#### 2010-2012 CX-7

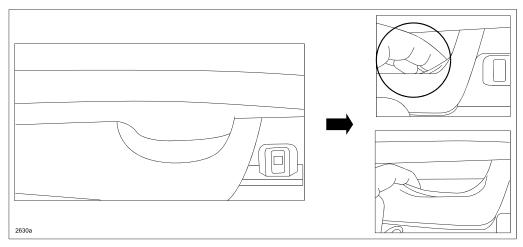
On some vehicles, the surface of the door trim arm rest may peel off, resulting in poor appearance. This may be caused by poor adhesion. The surface may peel when the arm rest is grabbed by hand.

As a mass-production improvement, additional adhesion has been applied to the arm rest surface.

Customers having this concern should have their vehicle repaired using the following repair procedure.
