Subject: DRIVERS SIDE SEATBACK RECLINING POSITION CHANGES BY ITSELF WHEN CUSTOMER EXITS THE VEHICLE	Bulletin No: 09-020/13
	Last Issued: 09/05/2013

2013-2014 CX-5 vehicles equipped with power seats, with VINs lower than JM3 KE***** 338025 (produced April 1, 2013)

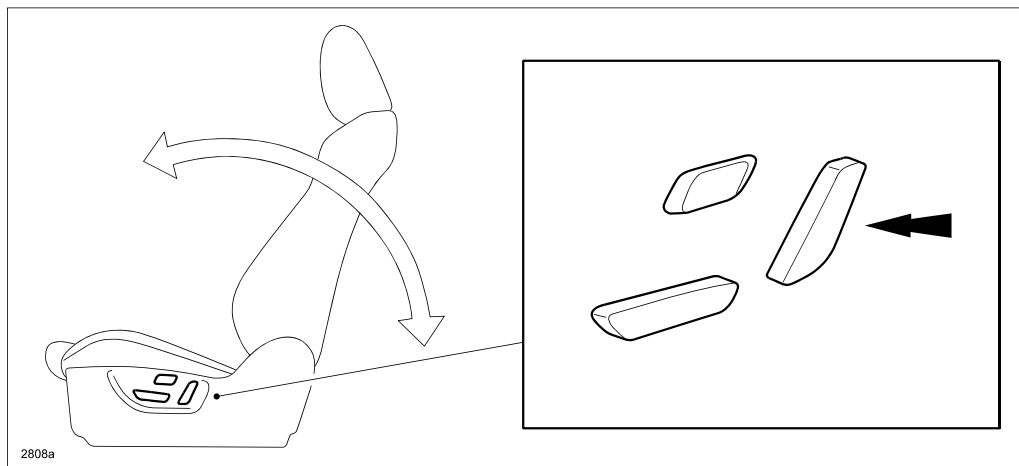
Some customers may complain that the driver side seatback reclining position seems to change by itself. This may be caused unknowingly by the customer when they exit the vehicle. The customer's leg may be contacting the recliner switch knob and changing the seatback reclining position.

- The configuration of the recliner switch knob has been changed to eliminate this concern. Customers having this concern should have their vehicle repaired using the following repair procedure.

1. Verify the customer concern.
2. Replace the recliner switch **knob** with a modified new part according to the instructions on MS3 online or the Workshop Manual (section 09-13 FRONT SEAT SIDE COVER REMOVAL/INSTALLATION).
3. Verify the repair.
