Subject: WHITE STAINS FROM OUTER DOOR MIRROR RUNNING DOWN DOOR PANEL	Bulletin No: 09-028/13
	Last Issued: 10/31/2013

2013-2014 CX-5 vehicles with VINs **between** JM3KE*****138997 ~ 398338 and produced from July 24, 2012 to October 1, 2013

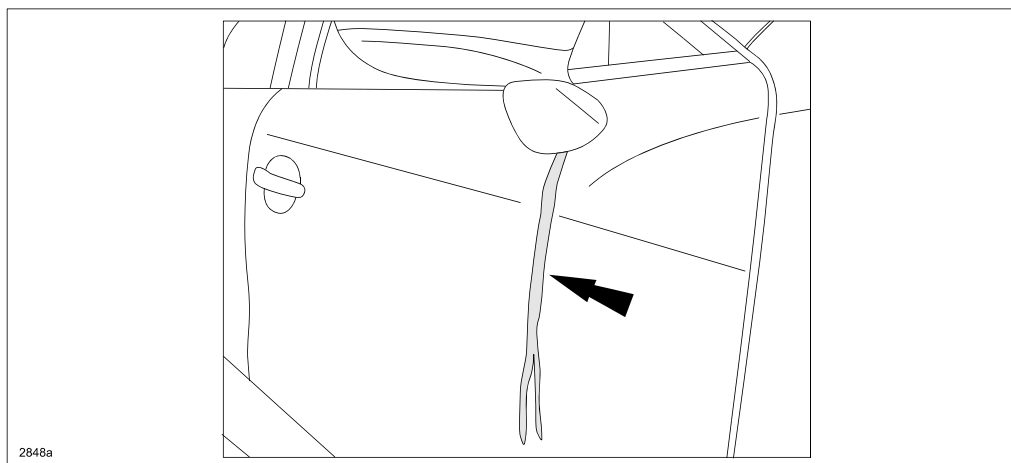
Some vehicles may exhibit a white stain running down the front door(s), which originates from under the outer door mirror. This is caused when water (containing white corrosion) is generated inside the door mirror base, then drains down the door panel causing a poor appearance concern.

The door mirror base was originally designed to drain water to the outside of the door. The shape of the door mirror base gasket has been modified to now drain water to the inside of the door. Replacing the gasket should eliminate this concern.
