Subject: REAR DIFFERENTIAL VENT CAP FLUID LEAK IN COLD AMBIENT TEMPERATURES	Bulletin No: 03-003/13
	Last Issued: 10/31/2013

2011 Tribute equipped with AWD

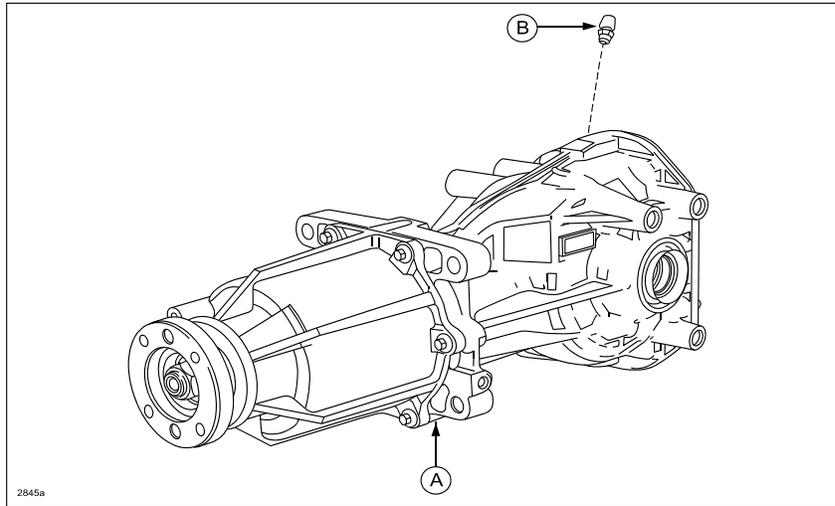
Some vehicles may exhibit an occasional fluid leak coming from the rear differential vent cap in temperatures below 32 degrees Fahrenheit (0 degrees Celsius) under certain conditions.

1. Inspect the rear drive unit (A) for oil leaking from the vent cap (B) located on the rear cover.

NOTE: A light residue found around the cap is normal.

3. Remove and discard the vent from the rear drive unit cover.
4. Install new vent.
5. Clean off any remaining residue.
6. Verify repair.
