<b>Subject:</b> <b>UNABLE TO LOWER REAR SEATBACK WITH REMOTE HANDLE / SEATS HARD TO LOCK</b>	<b>Bulletin No:</b> 09-013/13
	<b>Last Issued:</b> 10/24/2013

2013-2014 CX-5 vehicles equipped with a 4:2:4 split type rear seat

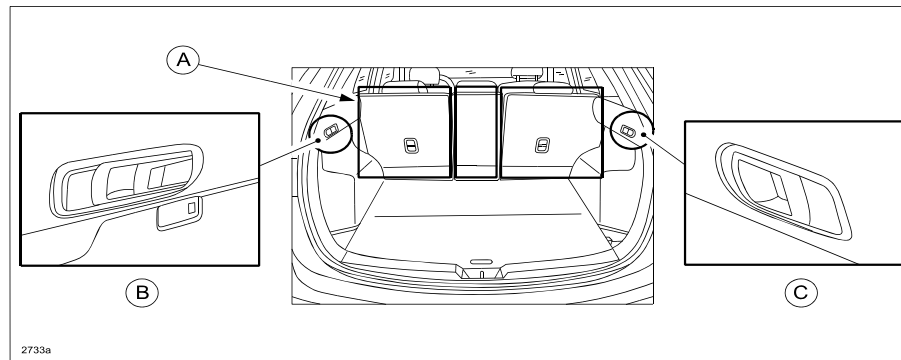
Some vehicles equipped with a 4:2:4 split type rear seat may be unable to lower the rear seatback (A) when pulling the left (B) and/or right (C) remote handles. Also, the seatbacks may not fully latch (lock) when placed in the upright position.

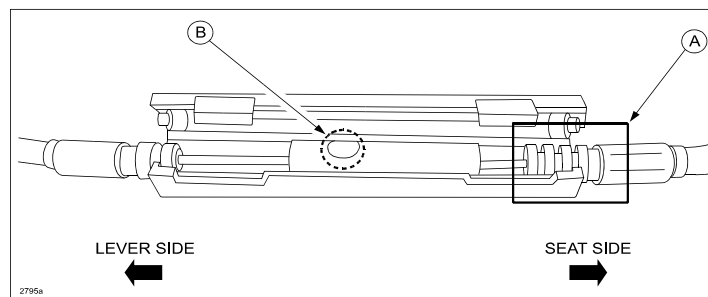
This concern may be caused by either of the following:

- Insufficient remote cable tension due to incorrect adjustment position (A) of the remote cable.
- The cable ball (B) gets seized on sharp edges inside the cylinder.

3. Replace the remote handle lever assembly (including the remote cable) according to the online MS3 instruction or the Workshop Manual (section 09-13 REMOTE HANDLE LEVER REMOVAL/INSTALLATION).

4. Set the adjustment groove to the position where the malfunction does not occur according to the online MS3 instruction or the Workshop Manual (section 09-13 REAR SEAT REMOVAL/INSTALLATION - Remote Cable Adjustment Procedure).
