Service Bulletin Mazda North American Operations

Subject:	DRIVER-SIDE POWER DOOR MIRROR VIBRATION	Bulletin No:	09-002/13
		Last Issued:	10/24/2013

2013-2014 CX-5

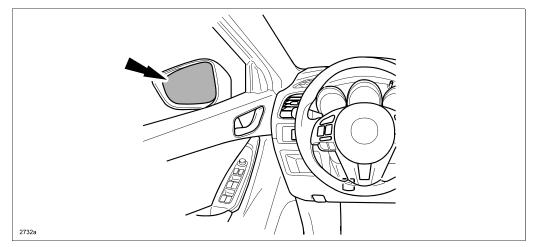
Some vehicles may exhibit a vibration from the driver-side power door mirror glass when the vehicle is driven at high speeds.

This concern may be due to a lack of rigidity of the mirror base so the mirror vibrates when it receives vehicle vibration or wind pressure.

Customers having this concern should have their vehicle repaired using the following repair procedure.
