<b>Subject:</b>  NOISE COMING FROM UNDER THE DRIVER SEAT	<b>Bulletin No:</b> 09-026/13
	<b>Last Issued:</b> 10/09/2013

2013 CX-5 vehicles without power seats with VINs lower than JM3KE\*\*\*\*\*144861 (produced Aug. 24, 2012)

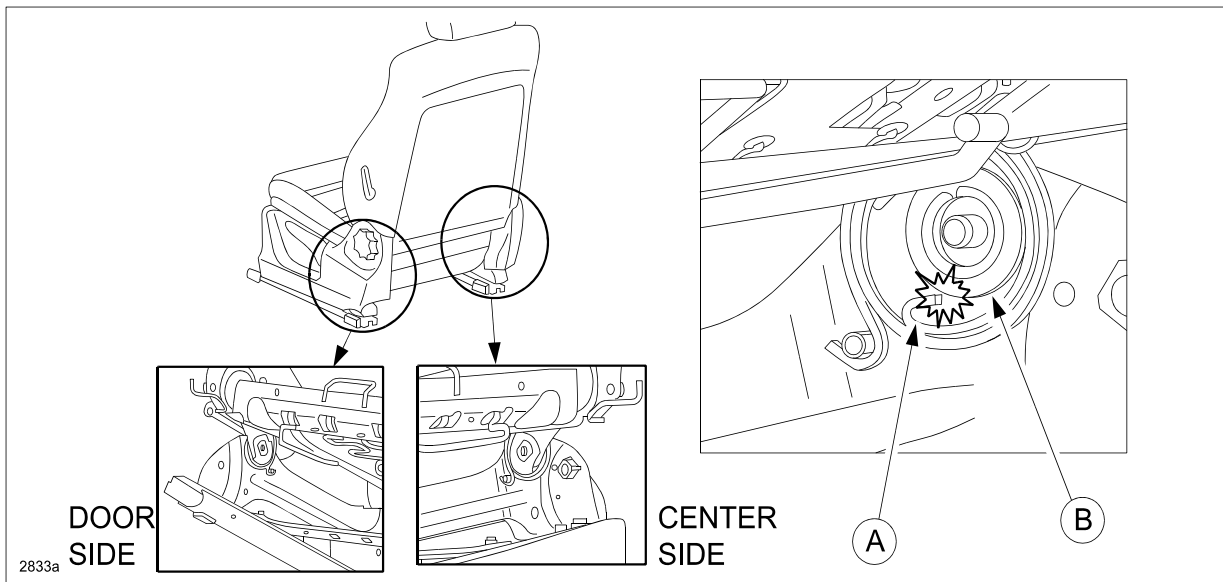
Some vehicles may exhibit a noise from under the driver seat while driving the vehicle. The noise may be caused by vibration when the bent-up end of the balance spring (A) interferes with the slider bushing (B).

To eliminate the noise, the clearance between the balance spring and the slider bushing has been increased. Customers having this concern should have their vehicle repaired using the following repair procedure.
