ENGINE NO START IN EXTREMELY COLD AMBIENT TEMPERATURES

Bulletin No: 01-023/13

2013-2014 CX-5

2014 Mazda6

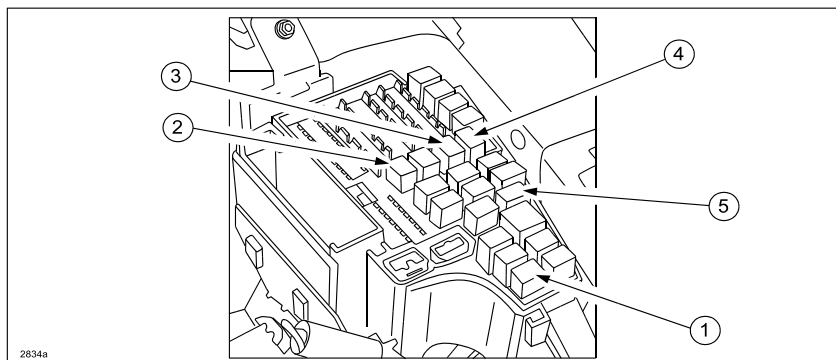
Some vehicles may exhibit an engine no start in ambient temperatures below -4 degree Fahrenheit (-20 degree Celsius) after driving for 10 - 20 minutes and then parking the car for about one hour. This may be caused by the contact point of the main relay freezing due to moisture inside the main relay.

1. Verify customer concern.
2. Replace the 5 relays shown in the table below.

Relay Name	DTC stored by malfunctioning relay	DTC stored by malfunctioning Ignition Relay and Main Relay
1	Main Relay	U0100	B10E7
2	Ignition Relay	B10E7	
3	Fuel Pump Relay	P025D	
4	Injector Relay	P0201, P0202, P0203, P0204, P0091	
5	E-VVT Relay	P0010
