Service Bulletin

bject: ONT SEAT BACK TRIM SEAMS COMING APART - (LEATHER SEATS ONLY)	Bulletin No:	09-025/13
	Last Issued:	10/04/2013

2013-2014 CX-5 vehicles equipped with leather seats with VINs lower than JM3KE*****327345 (produced March 1, 2013)

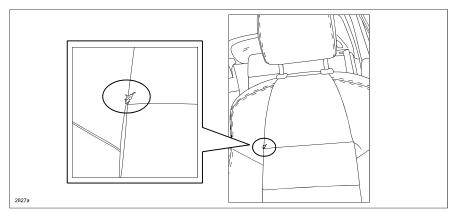
Some vehicles may exhibit a condition where the front seat back trim is coming apart at the seams. This condition is caused by insufficient sewing strength in the seams. The sewing method has been improved to eliminate this concern.

- 1. Verify the customer concern.
- 2. Replace the seat back trim with modified service parts according to the on-line instructions on MS3 or the Workshop Manual (section 09-13 FRONT SEAT BACK TRIM REMOVAL/INSTALLATION).
- 3. Verify the repair.
