Subject: VEHICLE SPEED DOES NOT INCREASE WITH ENGINE SPEED AND ATX DOES NOT SHIFT UP OR DOWN	Bulletin No: 05-008/13
	Last Issued: 12/12/2013

2013-2014 Mazda3 (with SKYACTIV-DRIVE A/T)

2013-2014 CX-5 (with SKYACTIV-DRIVE A/T)

2014 Mazda6 (with SKYACTIV-DRIVE A/T)

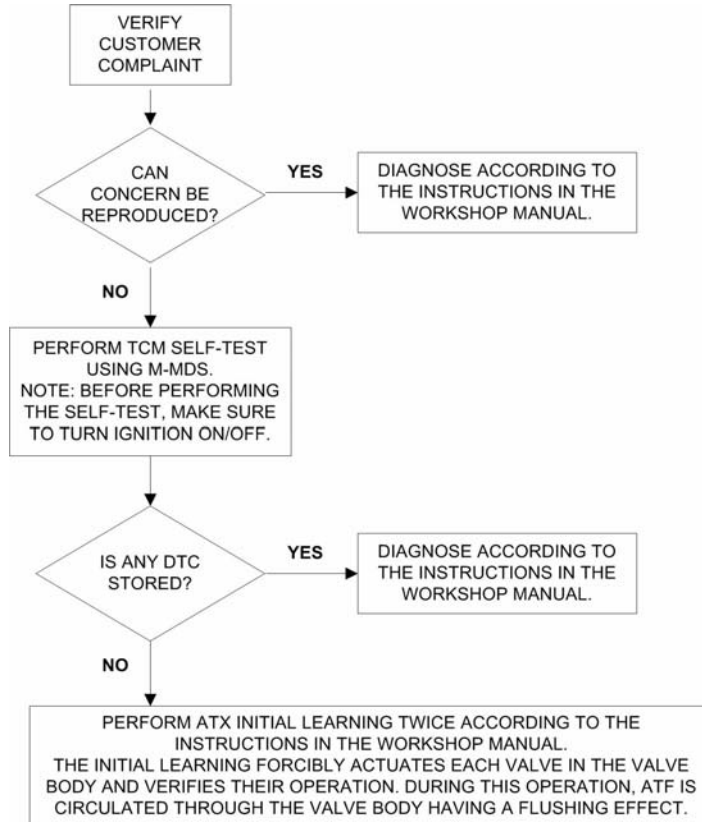
The condition may not always be able to be reproduced and DTCs may not be stored when the vehicle is brought in. Foreign material (iron particles in the ATF) may enter the ATX valve body and cause a temporary malfunction of the valve body and/or sensor (ATX fail-safe function activated). The fail-safe function is canceled without DTCs recorded if the malfunction goes away and does not occur again at the next drive cycle.

1. Verify customer concern.
2. Follow the chart to determine course of action.
