<b>Subject:</b> <b>UNABLE TO ADJUST DRIVER SEAT UP OR DOWN - (MANUAL SEAT ONLY)</b>	<b>Bulletin No:</b> 09-037/13
	<b>Last Issued:</b> 12/10/2013

2010-2012 CX-7 vehicles equipped with manual seats

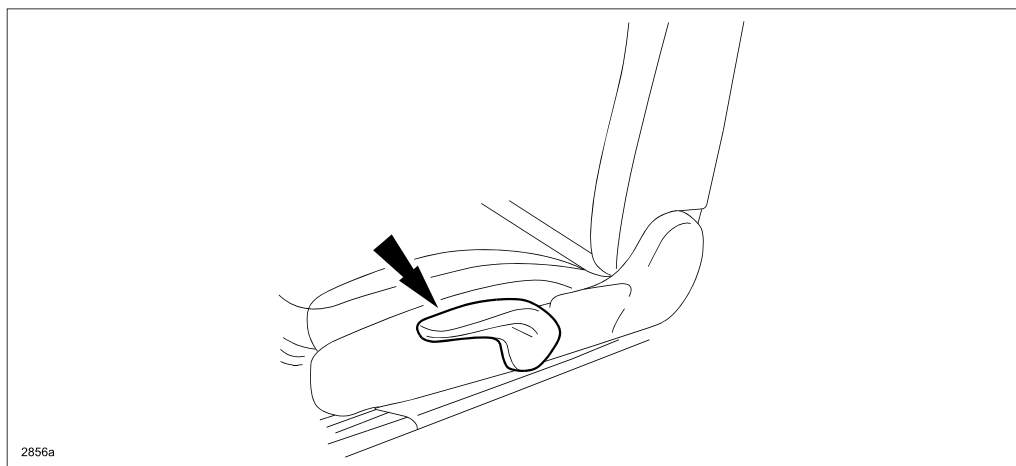
On some vehicles, it may be difficult to adjust the driver seat up or down using the manual seat lift lever.

This may be caused by a broken front seat side cover that interferes with the operation of the seat lifter mechanism. The cover may have been previously broken by an outside impact.

1. Verify the customer concern.
2. Replace the front seat side cover with a modified one according to the instructions on MS3 online or the Workshop Manual (section 09-13 FRONT SEAT SIDE COVER REMOVAL/INSTALLATION).
3. Verify the repair.
