Subject: HOOD VIBRATION WHILE DRIVING AT HIGHWAY SPEED	Bulletin No: 09-036/13
	Last Issued: 12/10/2013

2013-2014 CX-5 vehicles with VINs lower than JM3KE*****387092 (produced before September 1, 2013)

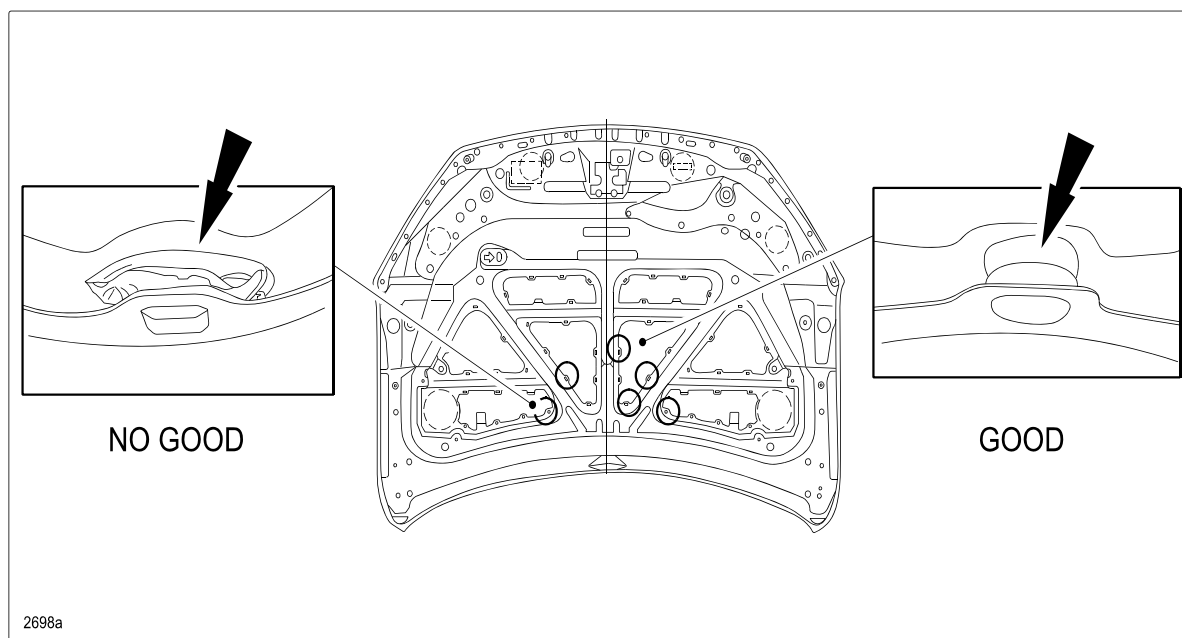
The amount of sealant used to fill in the space between the inner frame and outer panel at the bottom area of the hood is insufficient. If the sealant detaches (as shown below on the left), it may cause the hood to vibrate.

The amount of sealant has been increased during vehicle production and the preload force of the cowl grill seal has been increased to eliminate the concern.

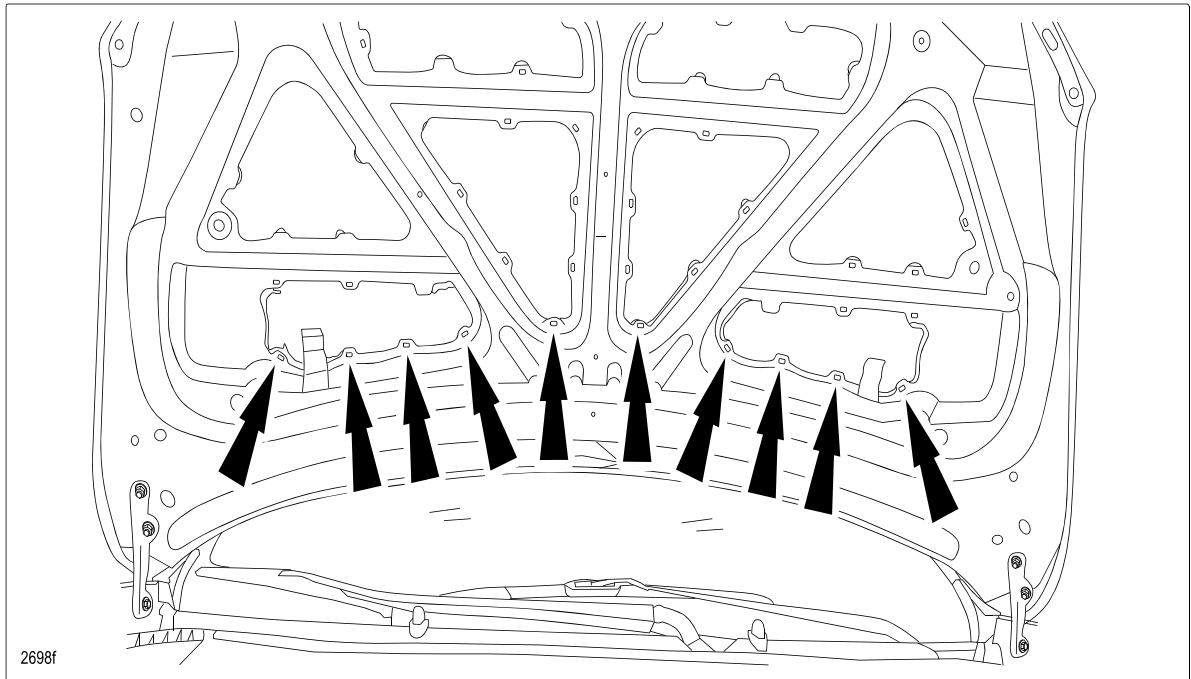
4. Inspect if the factory applied sealant between the outer panel and the inner frame at the back of the hood is separated.
 - If the sealant is separated, go to step 5.
 - If the sealant is not separated, go to step 21.
5. Remove the hood insulator according to the MS3 online instructions or the Workshop Manual (section 09-10 HOOD DISASSEMBLY/ASSEMBLY).

6. Confirm the ten (10) original sealant spots at the bottom area of the hood.

- Additional dampening material will be applied **between** these ten (10) original sealant spots.
- It is not necessary to apply dampening material to other areas of the hood. Even if the original sealant has become detached, it will have no influence on the hood vibration concern.
