TECHNICAL BULLETIN

Q255NAS1

Service Action: Water Induced Misfire / Restricted Performance

Range Rover Evoque (LV)

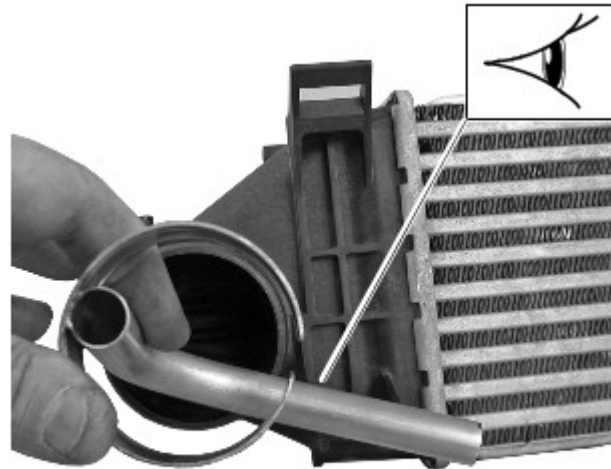
E149136

**NOTE: Charge Air Cooler (CAC) shown removed from the vehicle for clarity.**

Note the required orientation of the venturi prior to installation.

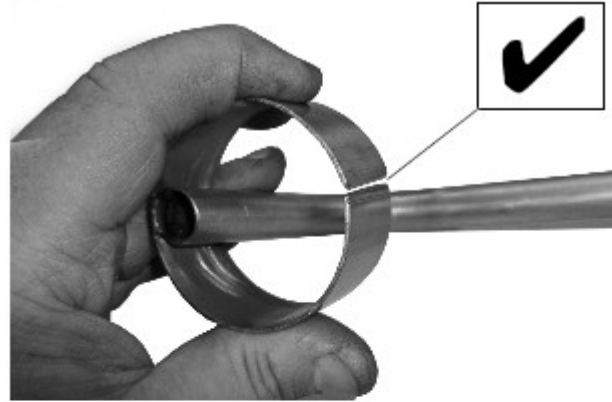
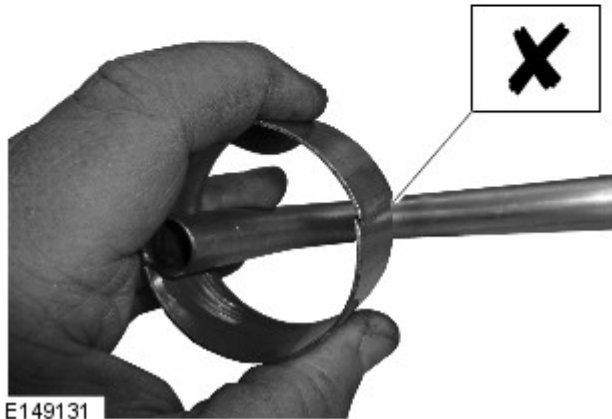
**CAUTION: The venturi ring will need to be slightly compressed during installation. Make sure that the ring is not compressed so that the ends of the ring overlap. Failure to follow this instruction may result in damage to the vehicle.**

Note the acceptable deformation of the venturi ring prior to installation.

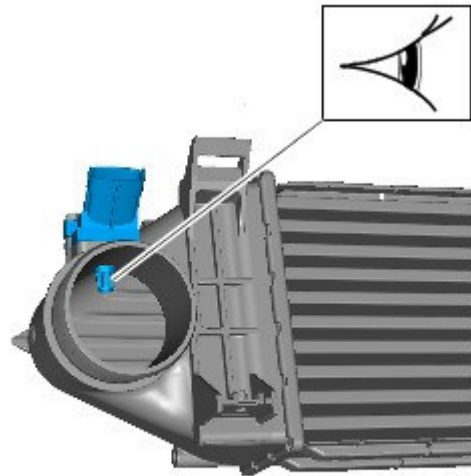
**CAUTION: Make sure that the sensor is not damaged during the installation of the venturi.**

Note the position of the sensor.

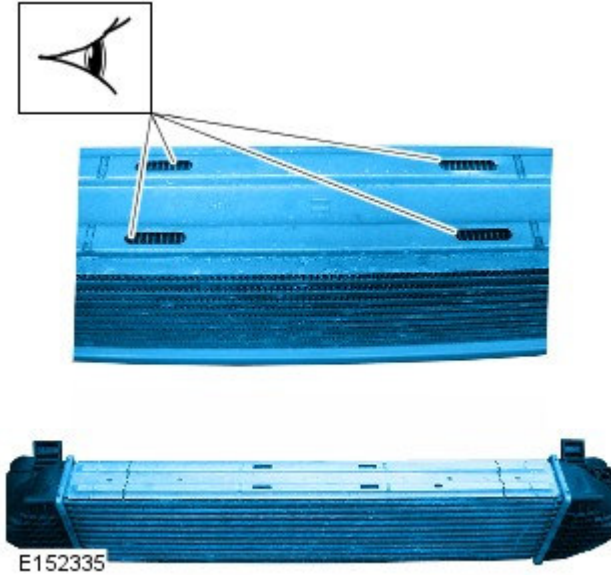
**NOTE: Upper section of Charge Air Cooler shown; lower section similar.**

Identify the eight (8) slots on the Charge Air Cooler.

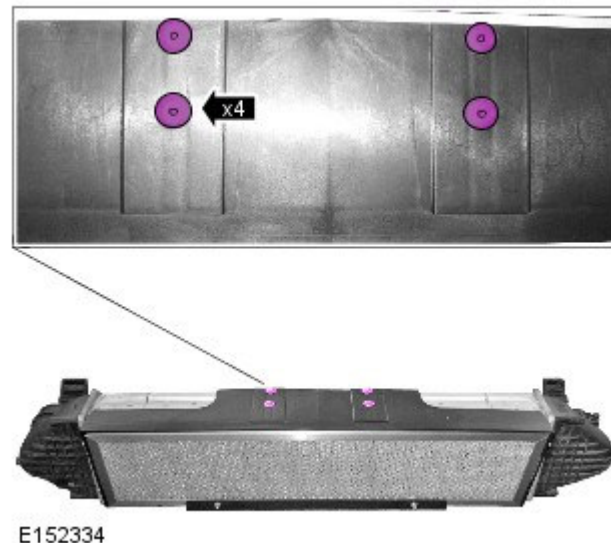
**CAUTION:** Make sure that upper section of the Charge Air Cooler grille is secured with all four (4) rivets before attempting to rotate the assembly. Failure to follow this instruction may result in the dislodging of the rivet(s), resulting in damage to the component.

Secure the Charge Air Cooler grille.

- Install the Charge Air Cooler grille to the Charge Air Cooler with the wider section at the top of the Charge Air Cooler.
- Install four (4) rivets to the upper section of the Charge Air Cooler grille.
- Rotate the assembly and install four (4) rivets to the lower section of the Charge Air Cooler grille.
