Reference	SSM51797
Models	Range Rover Sport / L320 LR4 / L319 Range Rover / L322
Title	Smart Key cover detaching from the Casing
Category	Electrical
Last modified	19-Sep-2013 00:00:00
Symptom	203000 Basic Electrical
Content	<p><u>Please note: Refer to technical bulletin LTB00563 which shows a low level repair if this issue is applicable. You should not replace the complete key.</u></p> <p><u>Issue</u> The outer cover on the remote key can detach from the casing. See attachment.</p> <p><u>Cause</u> The Root cause was found to be that anti rust oil residue remains on the supplier's tooling at the start of a production run.</p> <p><u>Action</u> The issue is resolved from 18th September 2012. Please note that the casing is now available as a separate part. Please see technical bulletin LTB00563 and supporting animation SSM 66357.</p> <p><u>Discovery 4/LR4, Range Rover Sport up to 12MY, Range Rover (L322) All</u> 120918 (year 2012, month September, day 18th), see attachment for location.</p> <p>Please only submit EPQR's for failures after this assured date, your continued support is appreciated.</p>

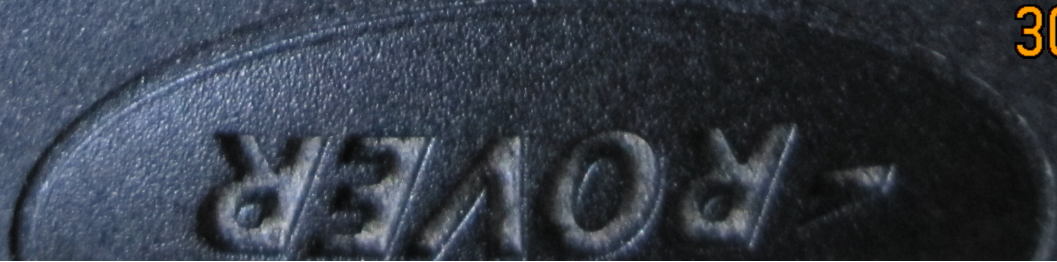
113date code.JPG

DATE CODE: 101009
LEAR P/N: 5E0B601A7
JLR P/N: AH22-15K601-BF
