SUBJECT: Service Update for Inventory Vehicles Only
Engine Knock Noise – Drive Audit
Expires November 30, 2014

MODELS: 2014 Buick Regal
2014 Cadillac ATS, CTS
2013-2014 Chevrolet Malibu
2014 Chevrolet Impala
Equipped with 2.5L Engine (LCV/LKW) or 2.0L Engine (LTG)

Subject: 13387A – Service Update for Inventory Vehicles Only
Engine Knock Noise – Drive Audit
Revised Part Information Section

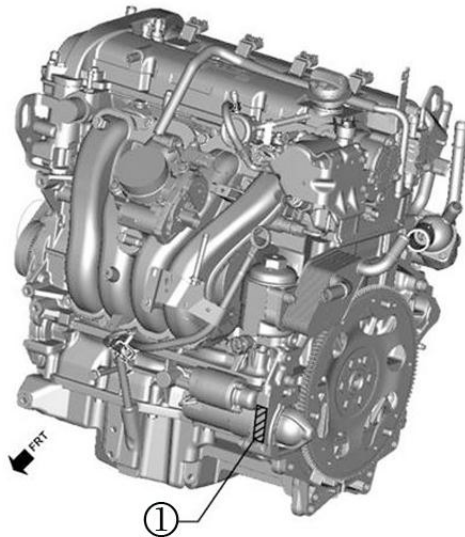
3613307

Note: A VIN derivative is required to be permanently engraved on the new engine prior to installation. Refer to the illustration above for VIN engraving location point. VIN derivatives must be formatted as indicated below (# = last eight characters of the VIN).
