**HYUNDAI**NEW THINKING.  
NEW POSSIBILITIES.**Technical Service Bulletin**

**14-BD-004**

**JULY 2014**

**ALL****SUBJECT:****WINDSHIELD DAMAGE WARRANTY INFORMATION**

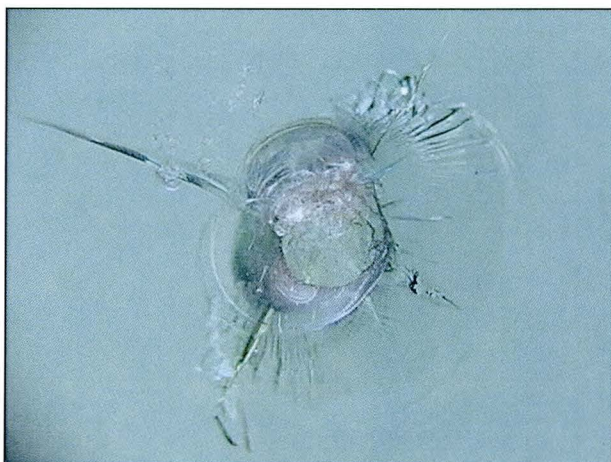
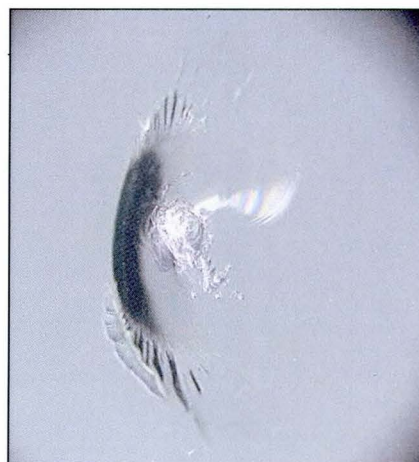
**Pictures above show examples of cone shaped breaks caused by road debris.**

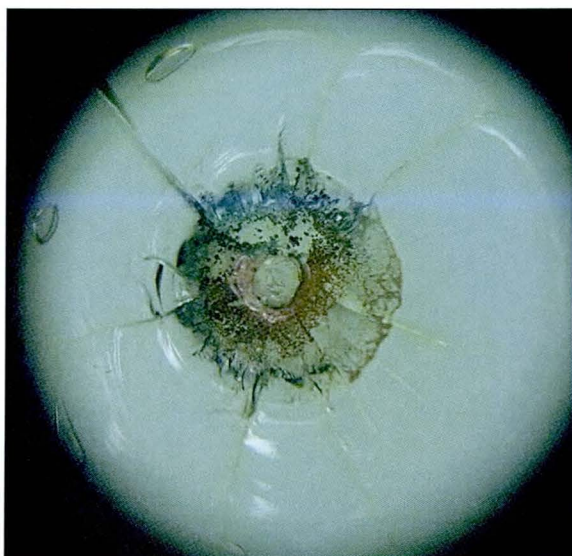
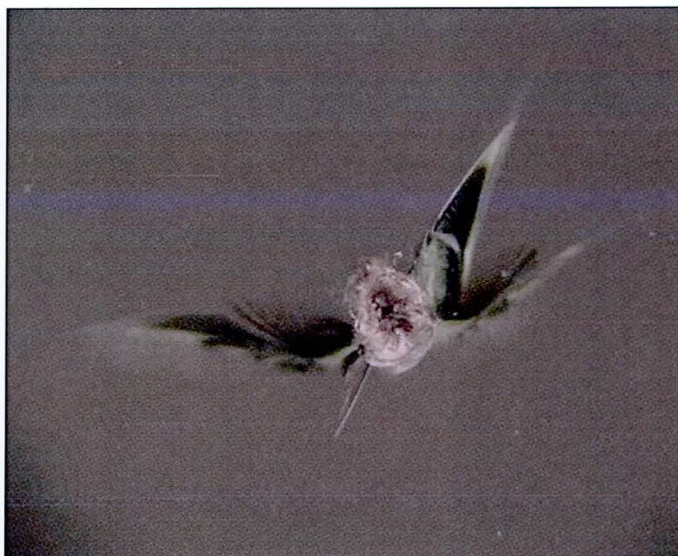
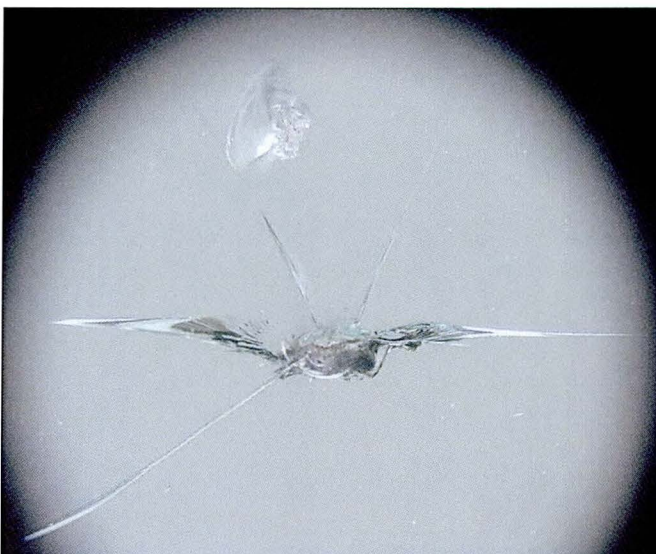
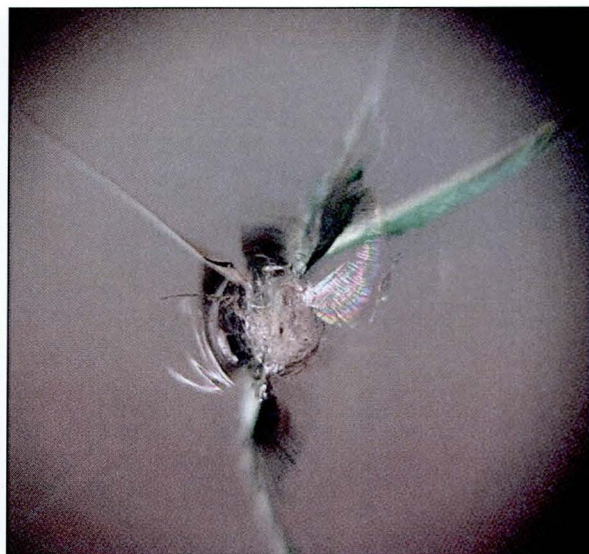
Pictures below show examples of star shaped breaks caused by road debris.
