SUBJECT: Service Update for Inventory and Customer Vehicles
Underbody Appearance
Expires with Base Warranty

MODELS: 2014 Chevrolet Silverado 1500
2014 GMC Sierra 1500

Subject: 14002 – Service Update Bulletin
Underbody Appearance

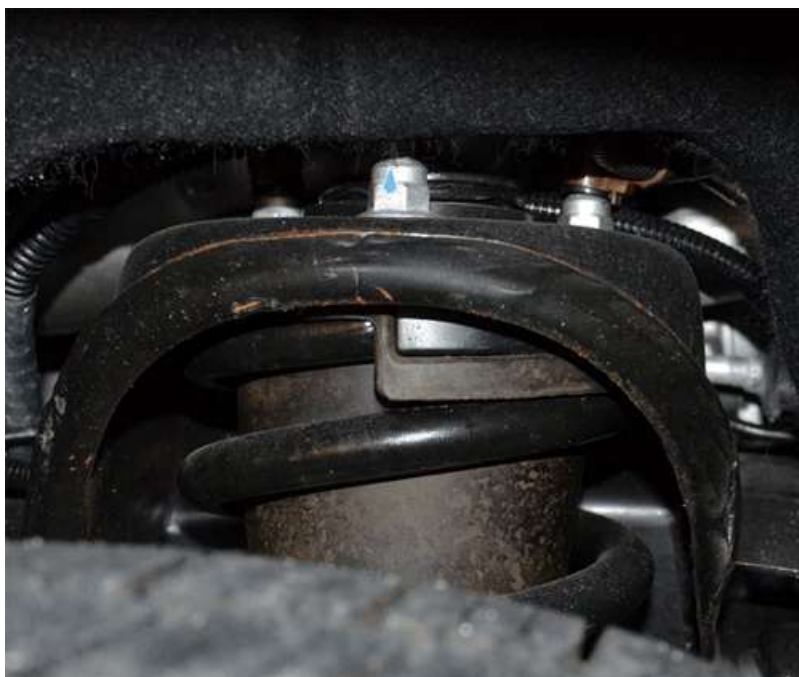
3686530

- Front spring mounts (visible through wheelhouse)

No Repair Required

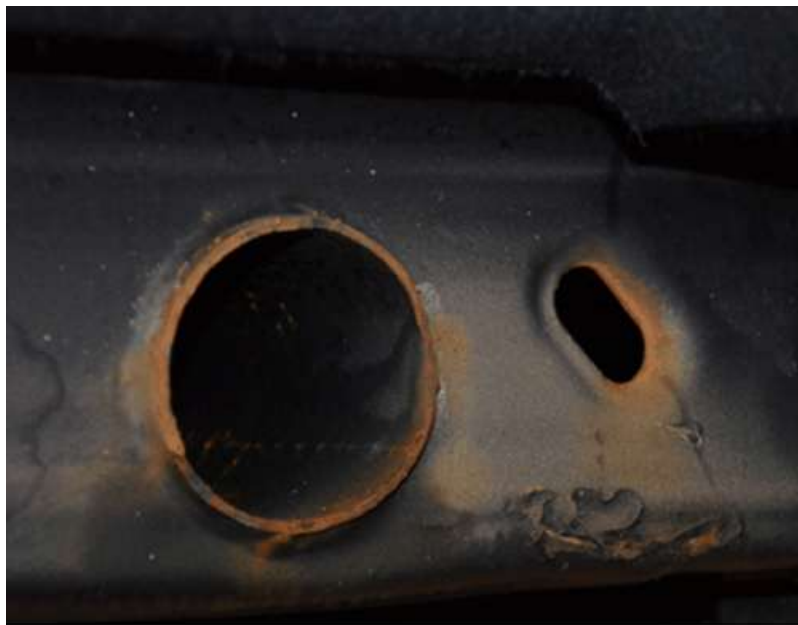
3687196

- Frame and flanges (visible through wheelhouse and underneath door(s))

Repair Required

1. Any loose rust or coating should be wire brushed off.
2. Using a rag and general purpose adhesive remover, wipe down the affected repair area.
3. For the front spring mounts, frame and body mounts, apply a coat of Daubert Nox-Rust® P/N X-121B “One Coat Rust Preventative Coating” (aerosol), or equivalent.
4. For the rear axle assembly and rear shock mounts, apply a coat of Lloyds Kryptonite Metal Treatment P/N 36502 Life Long Rust Protection (14 ounce aerosol), or equivalent.

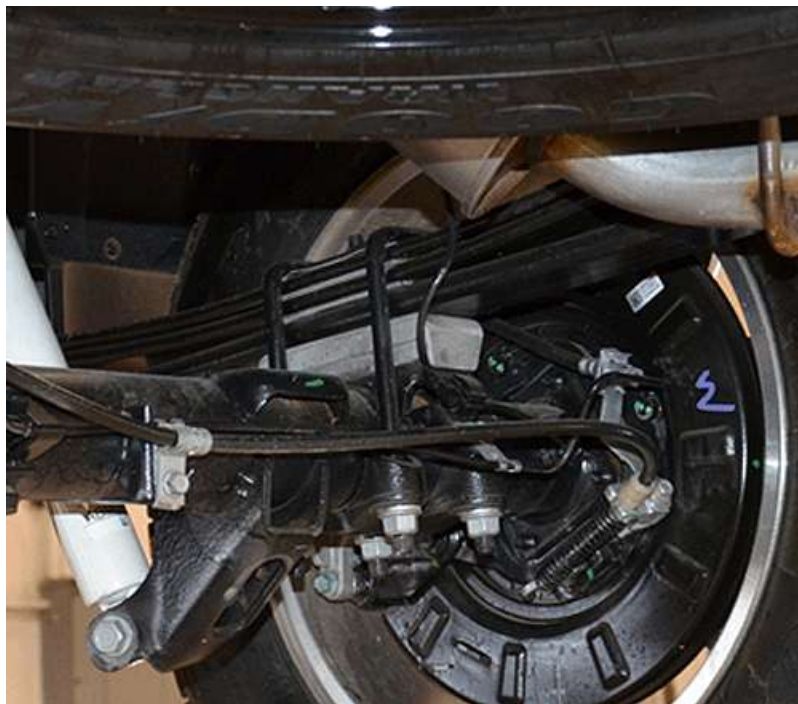
3687935

- Rear shock lower mounts

No Repair Required

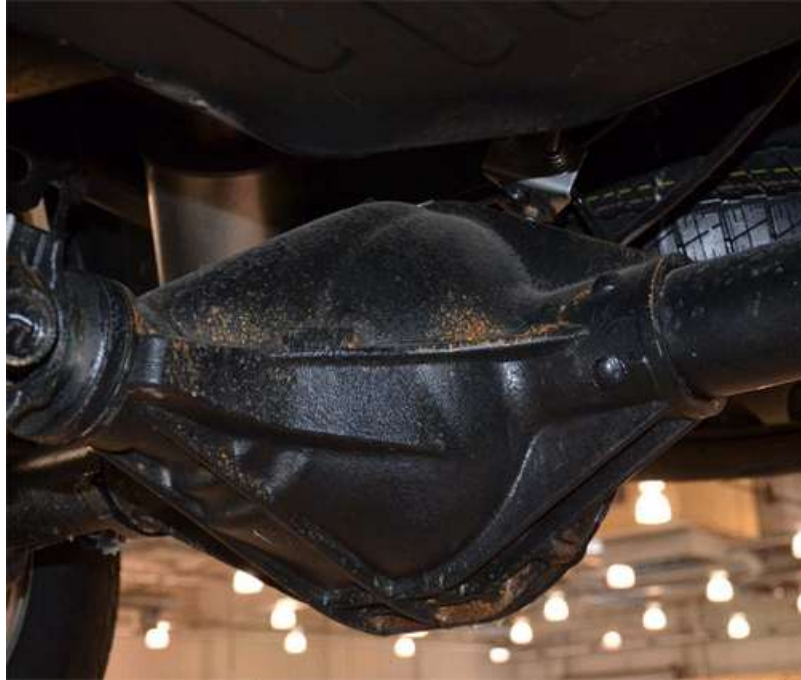
- Rear axle assembly

No Repair Required
