TECH TIPS

Subaru Service and Technical Support Line Newsletter

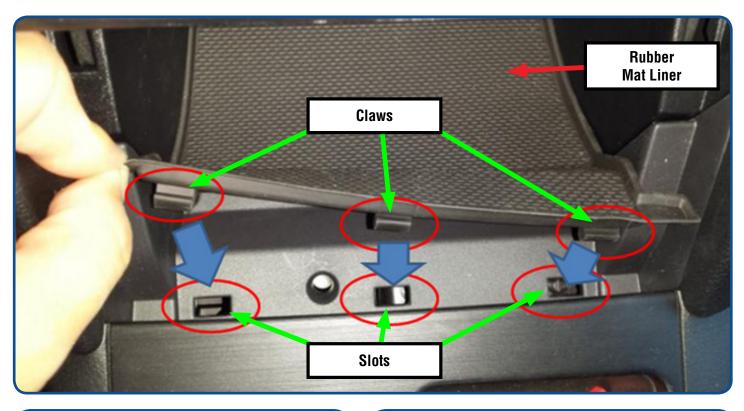
If you receive a customer concern of the front console door (ahead of the shifter) not opening or closing properly, there are 2 areas to inspect for the source of the binding condition. First, always make sure the rubber liner / mat on the bottom of the compartment is fully seated along the front edge inside the compartment. The top photo below shows where to inspect for proper retention and fit of the rubber liner / mat. The 3 retaining "claws" must be fully seated in their respective slots. The second photo shows the liner / mat fully seated but not properly aligned with the surrounding shifter trim panel. This is an indicator of the shifter trim panel not being installed properly. If the shifter trim panel is not installed properly, most likely the compartment door will be difficult to operate. If after removing the trim panel, a close inspection reveals any deformation, it must be replaced. Always inspect these 2 areas closely before ordering any replacement parts for this condition.

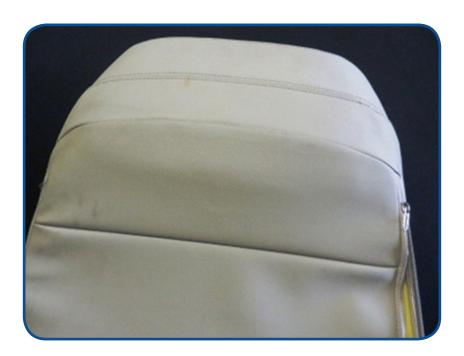
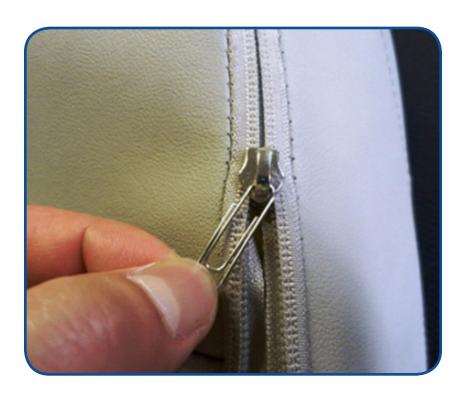
Be advised, a design change was made during June, 2014 eliminating the zipper pull tab found on the front seat backrest covers used on all 2014-15MY Impreza, 2015MY Forester and 2015 Legacy and Outback models. A paper clip fed through the hole of the closer portion as shown in the photos below makes for an easy replacement pull tab.

NOTE: Do not replace a seat cover for a missing pull tab.

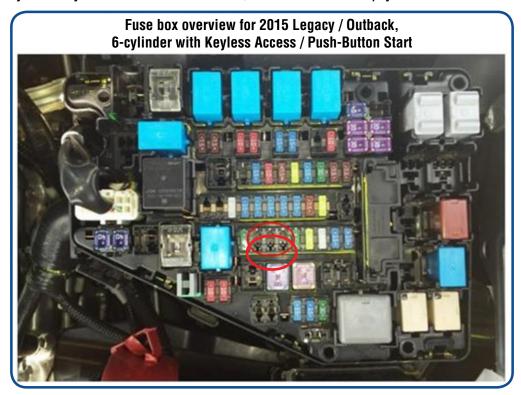
Inquiries have been received regarding some confusion while performing the Pre-Delivery Inspection (PDI) involving the under-hood (M/B) fuse box and its cover being used on 2015MY Legacy and Outback models. Some had questions regarding what appeared to be missing fuses. Others mentioned discrepancies between the fuse location / circuit name diagram located inside the fuse box cover and the Service Manual. Before spending any diagnostic time unnecessarily, always keep the following points in mind:

- Refer to the June, 2014 issue of TIPS for Transit Fuse Information. Relocating this
 fuse is the ONLY item which should need to be addressed inside the M/B during the
 PDI procedure.
- There is no need to install any additional fuses in the M/B other than relocating the transit fuse. For example, on 6-cylinder models, there are 3 empty fuse slots as shown in the photo below. One of these empty slots is for the Active Grille Air Shutter System which is used only on 4-cylinder models therefore, the slot is left empty.

- If a required fuse is truly missing, the circuit it controls will be inoperative and will likely become apparent while performing the operational check portion of the PDI. In some cases, the Check Engine light may also illuminate.
- The information on the lid of the fuse box is designed to provide very general information in the event of an unanticipated electrical failure. As such, it must never be used as a primary diagnostic aid when performing actual electrical repairs. When diagnosing an electrical concern, always refer to the applicable Service Manual Wiring Diagram section for detailed information about the related circuit(s).
