VW Elsa Newsletter

Edition 104: September 22, 2014

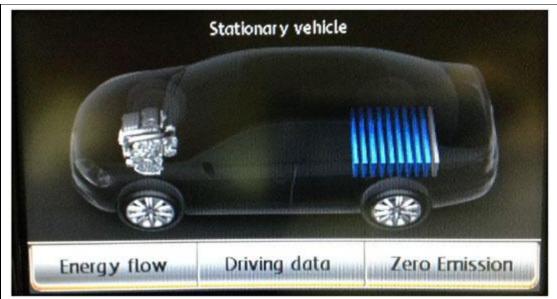
91 14 08 - 2038293 Stationary Vehicle Displayed While in Motion (Premium 8 Radio)

The customer may report that while the vehicle is in motion, the display on the Premium 8 radio displays the "Stationary Vehicle" driving mode. This symptom is often intermittent and can be temporarily resolved by performing a key cycle. This condition only affects vehicles equipped with Premium 8 radio.

Production Solution: SW 0011 implemented into production in CW 37/14.
