Bulletin No.: PI1357

# Service Bulletin

**Subject:** Air Bag Light On, Service Air Bag Message Displayed on DIC

**Models:** 2014-2015 Buick Enclave  
2014-2015 Chevrolet Traverse  
2014-2015 GMC Acadia

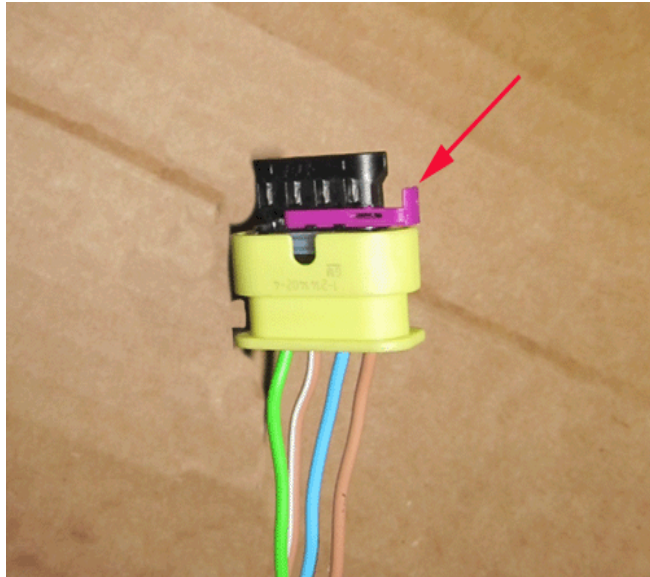
3990716

**Note:** A yellow 4-way connector (passenger) as shown above is similar to the 6-way yellow connector (driver).

5. Remove the terminal position assurance (TPA) lock as shown above.

**Note:** Always use care when removing a terminal position assurance (TPA) in order to avoid damaging it.
