# Service Bulletin

Bulletin No.: PI1365

**Subject:** HVAC Mode Setting Adjustments Not Available and/or Clicking Noise Heard Under Instrument Panel When Switching HVAC Modes

**Models:** 2015 Chevrolet Equinox  
2015 GMC Terrain  
Equipped with HVAC Systems (RPOs C67, C68)  
Vehicles Built Prior to August 8, 2014

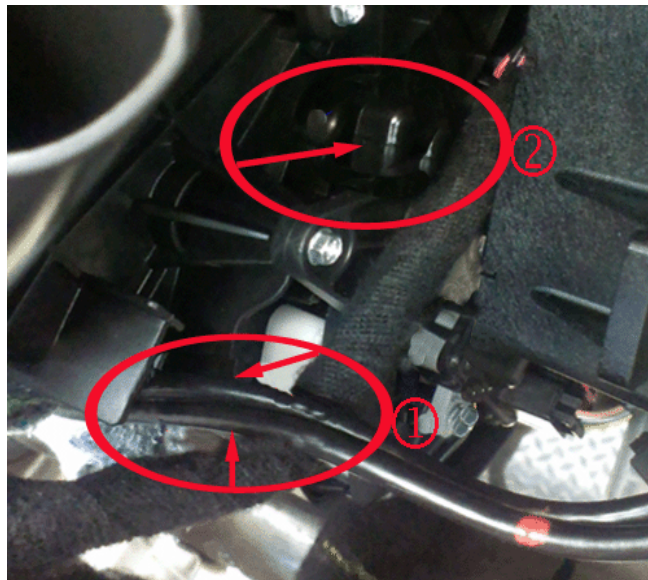
3998429

Some customers may comment on a clicking noise heard under the instrument panel when switching HVAC modes or HVAC System mode switching may not operate as expected.

This may be due to the routing of the OnStar cables (1), restricting the travel of the HVAC mode door (2).
