2014 Tundra/Tacoma Quality Confirmation Inspection

Dealer Instructions

1. Intermediate Shaft N. 2 Inspection Procedure

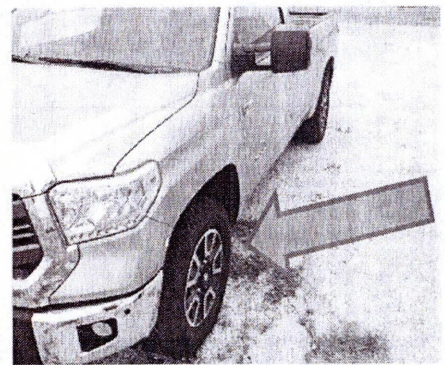
4x2 Tundra & Tacoma:

Linkage will be easily viewable without mirror.

**no 4x4 components blocking view point

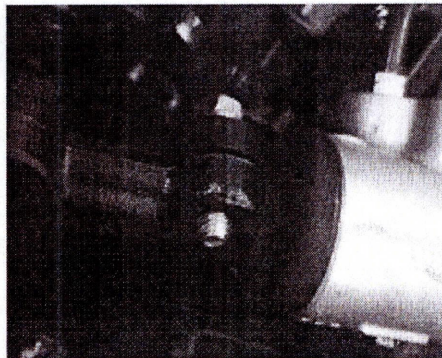
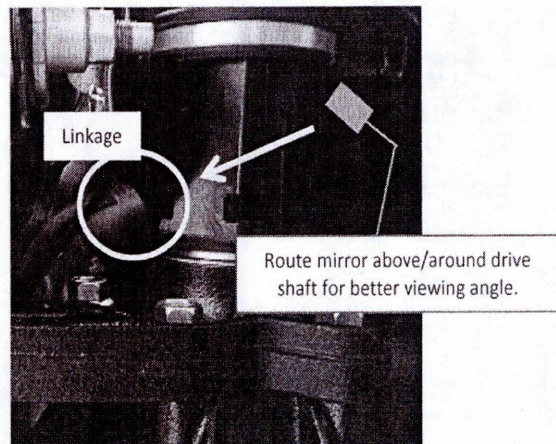
4x4 Tundra & Tacoma

Route adjustable mirror around opposite side of drive shaft to view linkage condition.

*Shine flashlight into mirror for better visibility.

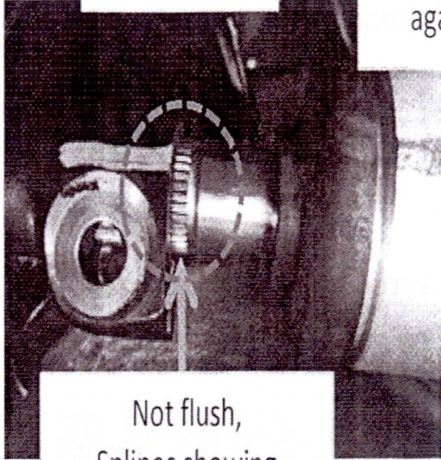
Tundra

Splines showing,
intermediate shaft no. 2 NOT flush
against steering gear assembly.

Not flush,
Splines showing

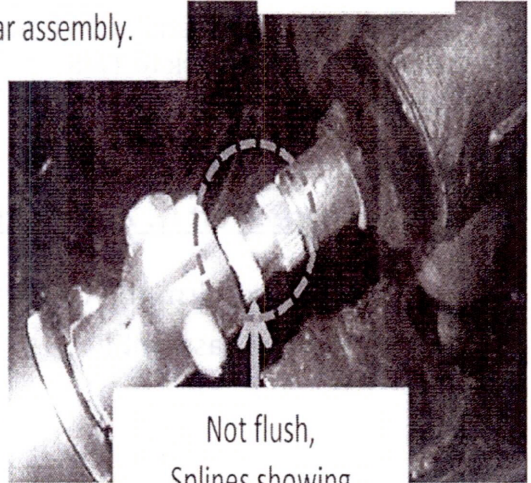
Tacoma

Not flush,
Splines showing

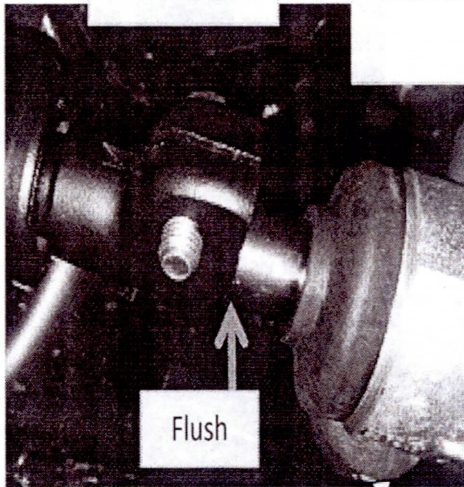
Tundra

No splines showing, intermediate
shaft no. 2 flush against steering
gear assembly.

Flush

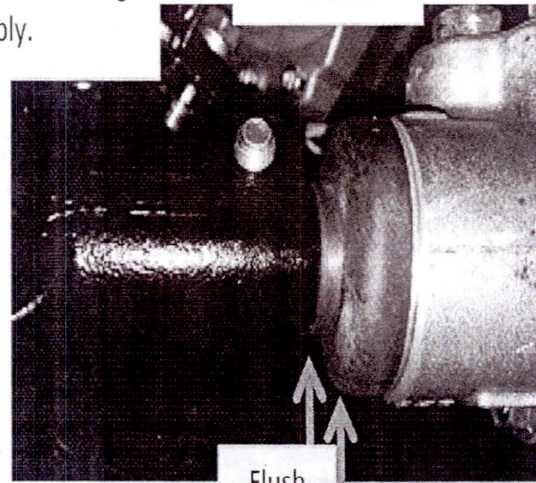
Tacoma

Flush
