## Service Bulletin

Issue Date: September 19, 2014

Subject: **Positive Battery Cable Routing**

Models Affected: Certain Collins Bus Diesel Models where no battery box is present.

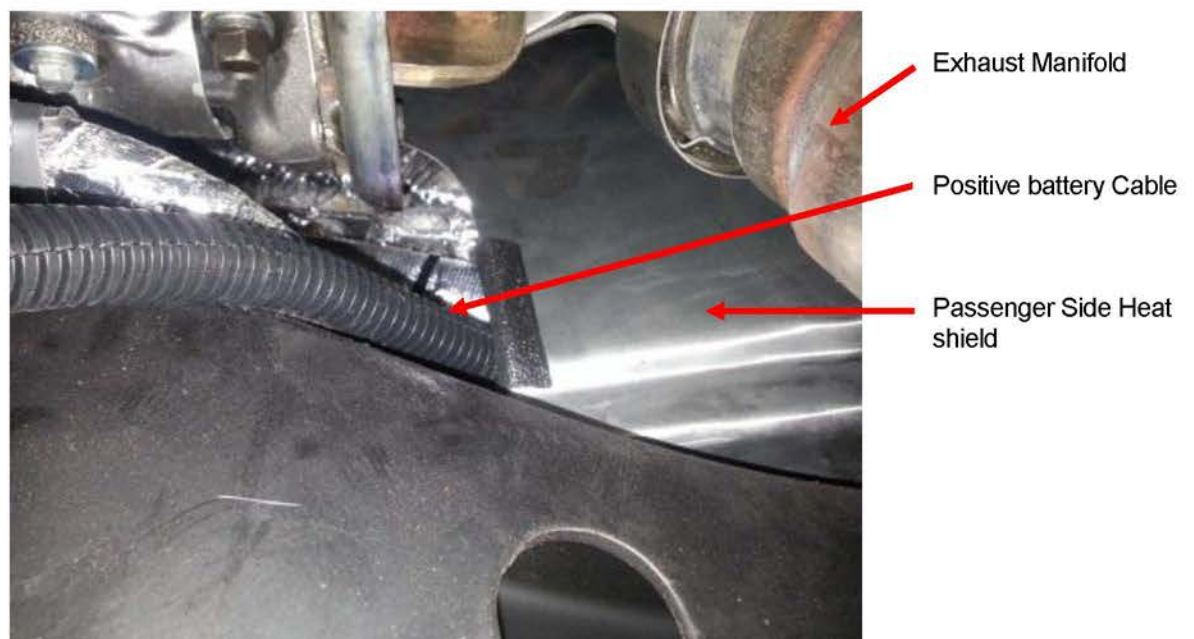
Issue: The Positive Battery Cable may have been routed under the heat shield.

Location: Passenger side between frame rail and exhaust manifold heat shield.

See Figure 1-A
