GROUP <b>Body</b>	MODEL <b>2014~2015MY Optima (QF)</b>
	NUMBER <b>PS364</b>	DATE <b>December 2014</b>

<b>SUBJECT: WATER LEAK/CONDENSATION IN REAR OUTER TAIL LAMP(S)</b>

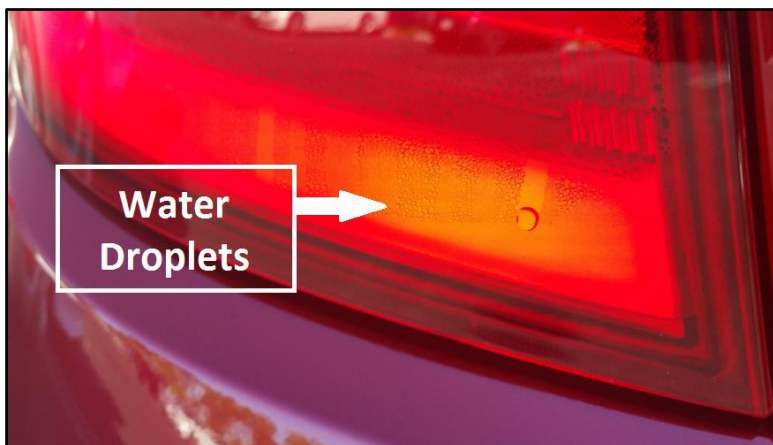
On some 2014~2015MY Optima (QF) vehicles, customers may complain about water droplets forming inside the rear tail lamp lenses following a rainstorm or after washing their vehicle. These water droplets are more visible at night and the quantity of water present is more than just a thin film of condensation which may not easily evaporate. This concern is caused by a gap between the tail lamp housing gasket and vehicle body which allows water to infiltrate into the tail lamp. To resolve this concern, order additional foam gaskets (one additional per side) and install them between the left and right tail lamps and the body of the vehicle, as outlined below.

1. Remove the affected outer tail lamp assembly and thoroughly clean the gasket surface and vehicle body of any dirt and/or debris, using a clean, damp shop towel. **NOTE: Make sure the gasket remains installed on the tail lamp housing.**
2. Add a second gasket to prevent condensation from forming inside the tail lamp. **Do not use Brake Clean in this step, damage to gasket surface may occur.**
3. Reinstall the tail lamp housing to the vehicle and torque the retaining nuts to 36~39 in-lb.
4. Reinstall all other removed components by reversing the removal process.
