ARTICLES CONTAINED IN THIS ISSUE

CODE	ARTICLE.....	PAGE
(01)	QMR of the Month.....	01
(01)	Techline New Hours of Operation	02
(01)	2015 WRX and WRX STI Launch - Your help is Needed	07
(02)	FA and FB Engine Timing Chain Tensioner Initial Setting Information.....	03
(02)	Piston Ring Installation TIPS..	04
(05)	Wheel Lug Socket Recommendation	01
(07)	2010-14 Legacy & Outback Fuse #16 Failed in the Main Fuse Box (M/B)	06
(07)	DTC P0724, Brake Switch Circuit High Input	05
(10)	2013-14 Legacy and Outback Center Console Rear Air Vent Function	08
(14)	GR8 Battery Testing Information.....	02
(15)	2010-14 Outback Rear Bumper Underguard Accessory Reminder	06

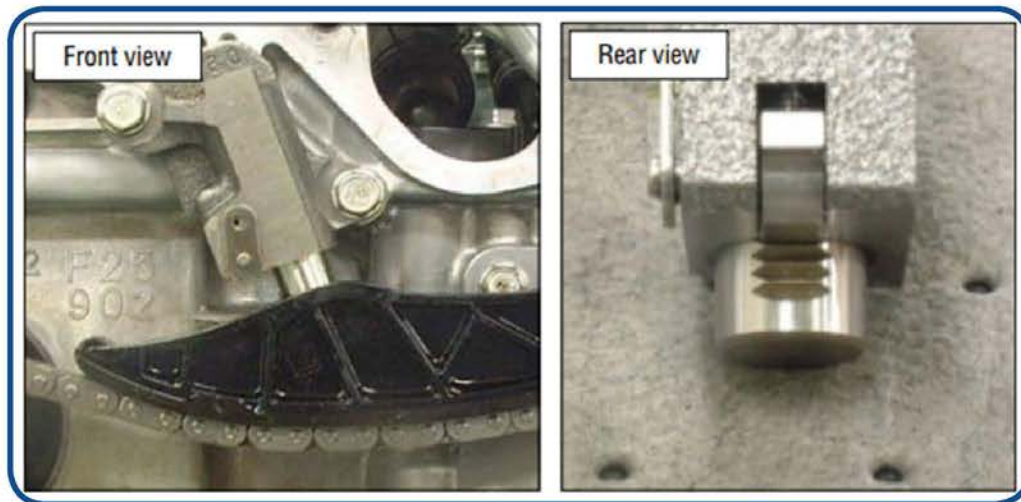
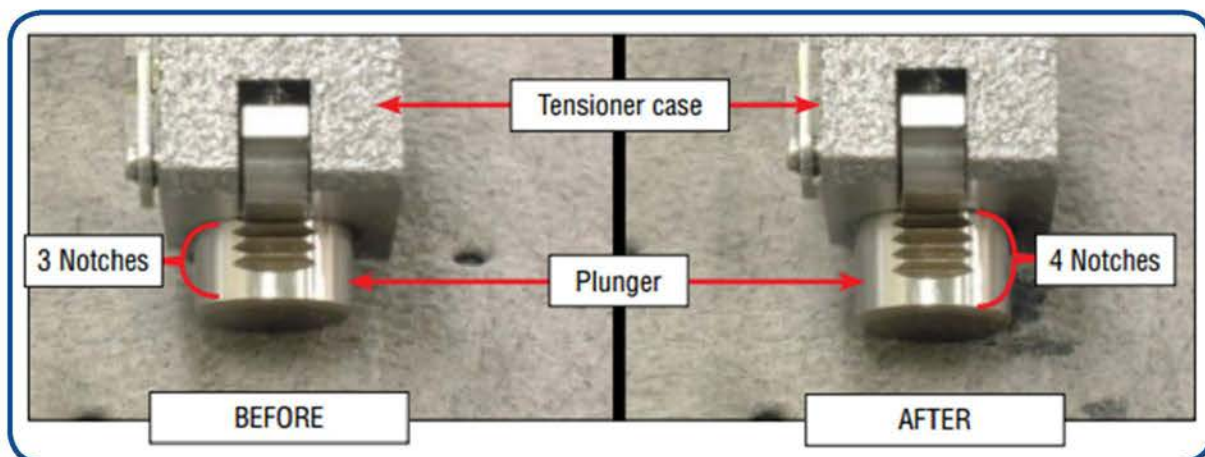
The Techline continues to receive calls regarding a cold engine tapping sound heard on initial start-up. In some cases, it is heard after engine repairs involving timing chain R&R are involved. In 2011, we released TSB# 02-113-11R on this subject. When reassembling the engine's timing chain components and performing the initial setting for of the chain tensioners, it is important to get that "extra click" out of BOTH tensioners as described below to minimize the chances of the cold engine sound reoccurring.

For example: If after timing component reassembly, you have 3 notches showing on the plunger, push down firmly on the upper chain guide to get the extra click so you end up having 4 notches showing. If you have 4 notches showing, you want to get the extra click to end up with 5. Whether you start with 3 notches or 4 showing depends on the amount of wear there is on the guides and timing chain.

- Use a small mechanic's mirror to help view the adjustment notches as they face the engine block and are difficult to see.

NOTE: It is **NOT RECOMMENDED** to use a pair of large channel lock-type pliers to squeeze the chain guides together and achieve the desired tensioner setting. Damage to the guides will likely result.

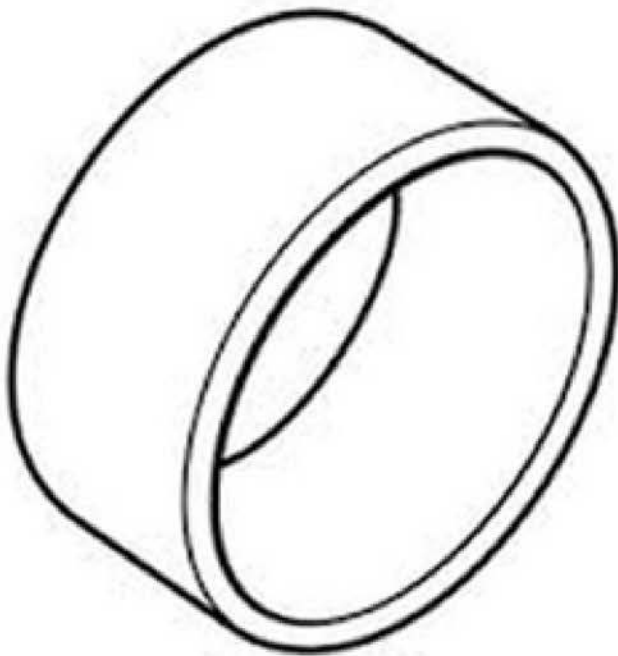
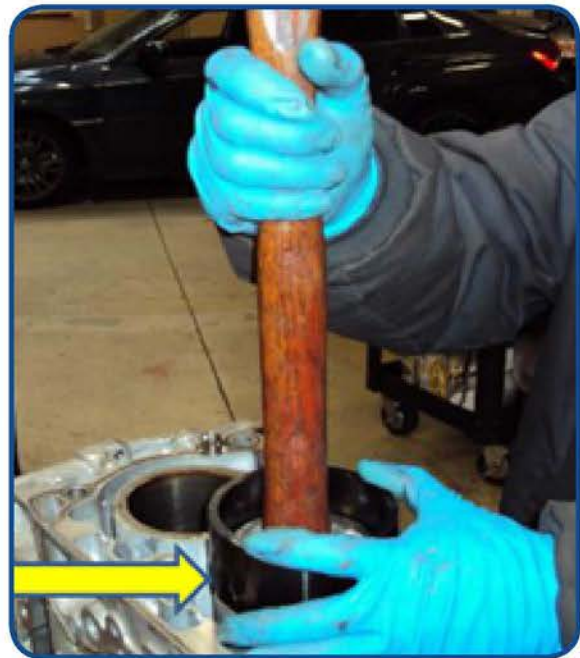
The Techline has received a limited number of reports with concerns of unusual oil consumption even after piston ring replacement. Most times, this condition is a result of incorrect piston ring installation resulting in either oil control rings being damaged or the piston ring end gaps becoming lined up. To build upon the piston ring replacement procedures included in the three recent surface treatment change to oil control / piston ring TSBs, the following tips are provided below.

All three bulletins (02-143-13R, 02-144-13R and 02-145-13R) recommend the use of the factory tapered or non-adjustable - type piston ring compressor, J-50553 for 2.5L FB engines and J-50984 for 2.0L FA engines as illustrated below.

This type of piston ring compressor takes the guesswork out of whether the rings are compressed sufficiently to enter the cylinder. This can be difficult to determine when using an adjustable band - type compressor resulting in a grip that may be too tight or too loose on the piston assembly. It also provides the best “seal” to the block deck surface when installing the piston assembly into the bore and minimizes the chance of oil scraper rings popping out from between the ring compressor and the block deck surface. It is important to always hold the compressor firmly on the block surface as shown in the above, right photo. Use one firm, direct motion for the actual piston assembly insertion. If an oil scraper ring is displaced during engine assembly, severe piston and cylinder wall damage will result. At that point, the need for a short block replacement is virtually guaranteed. The photos below illustrate damage that occurred when an improperly installed oil control ring went undetected during engine reassembly. Always turn the engine over after each piston assembly is installed and develop a “feel” for how much turning effort is required. If it doesn’t “feel” right and seems to take more effort than normal, a loose / bent over scraper ring might just be the cause. In addition, check for any unusual vertical markings on the cylinder walls after rotating the crankshaft by hand. The photo at the top of page five (5), on the left, shows an upper oil scraper ring bent over and on the right, the resultant damage to the cylinder wall after the engine was taken apart again because of persistent, unusual oil consumption.

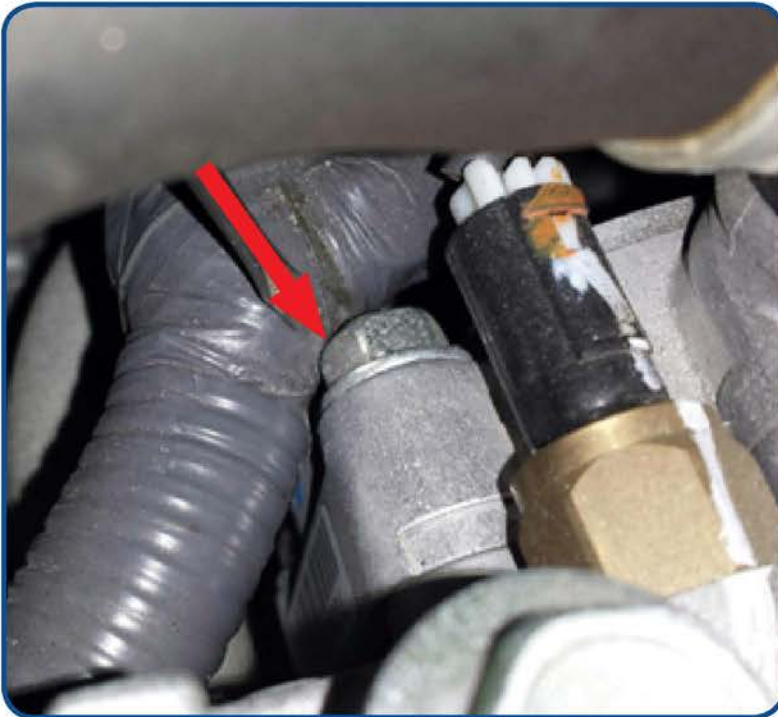
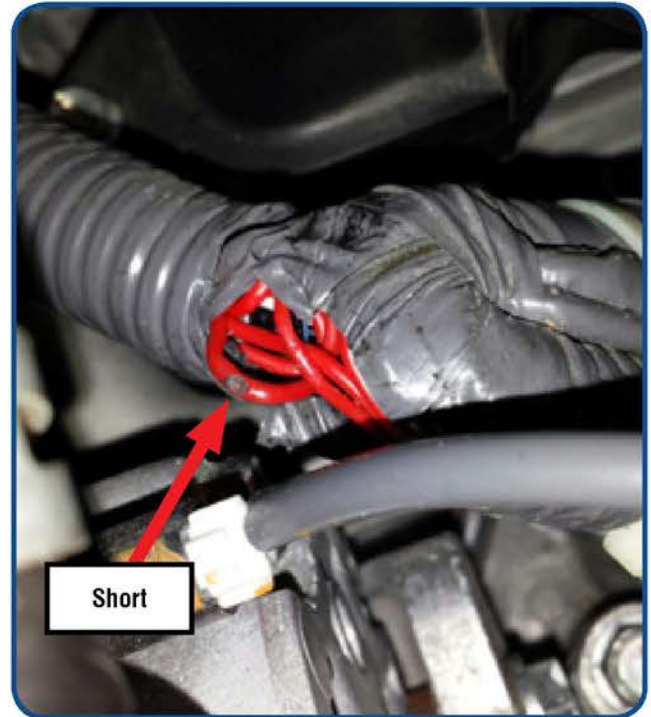
If you encounter a vehicle with electrical concerns and find fuse #16 in the under-hood fuse box (M/B) failed, inspect the engine wiring harness in the area of the power steering pump mounting bolt closest to the pressure switch for chafing or rub-through. The photos below show the area to inspect and damage to the harness which resulted in a short to ground and the root cause for the open fuse #16. This information applies to both H4 and H6 models.

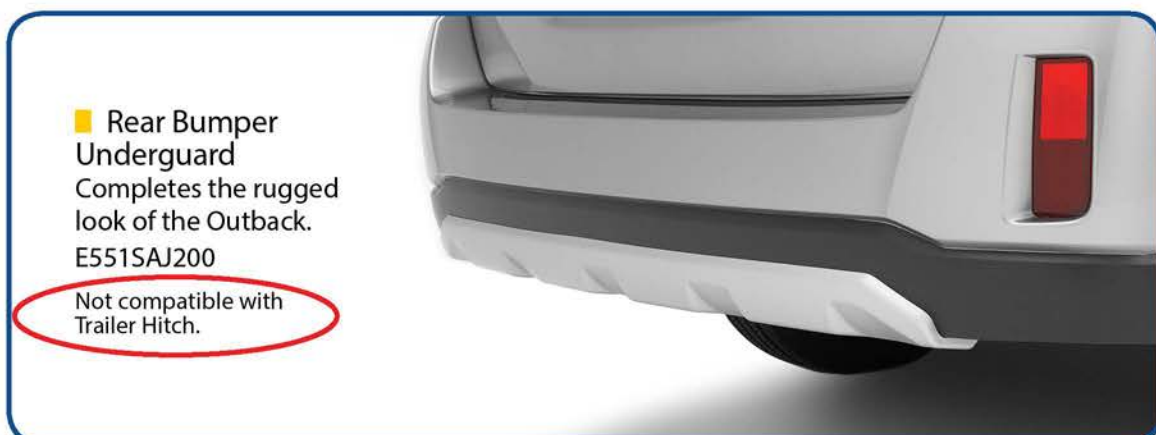
As per the Outback accessory brochure, when accessorizing a 2010-2014MY Outback, the Rear Bumper Underguard accessory, E551SAJ200 is not compatible with the L101SAJ001 Trailer Hitch accessory as shown below.
