# Special Service Message

**SSM 71238 - Exhaust sound enhancement vacuum pump - correct routing**

**Models :** X152 - F-Type

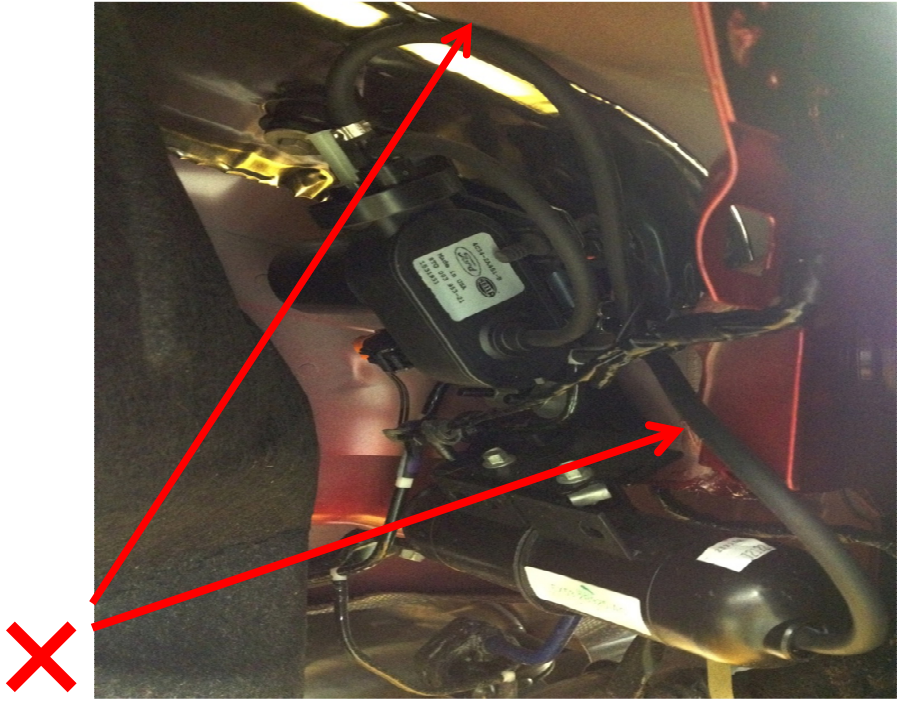
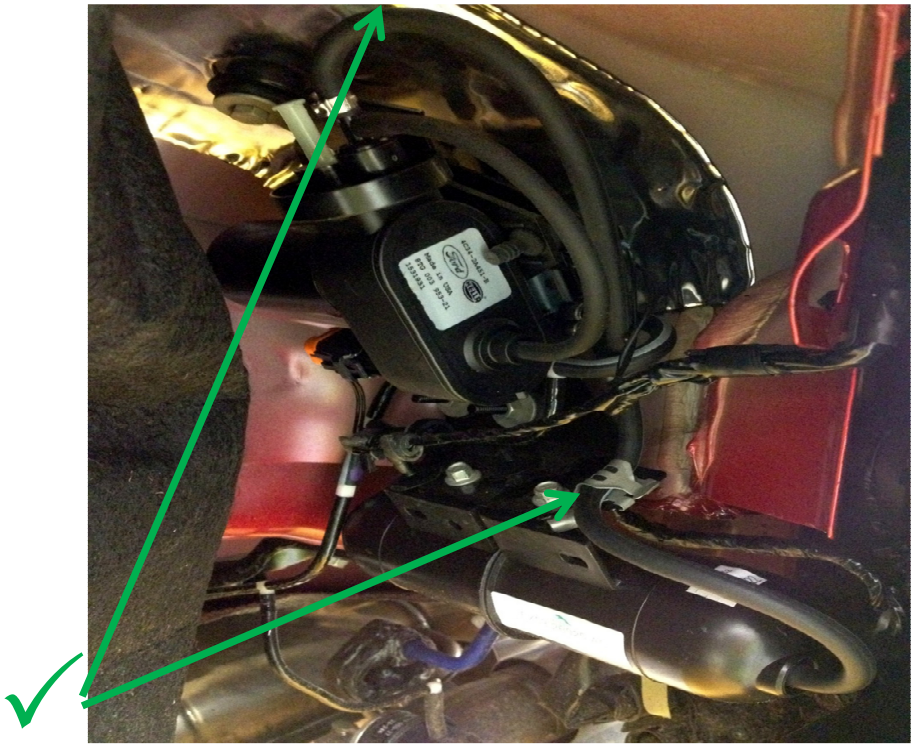
**File :** [SSM71238 Vac hose1.pdf](#)

**Content :** Issue: A Customer may report a noise in the cabin area, that may appear to be coming from the rear left hand side of the Vehicle

Cause: This may be due to the vacuum hose on the exhaust sound vacuum pump, being in contact with the Body.

The attachment shows the correct location for the vacuum hose and the location for the fitment of an additional clip. Part number C2S17736 Clip.

Action: Refer to TOPIx, workshop manual section 16768, exhaust system 309-00B.
