Special Service Message

SSM 71358 - XJ Door veneer speaker noise `tizz / buzz`

Models : X351 - XJ

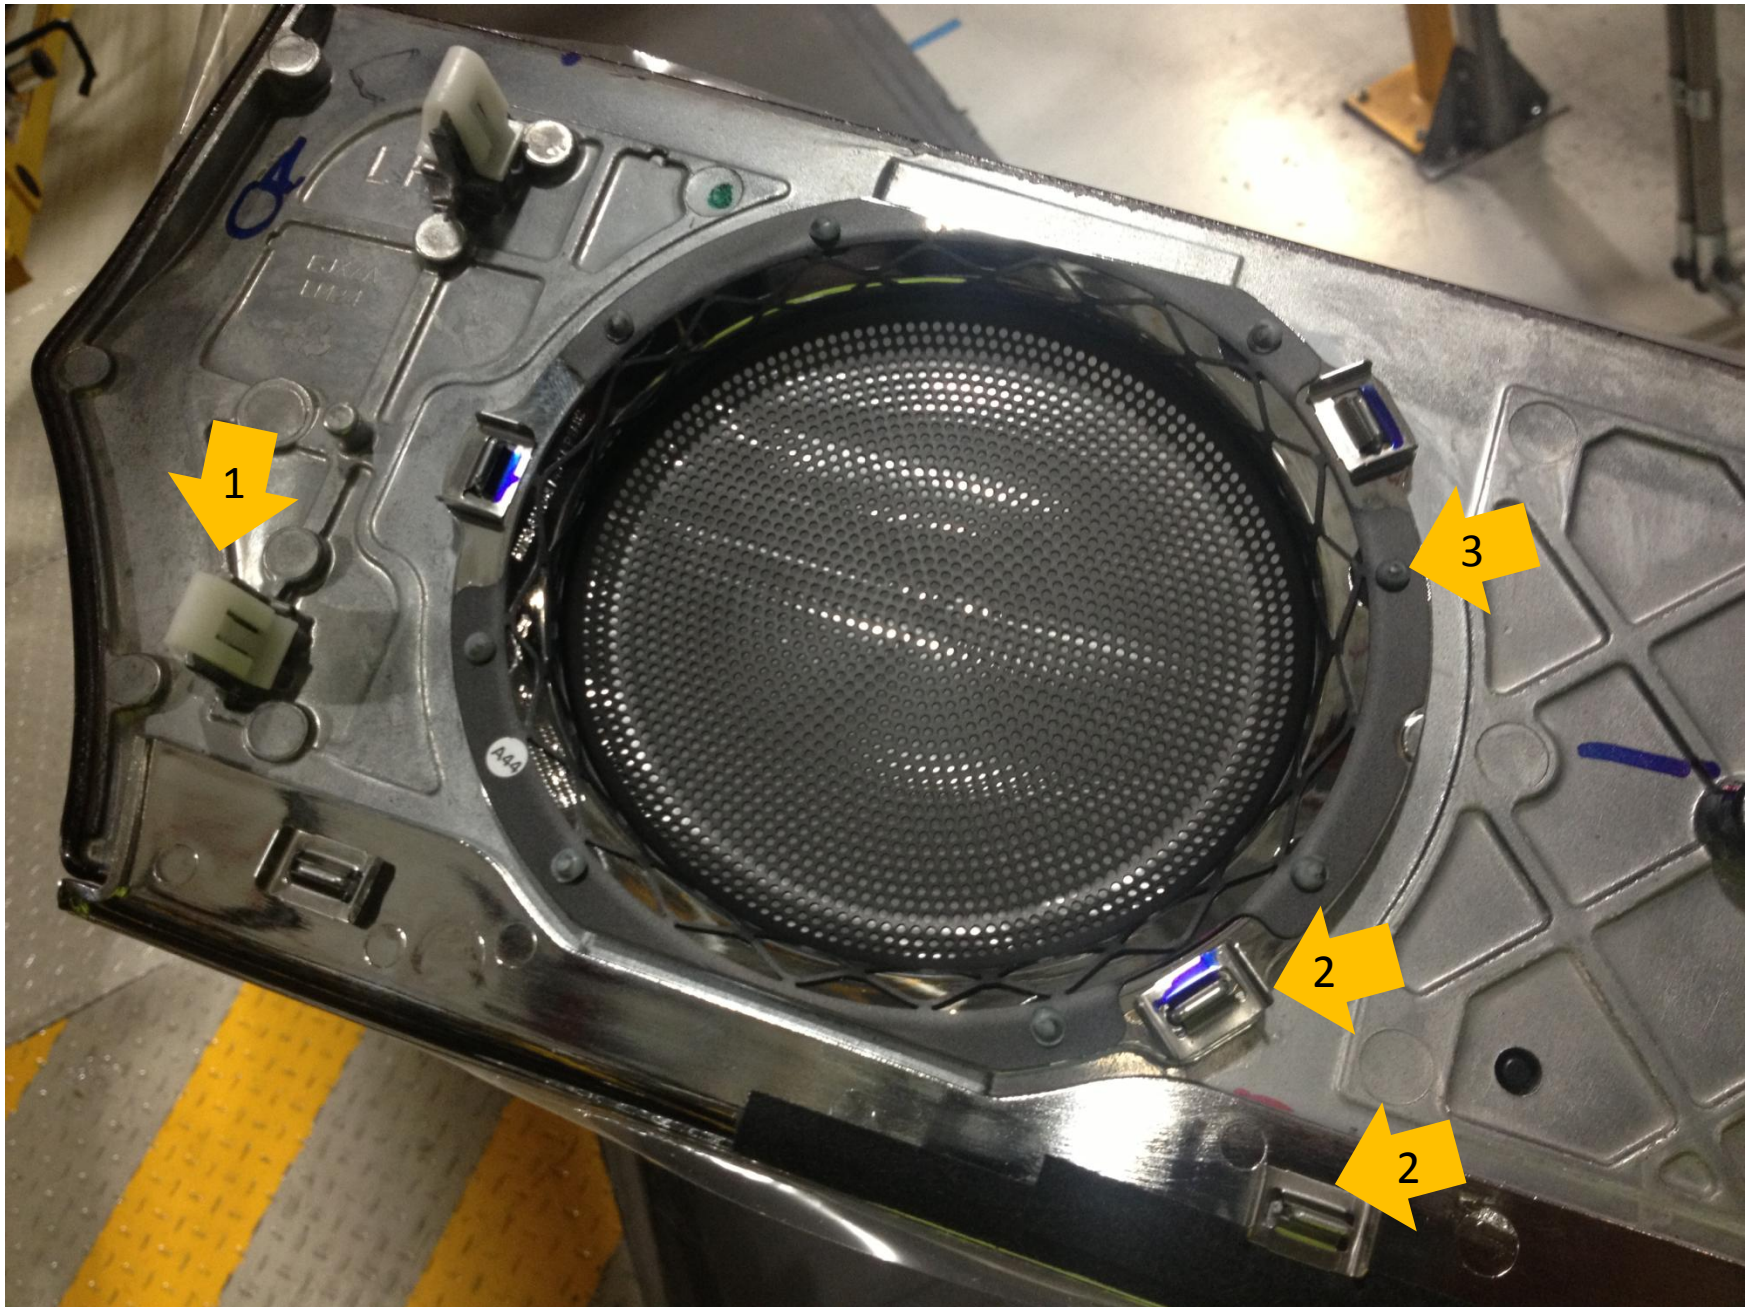
File : [XJ Speaker Tizz image - SSM.pdf](#)

Content : Issue: Tizzing / buzzing sound from door speaker when veneer reinstalled

Cause: Fixings incorrectly located / not renewed

When refitting a door veneer please note the following;

1) Veneer clips **MUST** be renewed when refitting back to door casing (*see arrow 1 for an example of a veneer clip*) Part Number C2D10041 - 2 of required per door veneer.

- These clips will engage onto the veneer backing with a positive click.

- NEVER reuse old clips.

2) Check the metal clips are fully engaged. (*see arrow 2 for an example of a metal clip fully engaged*)

3) Check the condition of the staked fixings. These should have a good purchase on the metal ring beneath them and not be loose (*see arrow 3 for an example of the staked fixings*)
