TECHNICAL BULLETIN
LTB00557NAS2
23 JAN 2014

Knock Sound From Front Suspension

Range Rover (LG)

Model Year: 2013 Onwards

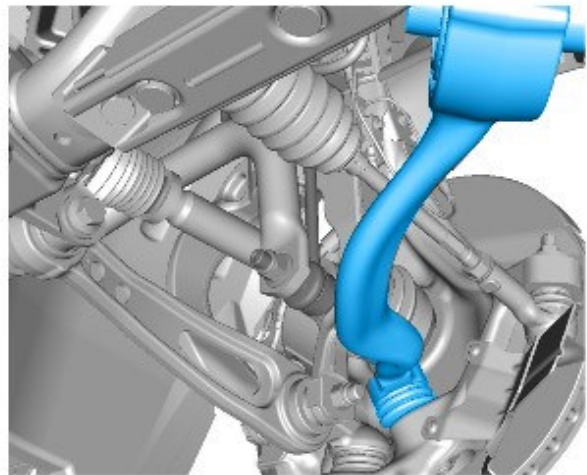
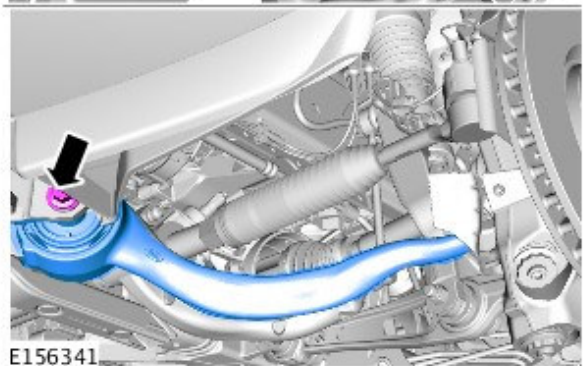
P3 Lower Control Arm to Frame

**NOTE: Minimum Torque: 190Nm (refer to table 1).**

- If the measured torque is less than the minimum residual torque shown, the fixing should be replaced with new and torque with reference to TOPIX Workshop Manual section 204-01: Front Suspension.

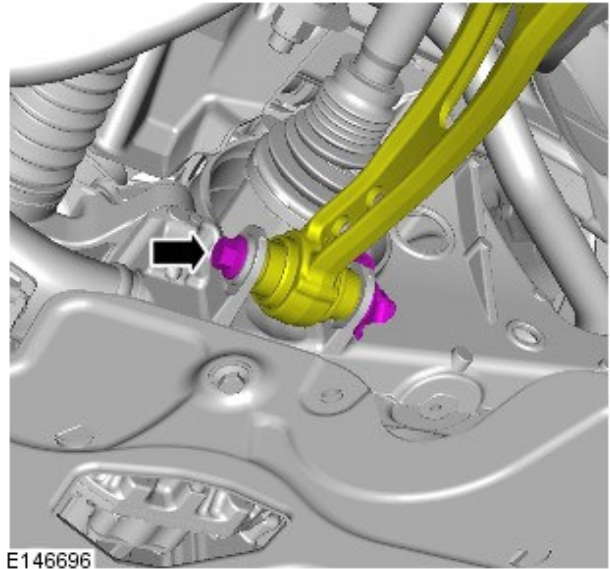
P4 Lower Control Arm to Frame

**NOTE: Minimum Torque: 190Nm (refer to table 1).**

- If the measured torque is less than the minimum residual torque shown, the fixing should be replaced with new and torque with reference to TOPIX Workshop Manual section 204-01: Front Suspension.

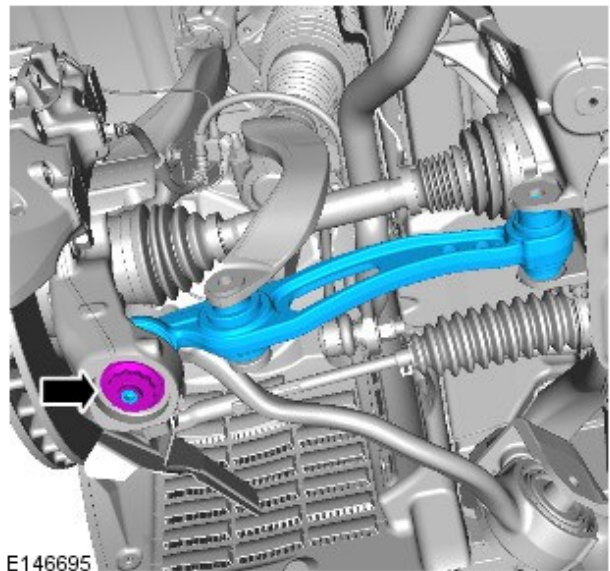
P6 Lower Ball Joint Knuckle (Lower Arm Rear)

**NOTE: Minimum Torque: 273Nm (refer to table 1).**

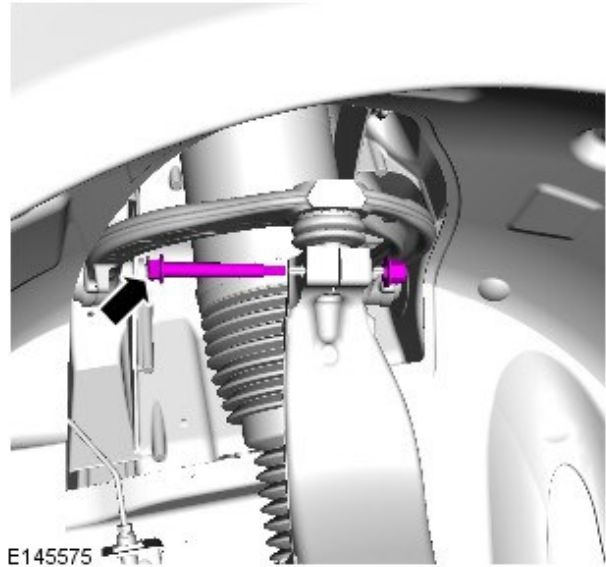
P7 Upper Control Arm to Knuckle

**NOTE: Minimum Torque: 60Nm (refer to table 1).**

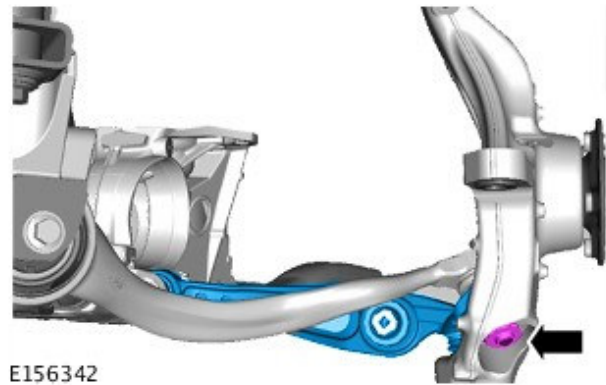
P40 Lower Ball Joint Knuckle (Lower Arm Front)

**NOTE: Minimum Torque: 273Nm (refer to table 1).**

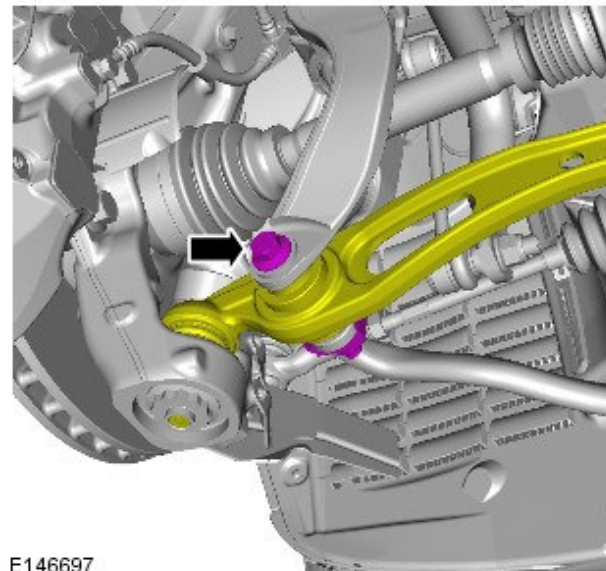
P56 Adaptive Shock Absorber Yoke to Lower Control Arm.

**NOTE: Minimum Torque: 210Nm (refer to table 1).**

- If the measured torque is less than the minimum residual torque shown, the fixing should be replaced with new and torque with reference to TOPIX Workshop Manual section 204-01: Front Suspension.

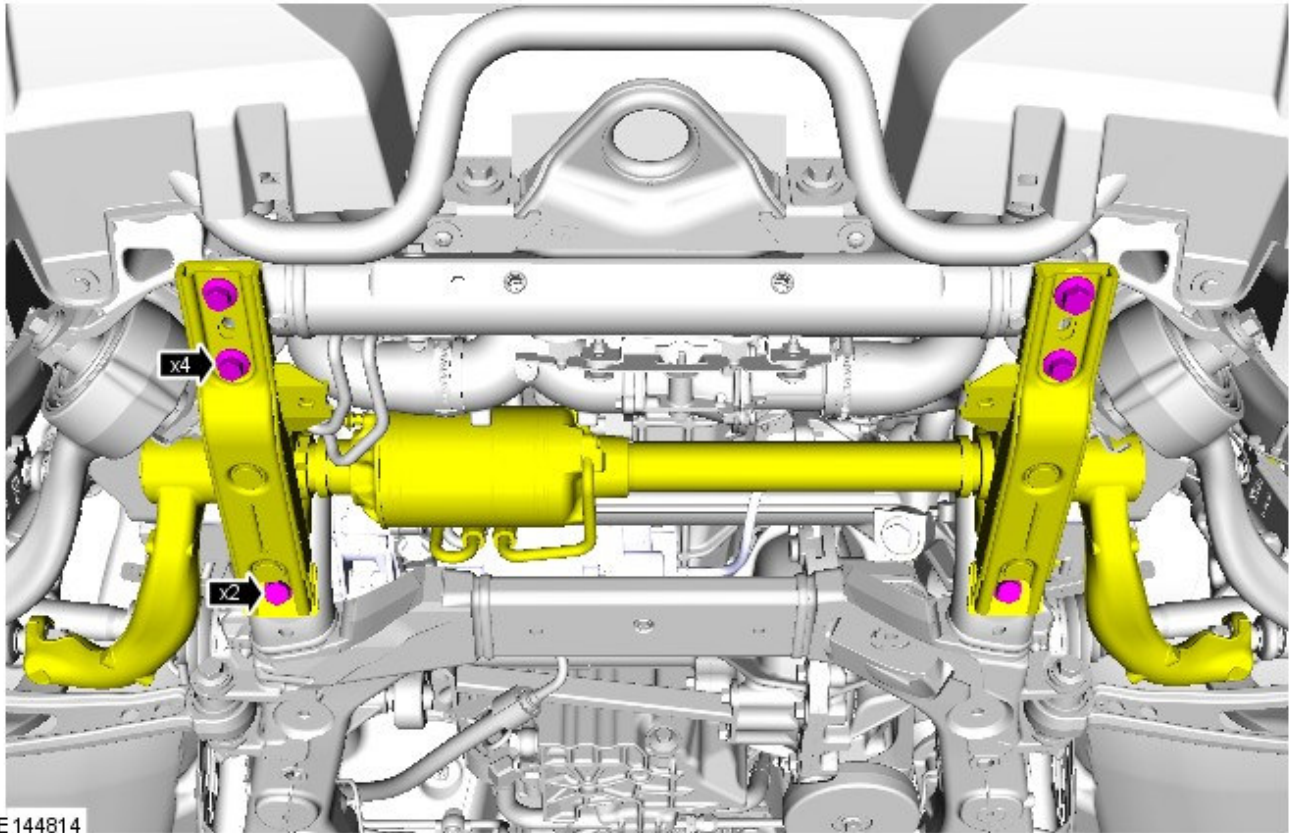
Dynamic Response Front Actuator Ski Bracket

**NOTE: M12 x 4 off Minimum Torque: 140Nm; M14 x 2 off Minimum Torque: 230Nm (refer to table 1).**

- If the measured torque is less than the minimum residual torque shown, the fixing should be replaced with new and torque with reference to TOPIX Workshop Manual section 204:01: Front Suspension.

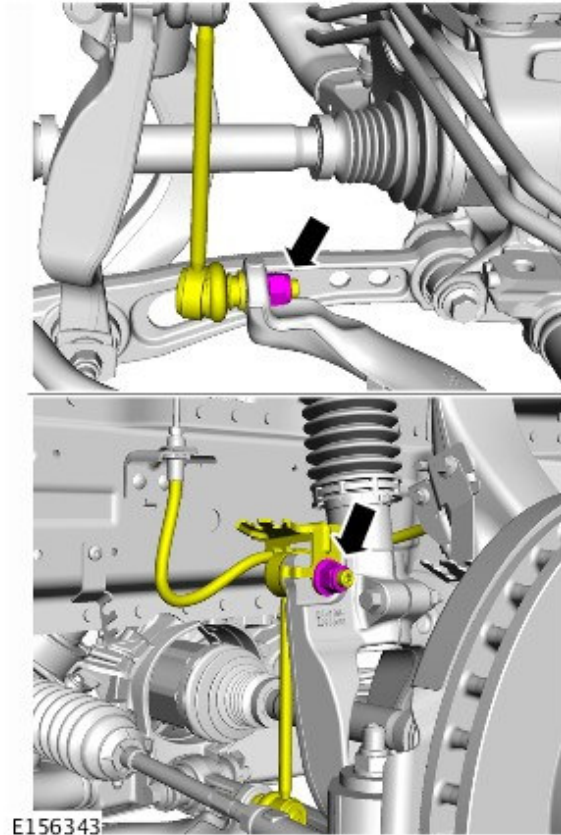
Front Stabilizer Links, Actuator Bar Arms to Knuckle

**NOTE: Minimum Torque: 174Nm (refer to table 1).**

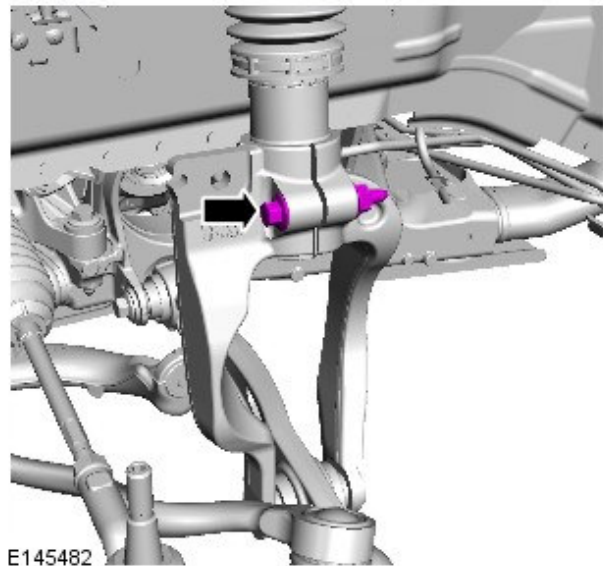
Pinch Bolt - Front Air Strut to Yoke

**NOTE: Minimum Torque: 89Nm (refer to table 1).**

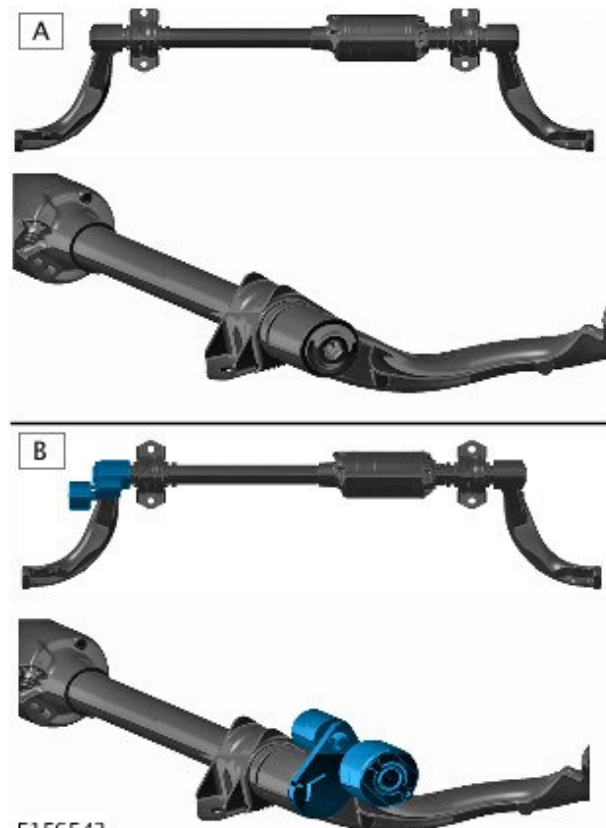
E156543

**NOTE: If any of the six (6) Dynamic Response front actuator ski bracket bolts have been removed on three (3) previous occasions, steel inserts are required to be fitted into the subframe (see TOPIx Workshop Manual section 502-00: Thread repair inserts).**

2013MY vehicles: If the knocking noise is still present and considered unacceptable after performing above steps, replace the Dynamic Response front actuator (vehicles fitted with Dynamic Response System [part number LR052058], shown as **B** in E156543; see TOPIx Workshop Manual section 204-06: Ride and Handling Optimisation - Front Stabilizer Bar). **2014MY vehicles from VIN EA125193 will have the latest level parts already fitted.**
