TECHNICAL BULLETIN  
LTB00618NAS1  
06 JAN 2014

**SECTION: 303-01**

'Click' / 'Rattle' Noise From Engine Compartment When Driving

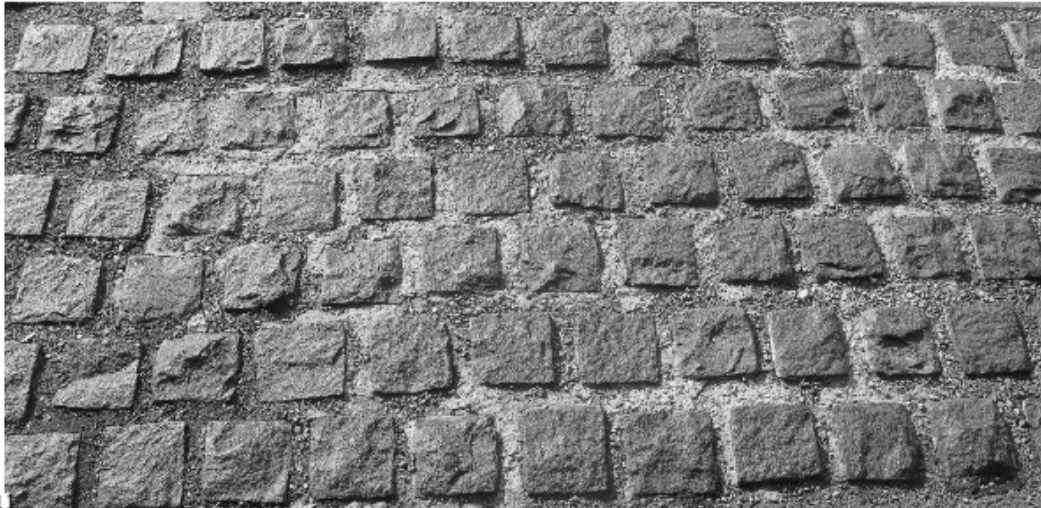
E15961

1. Typical road surface that can generate the 'rattle' sound.

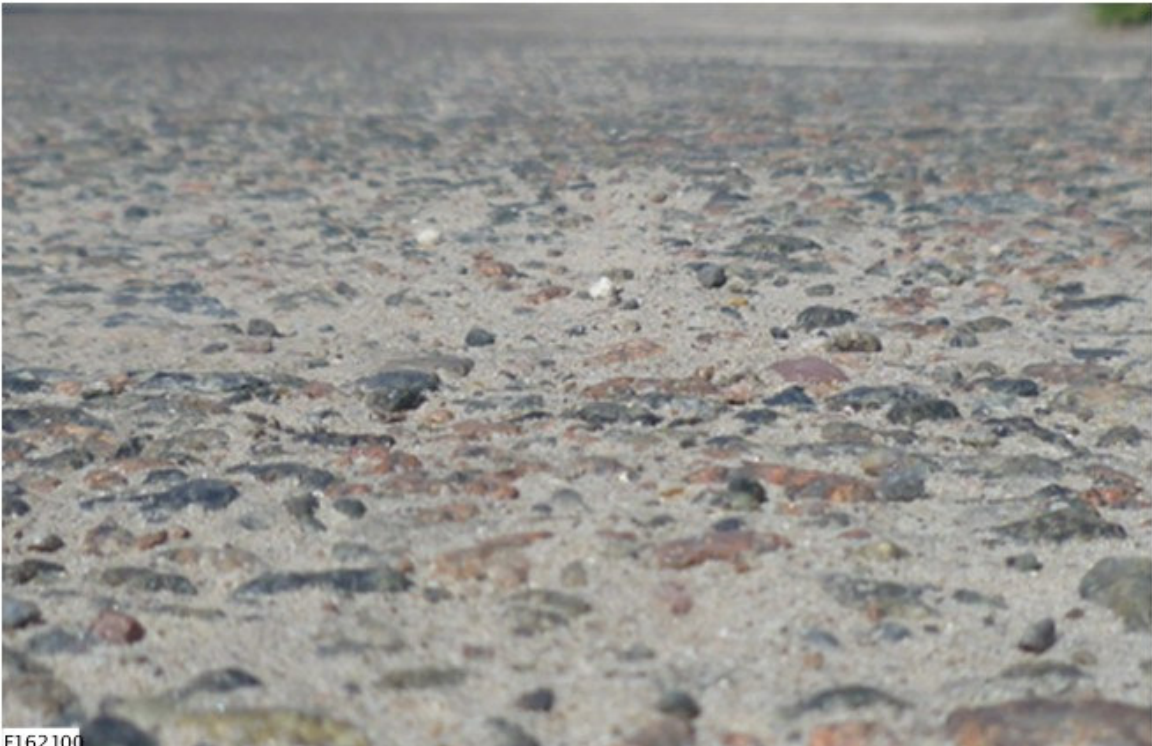
E162100

2. Typical road surface that can generate the 'rattle' sound.
