TECHNICAL BULLETIN LTB00626NAS1 06 JAN 2014

<u>SECTION: 419-01A</u>

Alarm False Activation / 'Hood Open' Message Displayed on Instrument Cluster

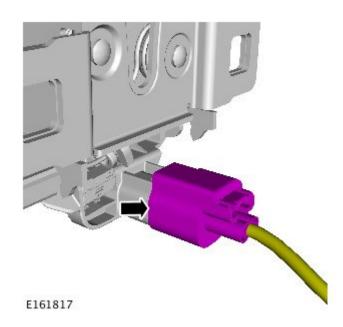
3. Disconnect the electrical connector on the hood switch.
