TECHNICAL BULLETIN
LTB00628NAS1
10 JAN 2014

SECTION: 501-28A / -28B

Roof Panel Damaged By A-Pillar Trim

Range Rover Evoque (LV)

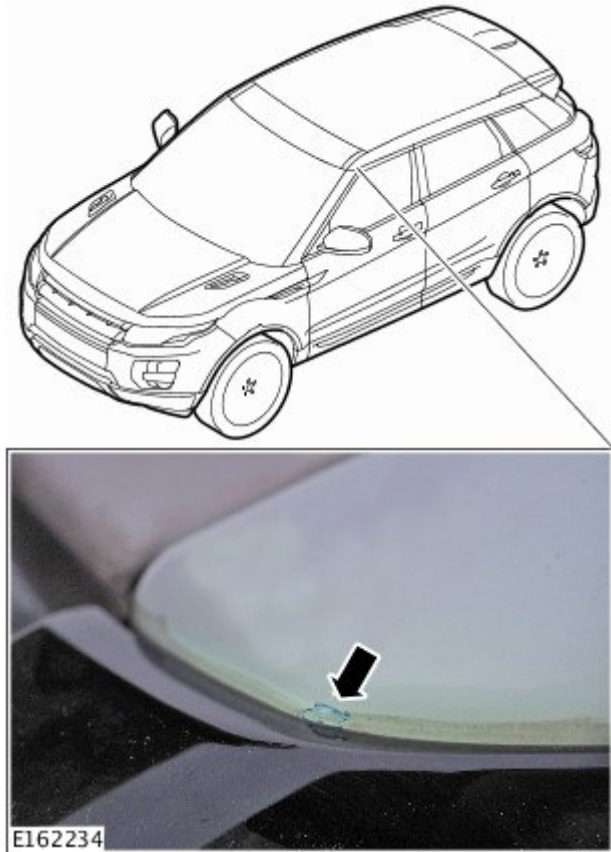
1.

Situation: Paint damage to the roof panel at the A-pillar area may be evident.

Cause: This may be caused by a clash between the A-pillar trim and roof panel.

Inspect both sides of the vehicle roof panel for damage in the area shown.
