Special Service Message

SSM 71420 - Primary door seals coming adrift

Models : LF - Freelander 2 / FL2

LV - Evoque

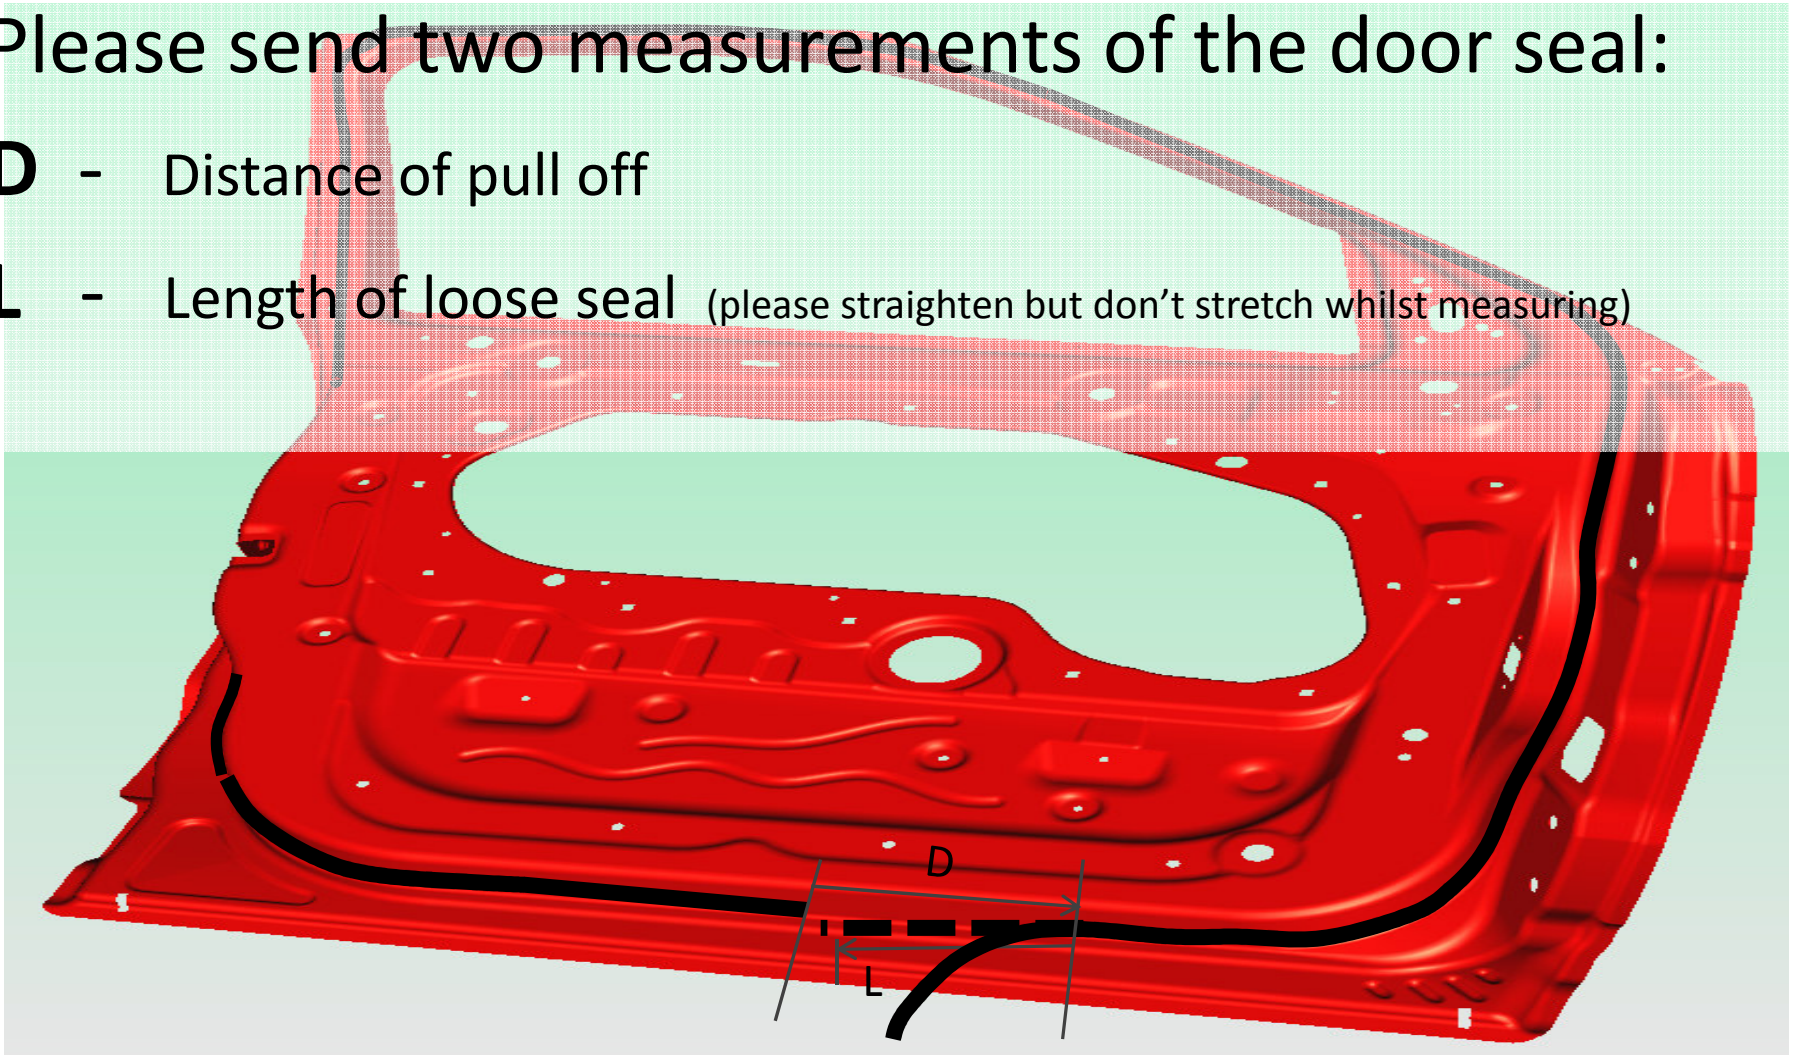
Door seal adrift

Content : **Issue:** The primary door seals come adrift from the body at the bottom of the door aperture.

Please send two measurements of the door seal:

D - Distance of pull off

L - Length of loose seal (please straighten but don't stretch whilst measuring)

Action: Please raise an EPQR detailing the measurements as shown in the attachment
