TECHNICAL BULLETIN
LTB00625NAS1
28 APR 2014

SECTION: 204-00

'Knock' Sound From Front Suspension

Range Rover Sport (LW)

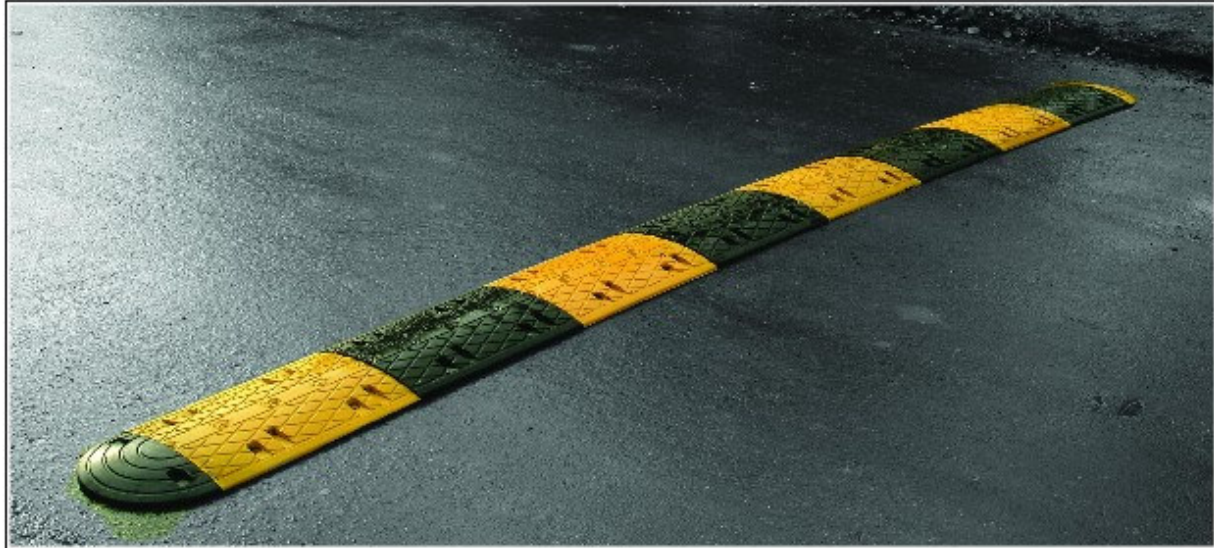
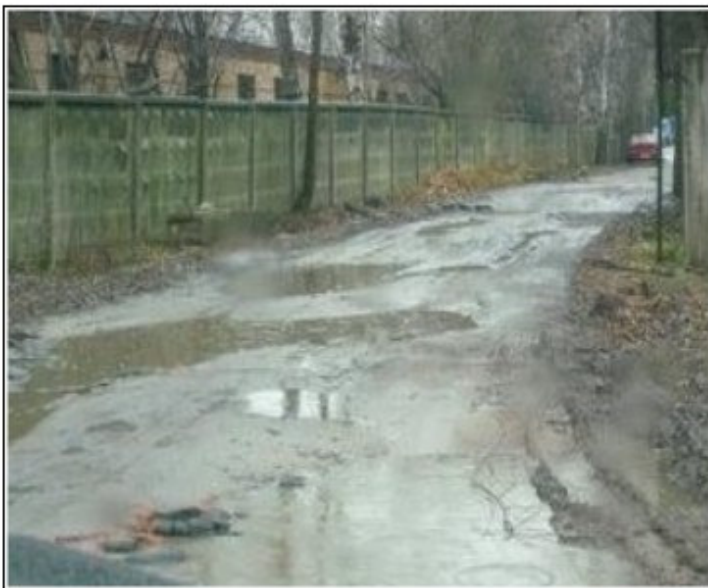
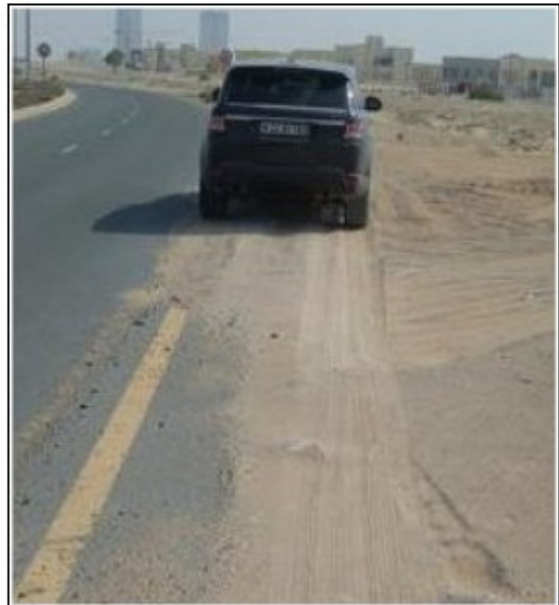
E162272

2. SYMPTOM: 'rattle' noise:

- **Drive Cycle / Conditions:** 'rattle' noise occurs when driving at speeds up to 20mph (32kmh) over surfaces shown

- **Action:** refer to Technical Bulletin LTB00618NAS, 'Click' / 'Rattle' Noise From Engine Compartment When Driving.

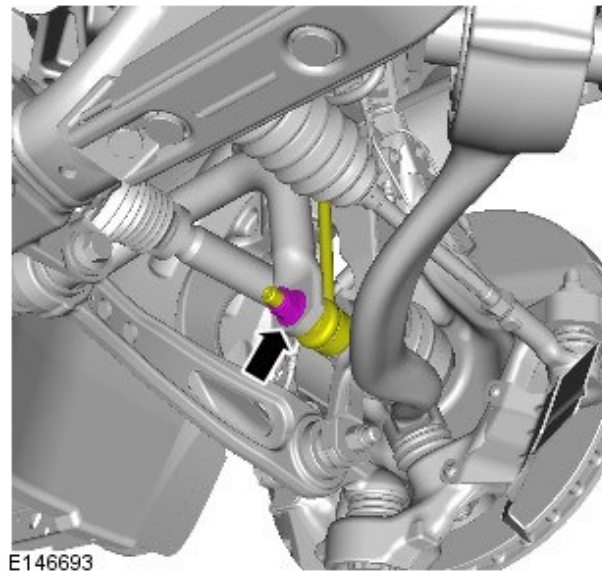
**NOTE: a small amount of pivot is normal.**

Check the front stabilizer bar links for visible play:

- Grasp the link by hand and attempt to move it up/down.
- If visible play is found, renew the stabilizer bar link (s).
- If visible play is not found, continue to the next step.

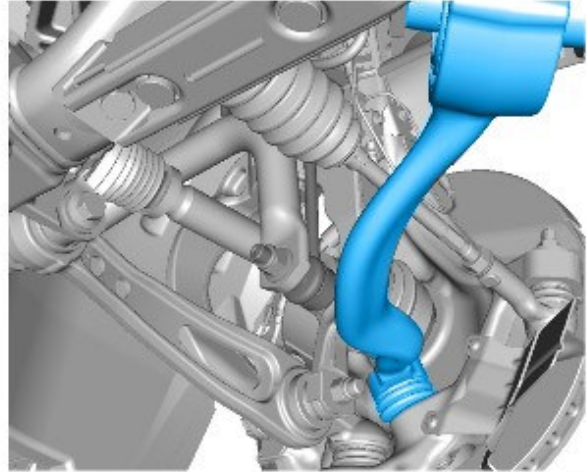
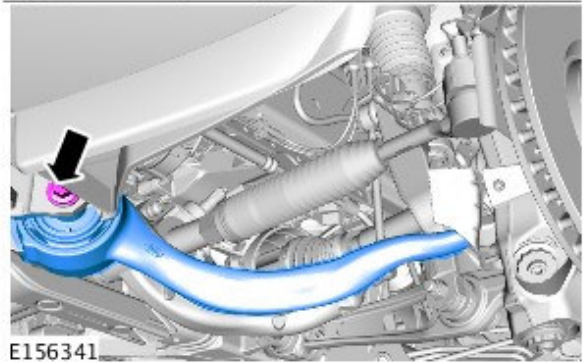
P3 Lower Control Arm to Frame

**NOTE: minimum torque: 190Nm (refer to TABLE 1).**

- If the measured torque is less than the minimum residual torque shown, the fixing should be replaced with new and torque with reference to TOPIX Workshop Manual, section 204-01.

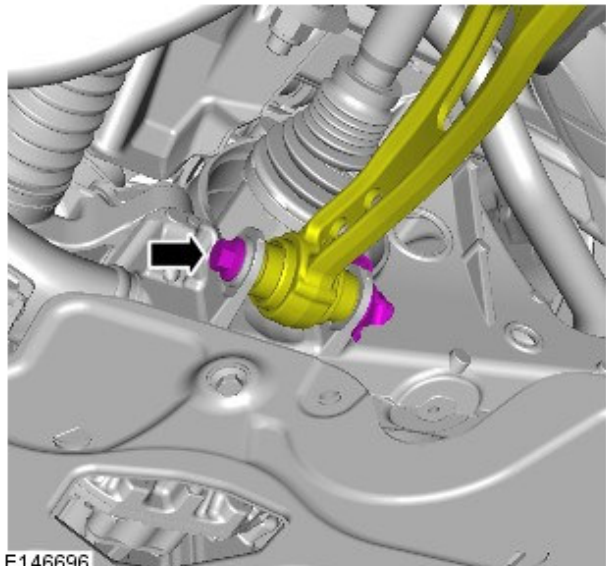
P4 Lower Control Arm to Frame

**NOTE: minimum torque: 190Nm (refer to TABLE 1).**

- If the measured torque is less than the minimum residual torque shown, the fixing should be replaced with new and torque with reference to TOPIX Workshop Manual, section 204-01.

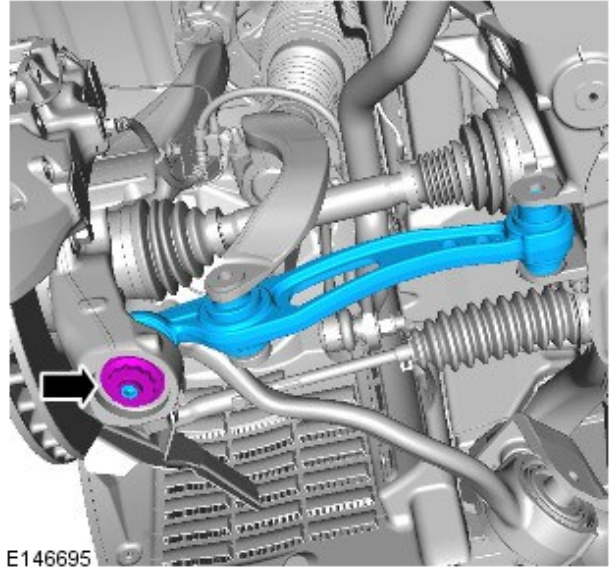
P6 Lower Ball Joint Knuckle (Lower Arm Rear)

**NOTE: minimum torque: 273Nm (refer to TABLE 1).**

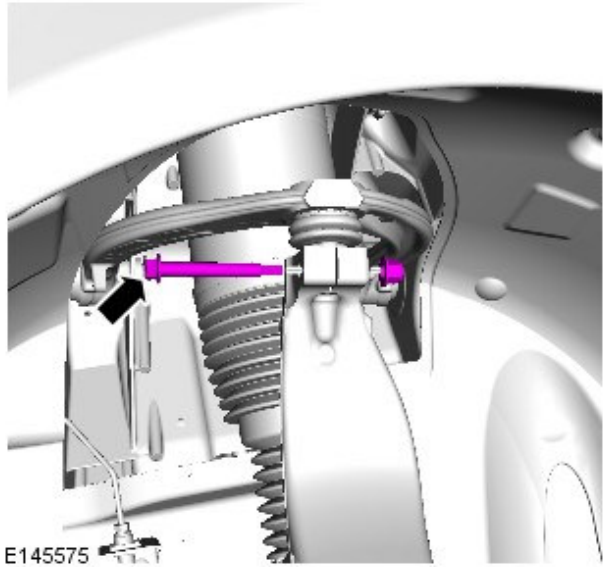
P7 Upper Control Arm to Knuckle

**NOTE: minimum torque: 60Nm (refer to TABLE 1).**

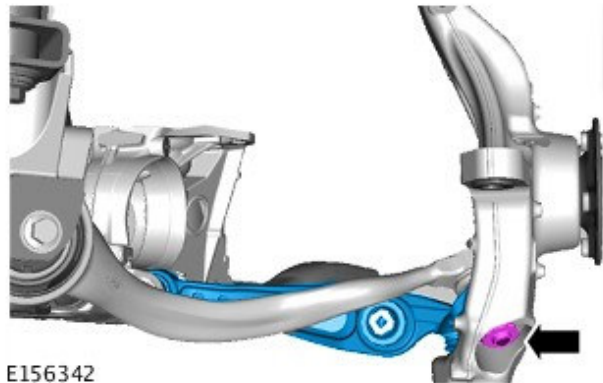
P40 Lower Ball Joint Knuckle (Lower Arm Front)

**NOTE: minimum torque: 273Nm (refer to TABLE 1).**

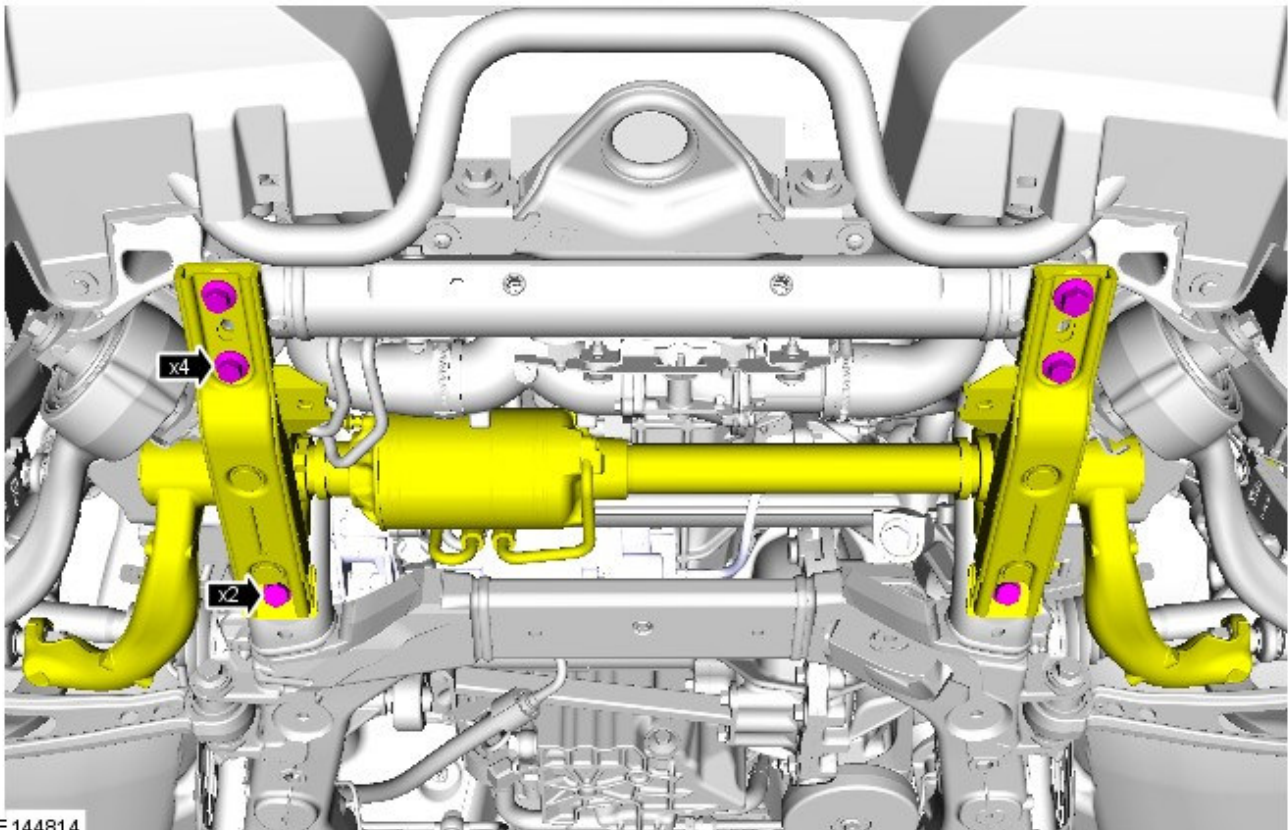
Dynamic Response Front Actuator Ski Bracket

**NOTE: M12 x 4 off minimum torque: 140Nm; M14 x 2 off minimum torque: 230Nm (refer to TABLE 1).**

- If the measured torque is less than the minimum residual torque shown, the fixing should be replaced with new and torque with reference to TOPIx Workshop Manual, section 204:01.

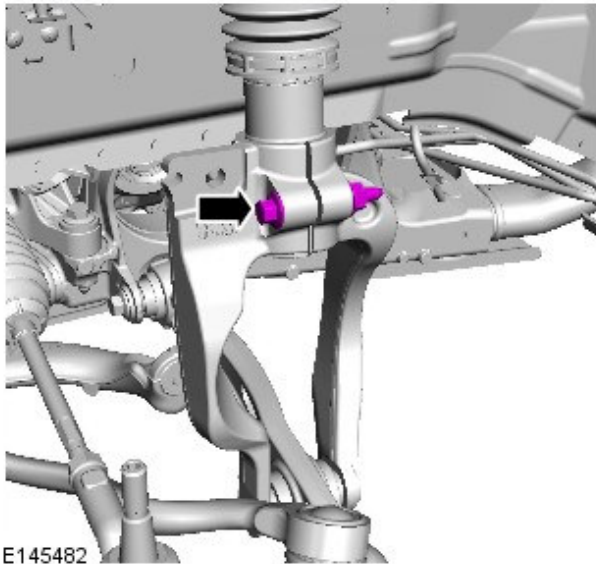
Pinch Bolt - Front Air Strut to Yoke

**NOTE: minimum torque: 89Nm (refer to TABLE 1).**

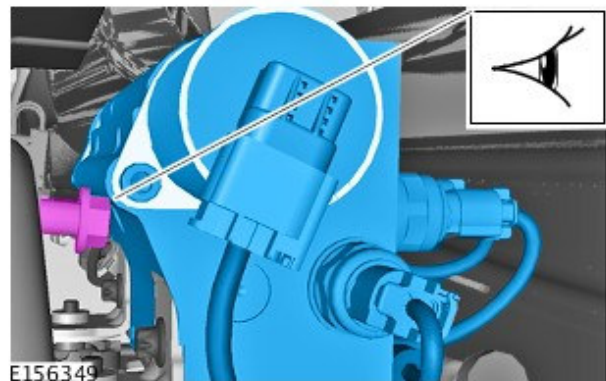
Valve Block to Body Stud Clearance

23. **NOTE: View of the end of hydraulic valve block from front of vehicle.**

- There should be 5mm clearance between the valve block body and the plastic body fastener that secures the fuel lines. Where no or very little clearance exists, the head of the fastener should be modified, by removing it and drilling an axial hole 5mm diameter through the head, so that the body stud passes through the head of the fixing.

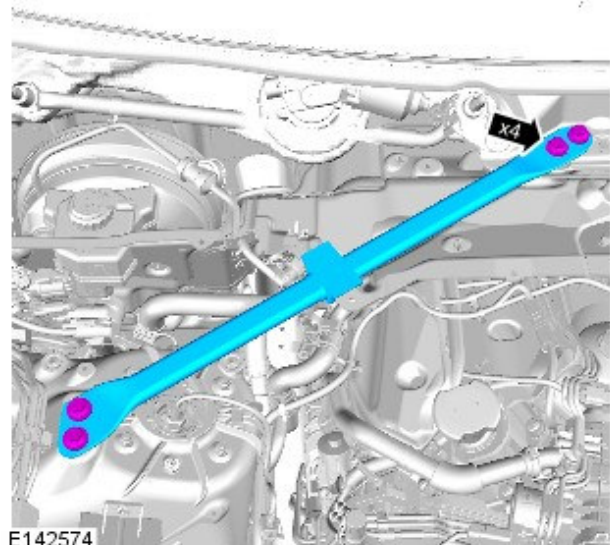
E142574

**NOTE: If the knocking noise is still present and considered unacceptable after performing the above steps, remove and discard both underhood strut brace bars.**

27. Remove both strut brace bars.
