TECHNICAL BULLETIN
Q336 UPS5513-5bNAS1
11 APR 2014

SECTION: 417-02

Update Prior to Sale: Door Interior Release Handle Lamp Operation

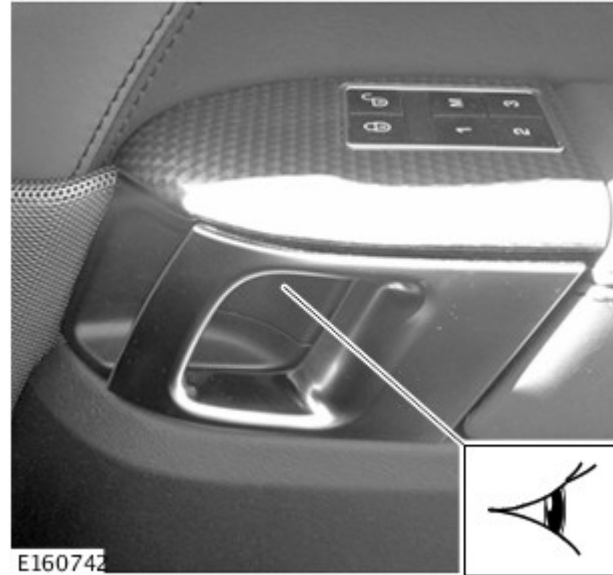
1. Turn the side lights 'ON'.
2. Check that the small white lamp at the front right door interior release handle aperture is

illuminated.

3. Carry out step 2 to the other three door interior release handle apertures / lamps:

- If the lamp is working on all the door interior release handle apertures, turn side lights 'OFF' and release the vehicle; no further necessary.
- If the lamp is not working on any of the door interior release handle apertures, turn side lights 'OFF' and continue to the next step.
