TECHNICAL BULLETIN

LTB00557NAS3

SECTION: 204-00

'Knock' Sound From Front Suspension

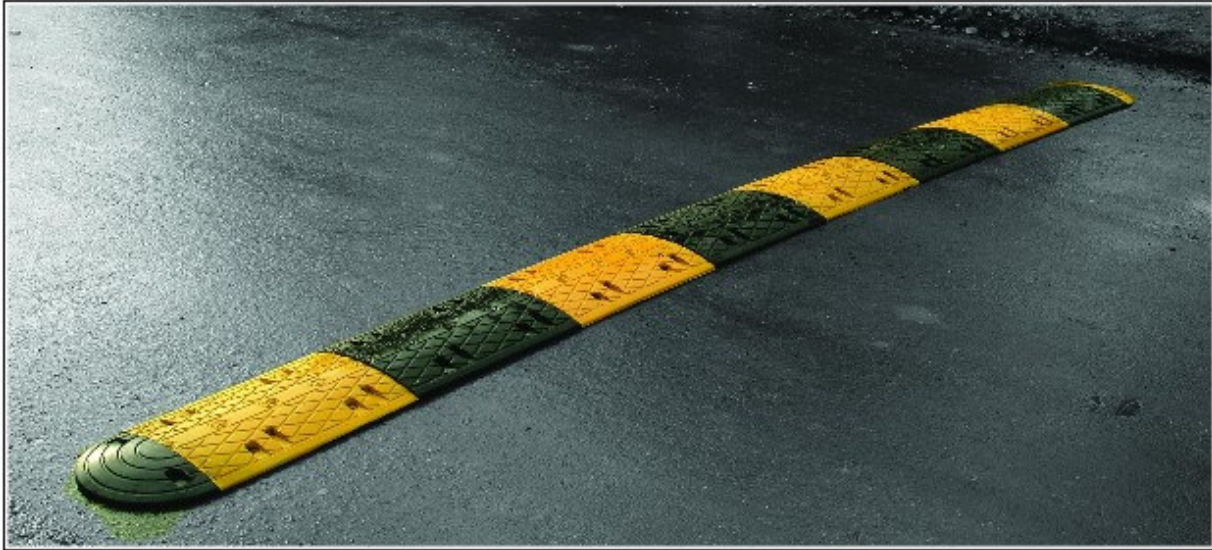
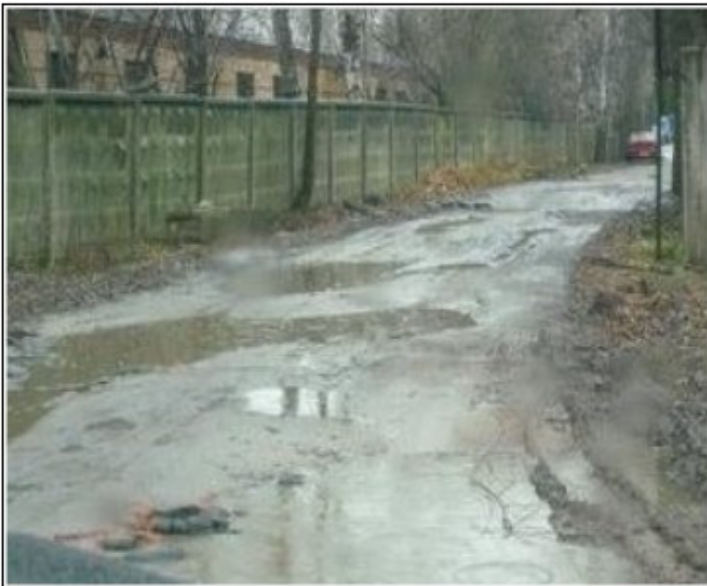
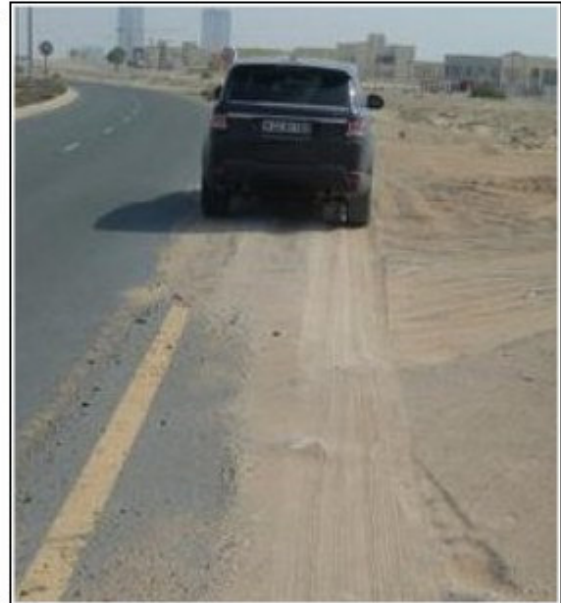
E162272

SYMPTOM: single 'knock' OR a series of isolated 'knocks':

- **Drive Cycle / Conditions:** single-wheel and dual-wheel inputs from speed bumps /damaged road surfaces or similar while traveling ONLY in a forward direction at speeds of up to 25mph (40kmh).

- **Action:** perform SERVICE INSTRUCTION 1.

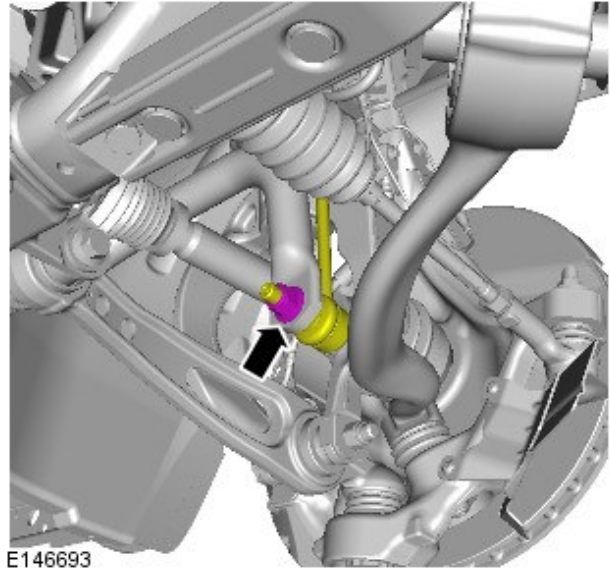
5. **NOTE: a small amount of pivot is normal.**

Check the front stabilizer bar links for visible play:

- Grasp the link by hand and attempt to move it up/down.
- If visible play is found, renew the stabilizer bar link (s).
- If visible play is not found, continue to the next step.

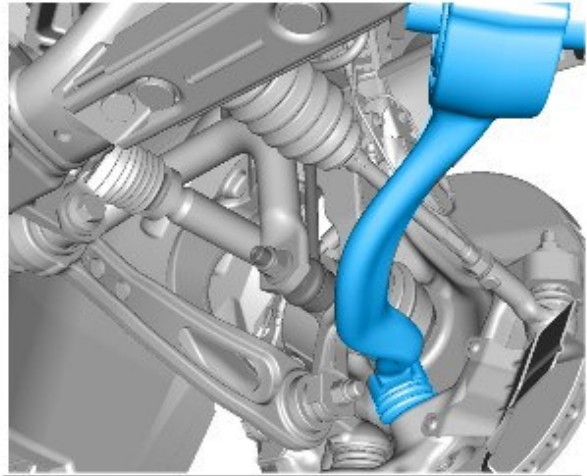
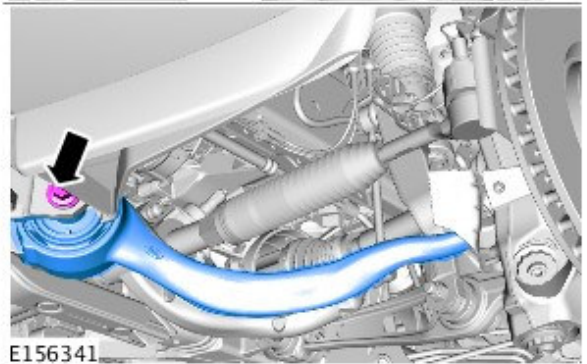
P3 Lower Control Arm to Frame

8. **NOTE: Minimum Torque: 190Nm (refer to table 1).**

- If the measured torque is less than the minimum residual torque shown, the fixing should be replaced with new and torque with reference to TOPIx Workshop Manual section 204-01: Front Suspension.

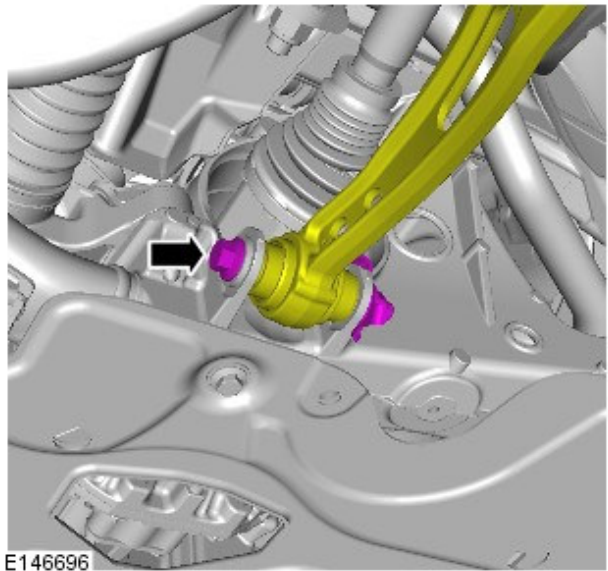
P4 Lower Control Arm to Frame

**NOTE: Minimum Torque: 190Nm (refer to table 1).**

- If the measured torque is less than the minimum residual torque shown, the fixing should be replaced with new and torque with reference to TOPIx Workshop Manual section 204-01: Front Suspension.

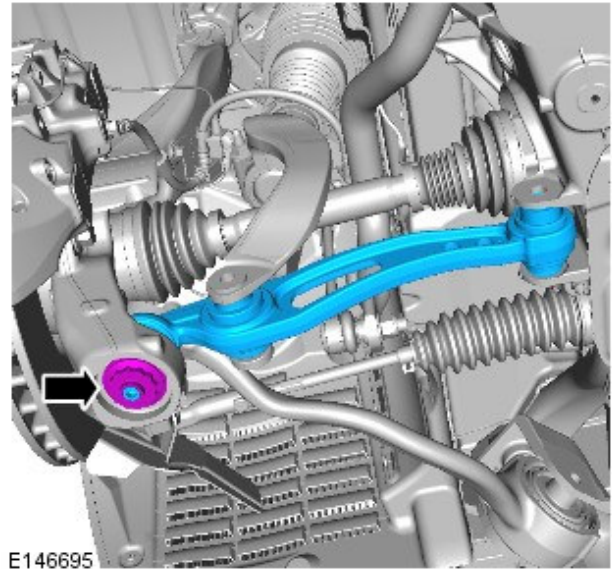
P6 Lower Ball Joint Knuckle (Lower Arm Rear)

**NOTE: Minimum Torque: 273Nm (refer to table 1).**

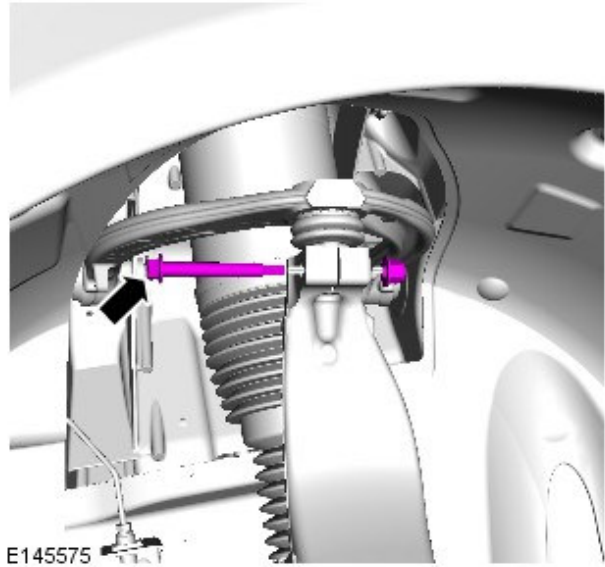
P7 Upper Control Arm to Knuckle

**NOTE: Minimum Torque: 60Nm (refer to table 1).**

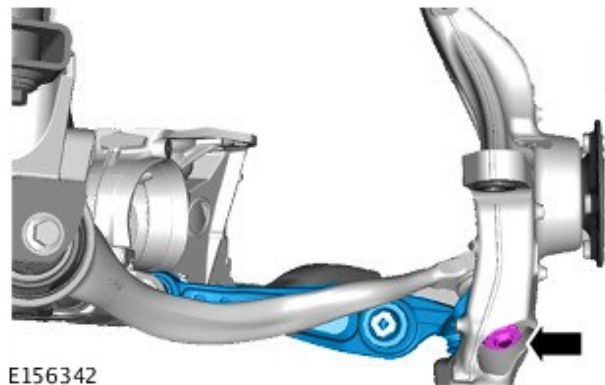
P40 Lower Ball Joint Knuckle (Lower Arm Front)

**NOTE: Minimum Torque: 273Nm (refer to table 1).**

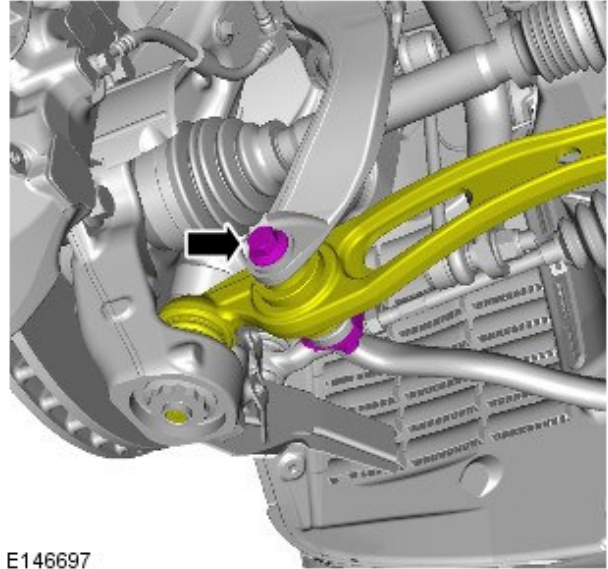
P56 Adaptive Shock Absorber Yoke to Lower Control Arm.

**NOTE: Minimum Torque: 210Nm (refer to table 1).**

- If the measured torque is less than the minimum residual torque shown, the fixing should be replaced with new and torque with reference to TOPIx Workshop Manual section 204-01: Front Suspension.

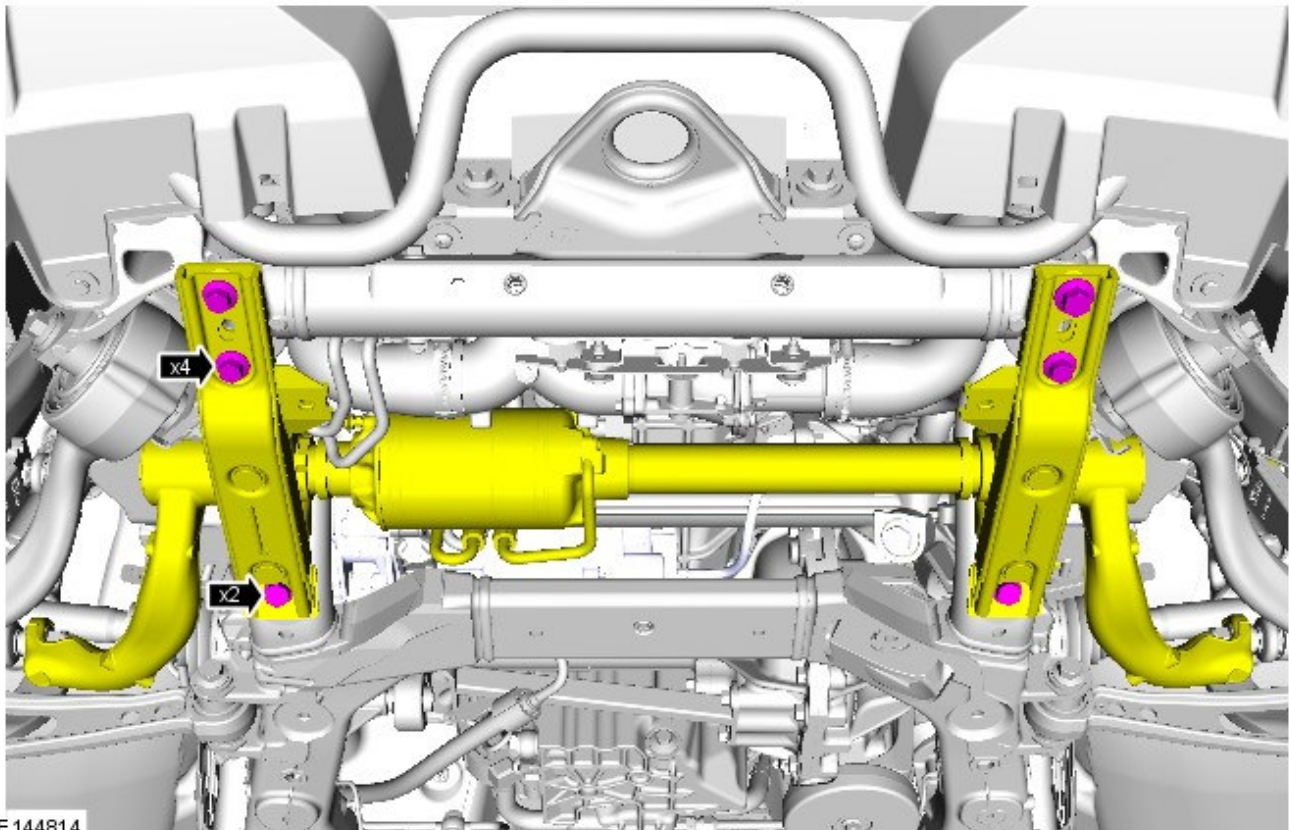
Dynamic Response Front Actuator Ski Bracket

**NOTE: M12 x 4 off Minimum Torque: 140Nm; M14 x 2 off Minimum Torque: 230Nm (refer to table 1).**

- If the measured torque is less than the minimum residual torque shown, the fixing should be replaced with new and torque with reference to TOPIx Workshop Manual section 204:01: Front Suspension.

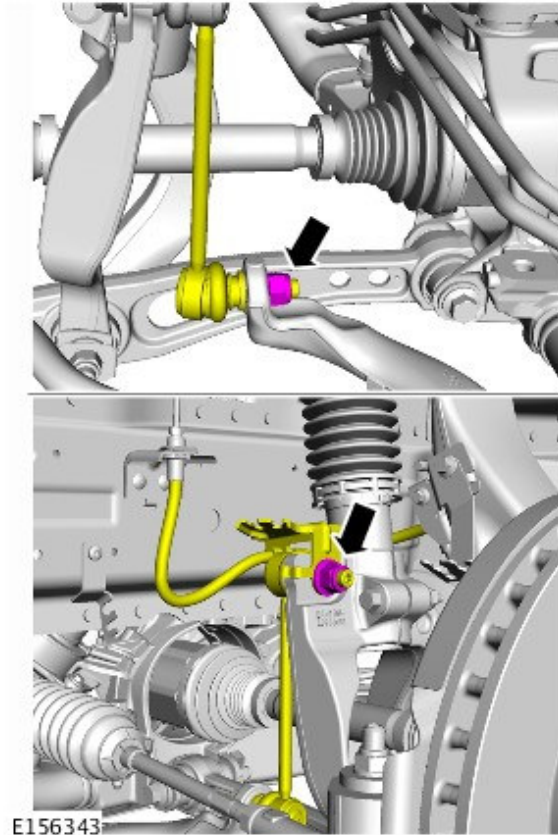
Front Stabilizer Links, Actuator Bar Arms to Knuckle

**NOTE: Minimum Torque: 174Nm (refer to table 1).**

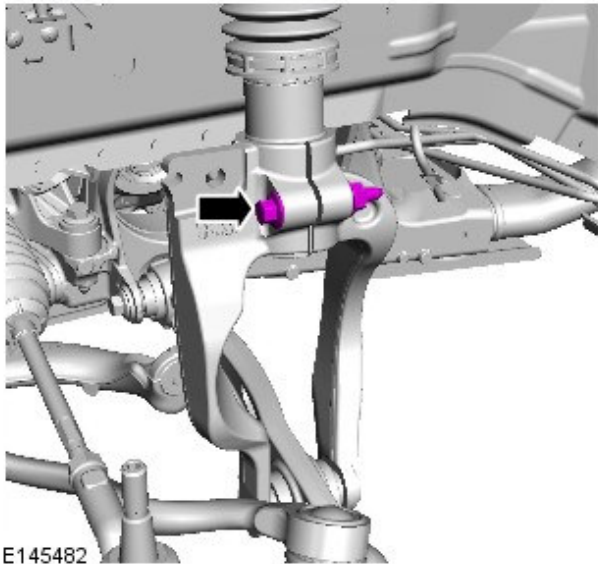
Pinch Bolt - Front Air Strut to Yoke

**NOTE: Minimum Torque: 89Nm (refer to table 1).**

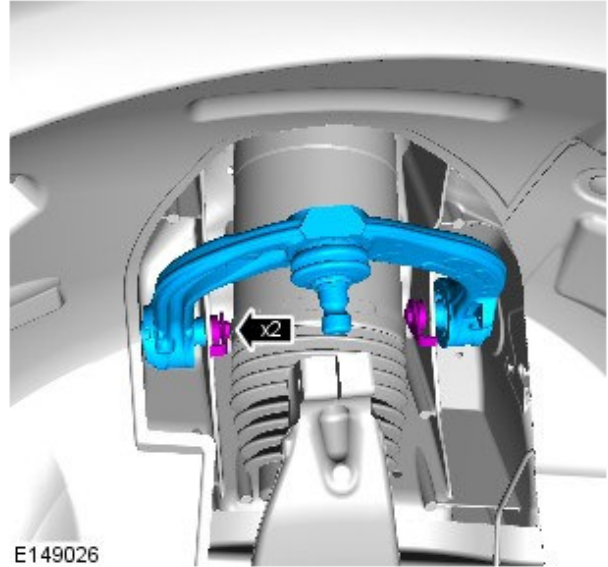
P1/P2 Upper Control Arm to Knuckle

**NOTE: Minimum Torque: 60Nm (refer to table 1).**

- If the measured torque is less than the minimum residual torque shown, the fixing should be replaced with new and torque with reference to TOPIx

Workshop Manual section 204:01: Front Suspension.

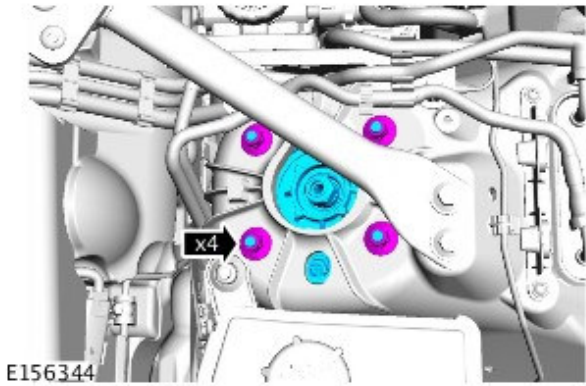
Upper Fixings - Front Air Strut

**NOTE: Torque: 30Nm (refer to table 1)**
Tighten in a diagonal sequence.

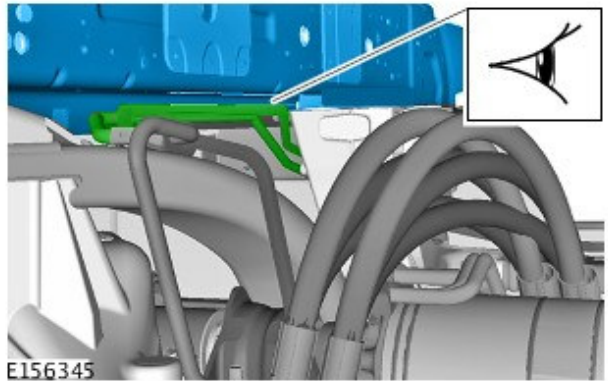
19. Check Pipes for Fouls

- Front pipe set to longitudinal. Check for a foul between the front hydraulic pipe set and the longitudinal.

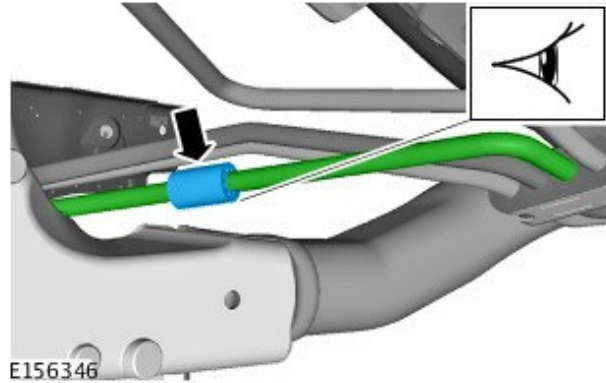
20. Front Pipe Set to Subframe

- Check that the rubber buffer is fitted to the hydraulic pipe. Ensure that there is not a hard foul between the hydraulic pipe and the sub frame.

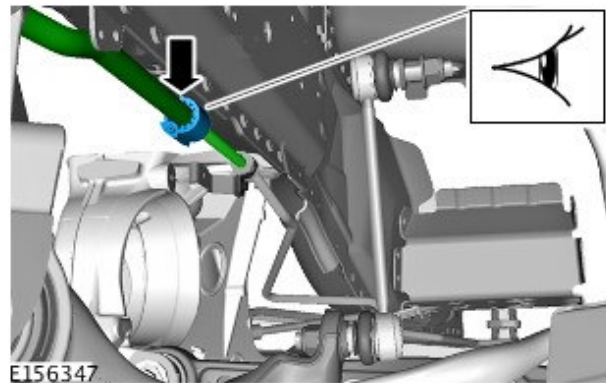
21. Return Hose to Longitudinal

- Check that the rubber buffer is fitted and that there isn't a hard foul between the return pipe/hose and the underside of the longitudinal.

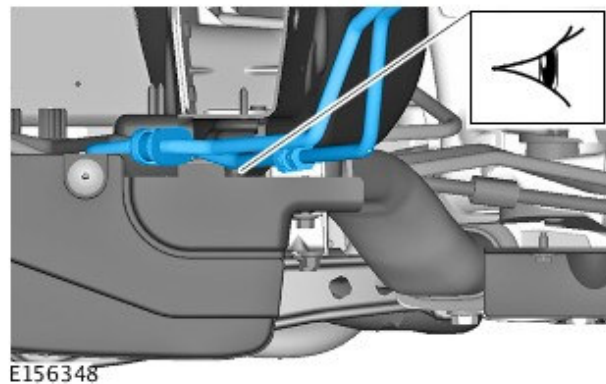
22. Rear Pipe to Aero Shield

- Check for a foul as the rear pipes exit from the aero under shield.
- Check the hydraulic pipe routing under the aero shield and ensure free of fouls to the fuel pipes.

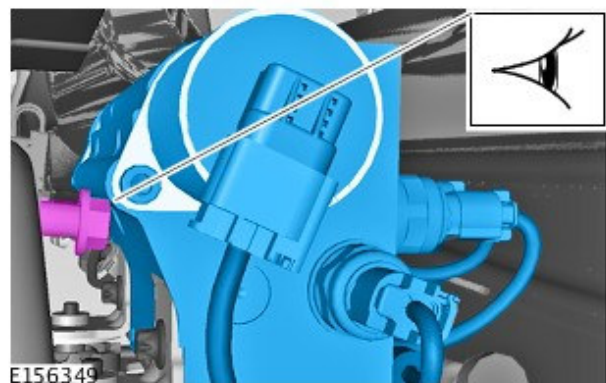
Valve Block to Body Stud Clearance

- There should be sufficient clearance between the valve block body and the plastic body fastener that secures the fuel lines. Where no or very little clearance exists, the head of the fastener should be modified, by removing it and drilling an axial hole 5mm diameter through the head, so that the body stud passes through the head of the fixing.

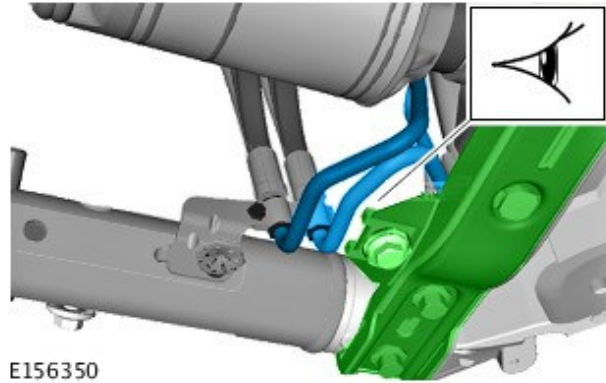
24. Front Pipes to Edge Clip on Subframe Ski Bracket (Front

- There should be sufficient clearance between the hydraulic pipes and the ski bracket.
