TECHNICAL BULLETIN
Q384 UPS3114-2bNAS1
23 MAY 2014

Update Prior to Sale: Trailer Harness Central Junction Box Connector Pin Locations

LR4 (LA)
Model Year: 2014
VIN: EA699718-EA713882

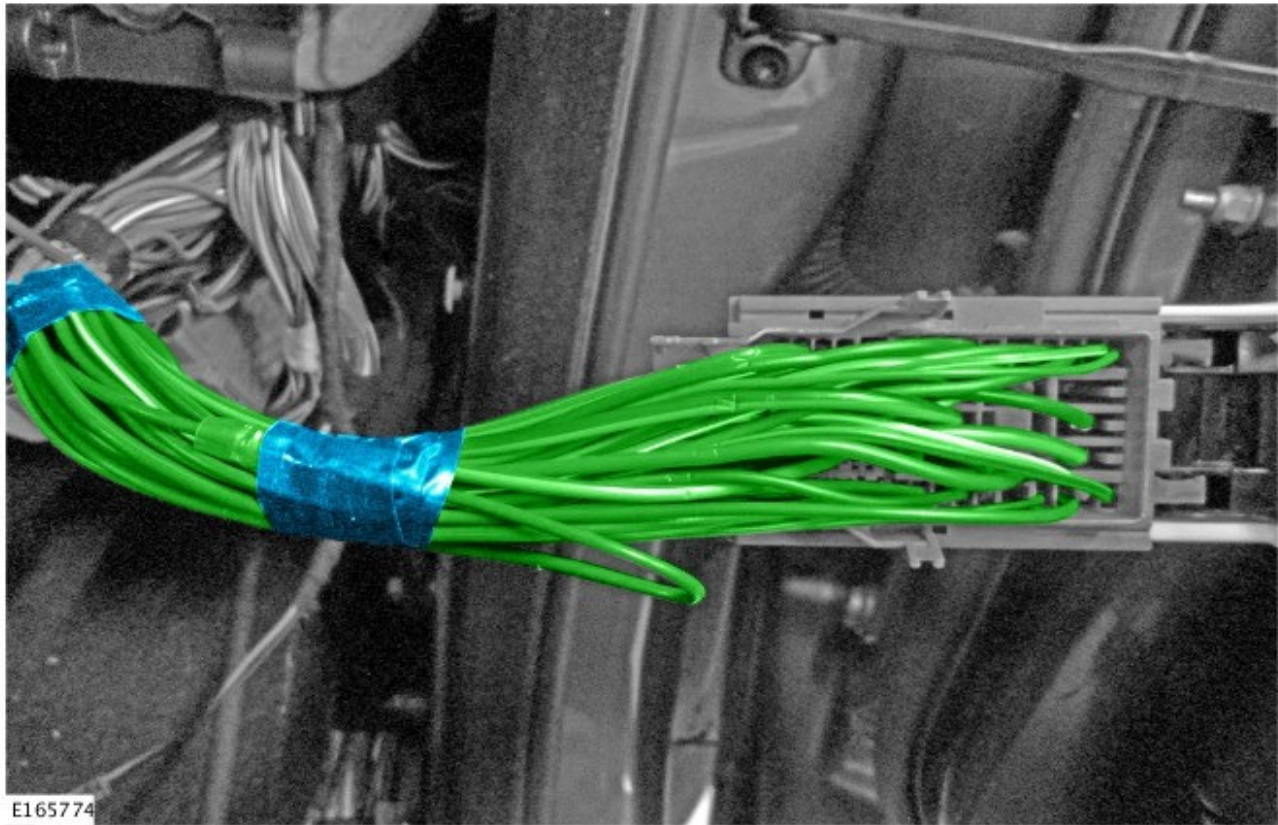
**NOTE: Make sure the repair wire follows the wiring harness and the wiring is not stretched.**

Install the extended-length repair wire to the main harness with insulation tape.
