| <b>Reference</b> | SSM66837 |
| <b>Models</b> | LR2 / L359 |
| <b>Title</b> | Gearshift Interlock Button / Spring Issue |

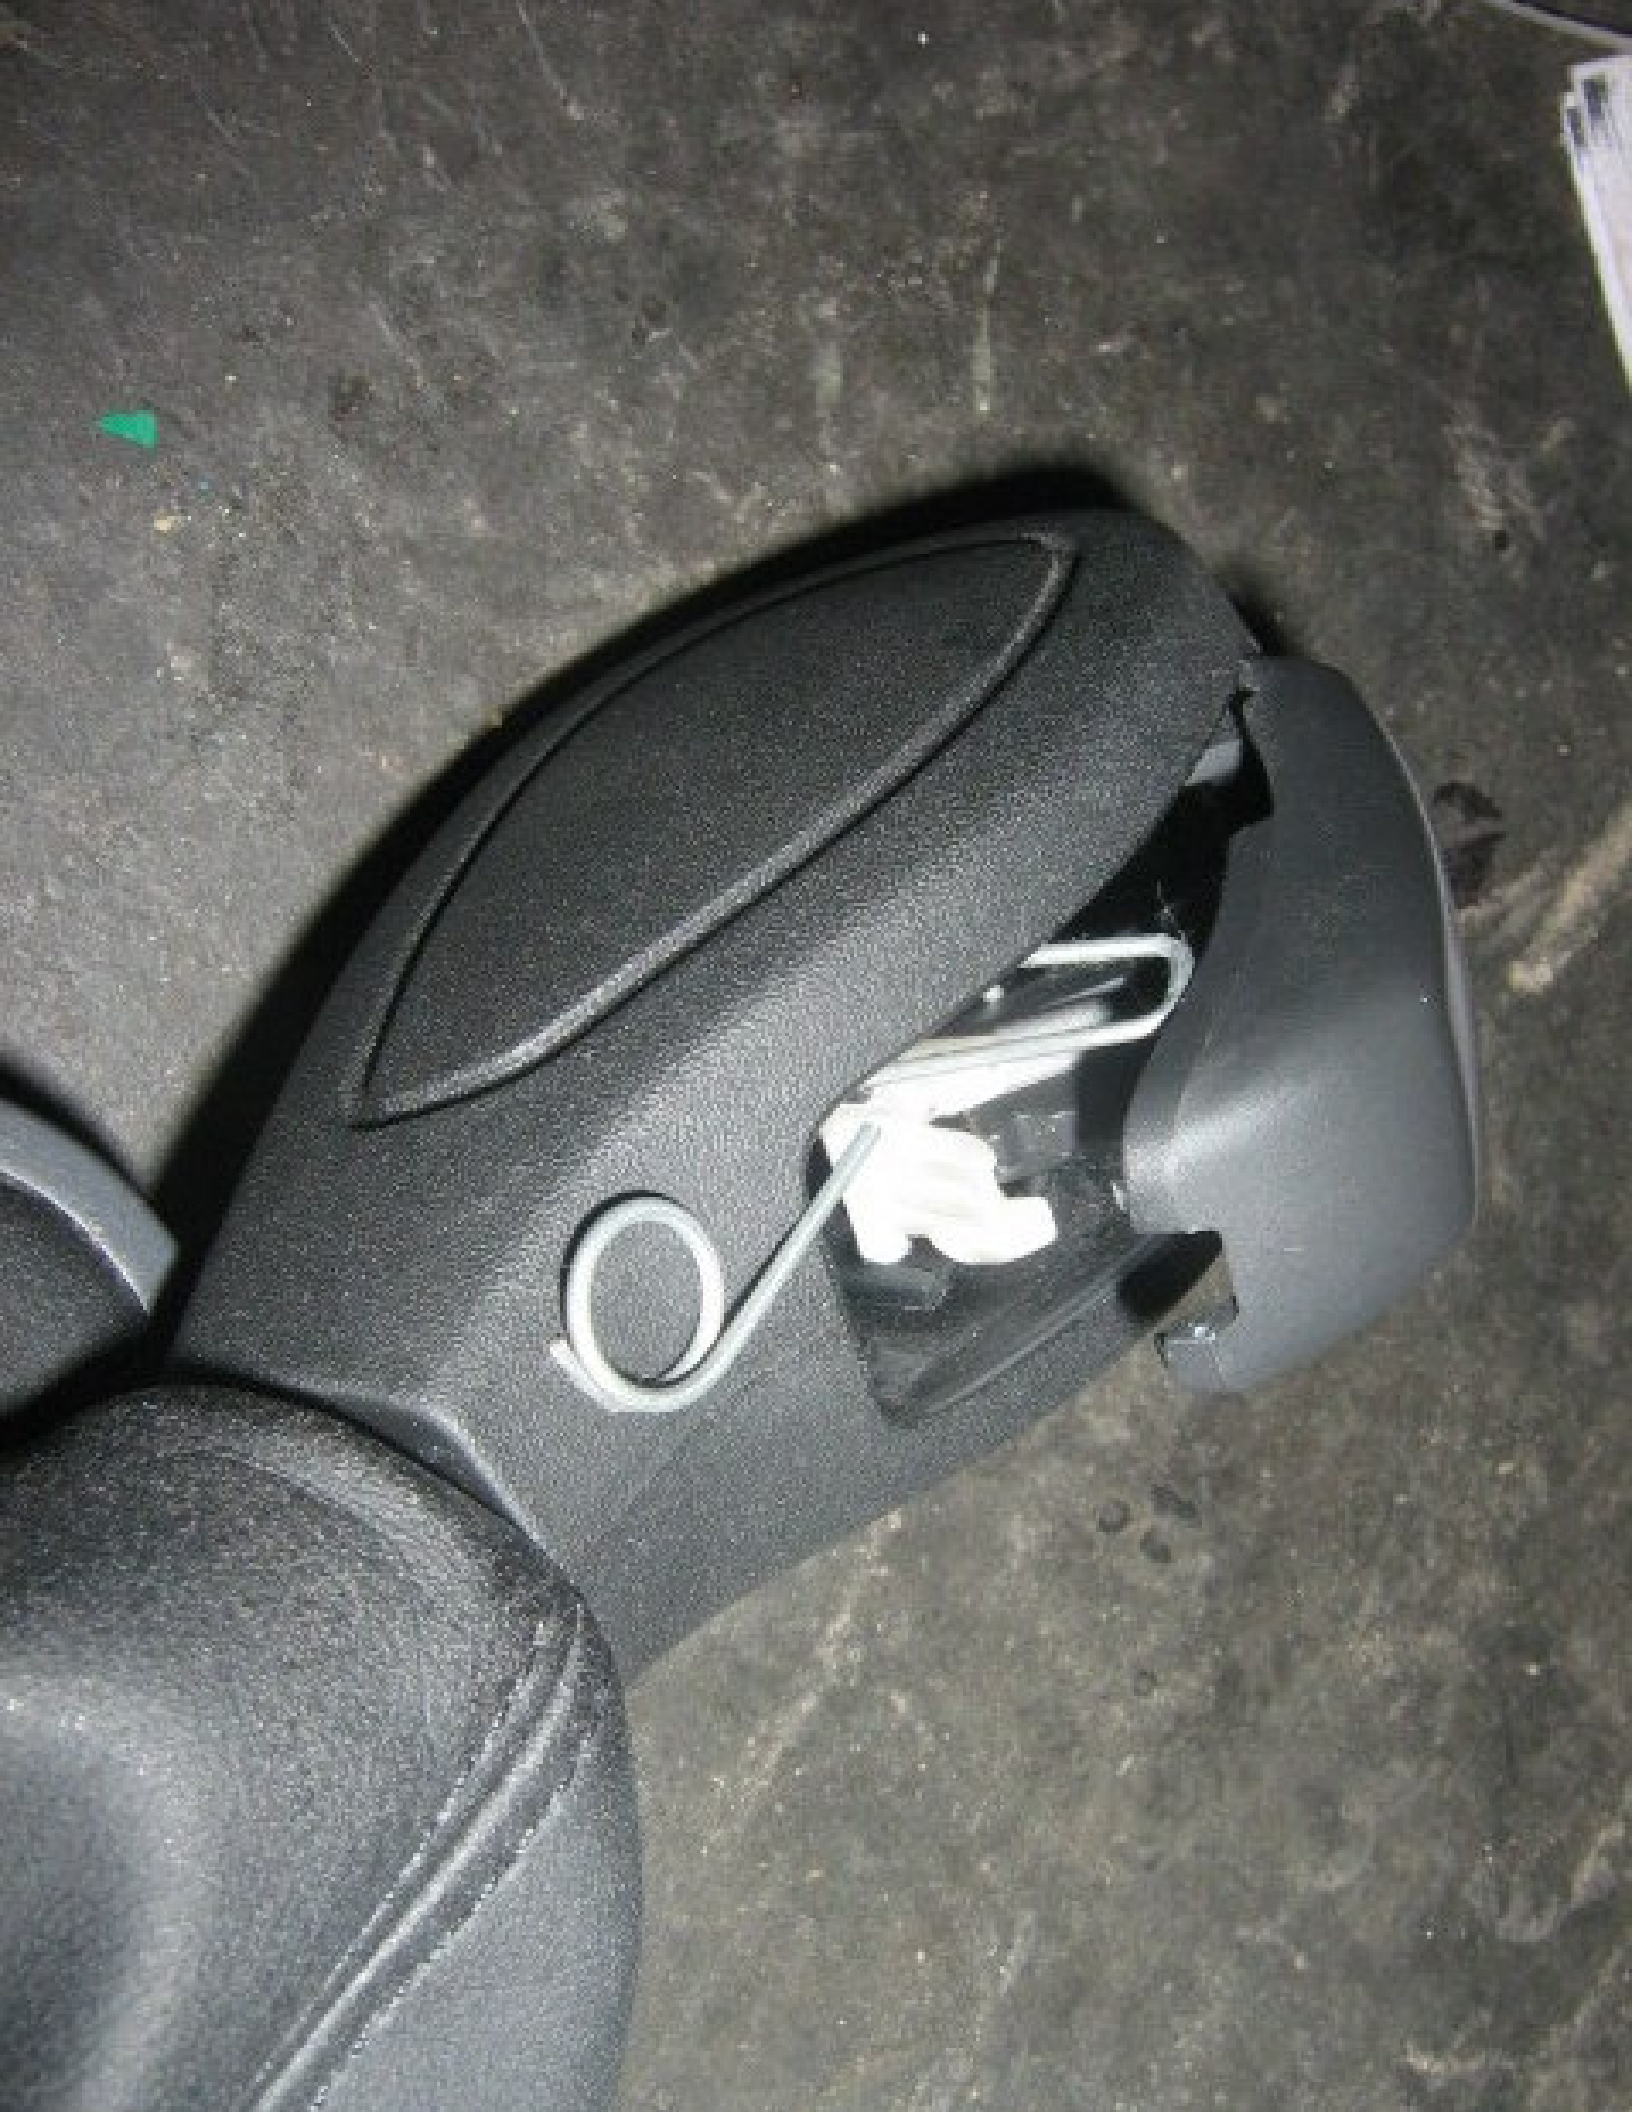
| <b>Content</b> | <p><b>Issue:</b></p> <p>The gearshift interlock button inoperative or spring has come adrift (See Attached)</p> <p><b>Cause:</b></p> <p>The interlock button mechanism has been modified to prevent this issue from Vin No. H372254 UK Build L910950 Pune Build</p> <p><b>Action:</b></p> <p><b>Please only submit further EPQR's for any vehicles that are <u>post</u> the above assured VIN's</b></p> |
