TECHNICAL BULLETIN

Q404NAS1

Service Action: Fixed Side Step 'Rattle' Noise / Trim Loose

Range Rover Sport (LW)

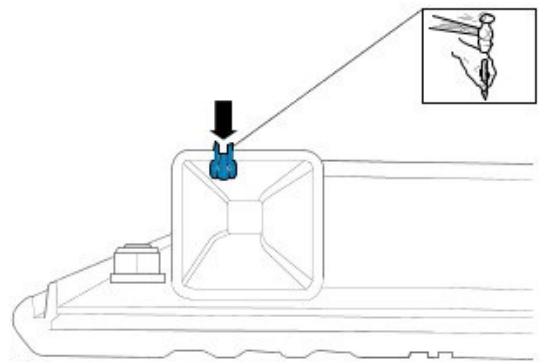
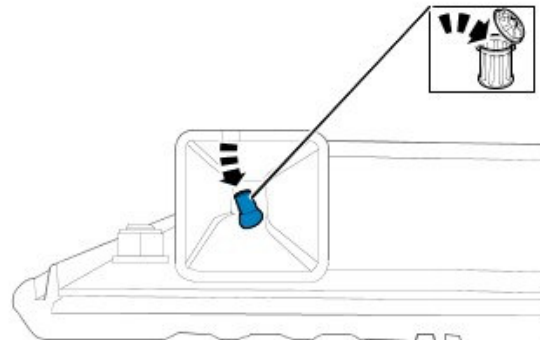
E16563

**NOTE: Make sure all the rivets are removed from the side step; failure to perform this may cause a rattle.**

Remove and discard the rest of the 10 rivet inserts.

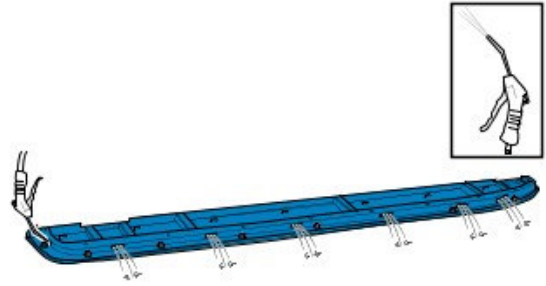
E165654

**NOTE: Make sure all the rivets are removed from the side step; failure to perform this may cause a rattle.**

Using a suitable tool, remove all the excess material from the rivet removal.

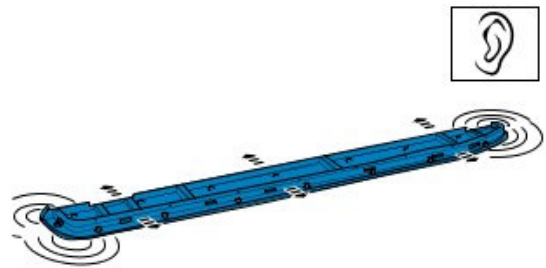
E165655

**NOTE: Make sure all the rivets are removed from the side step; failure to perform this may cause a rattle.**

Shake the side step to make sure there is no material inside the step after drilling.
