<b>Reference</b>	SSM71958
<b>Models</b>	Range Rover / L405 Range Rover Sport / L494 Range Rover Evoque / L538
<b>Title</b>	Diagnostic process when drivers airbag warning light is illuminated
<b>Category</b>	Body
<b>Last modified</b>	26-Aug-2014 00:00:00
<b>Symptom</b>	104000 Restraint Systems
<b>Attachments</b>	Locking Tab Photos (6).pdf

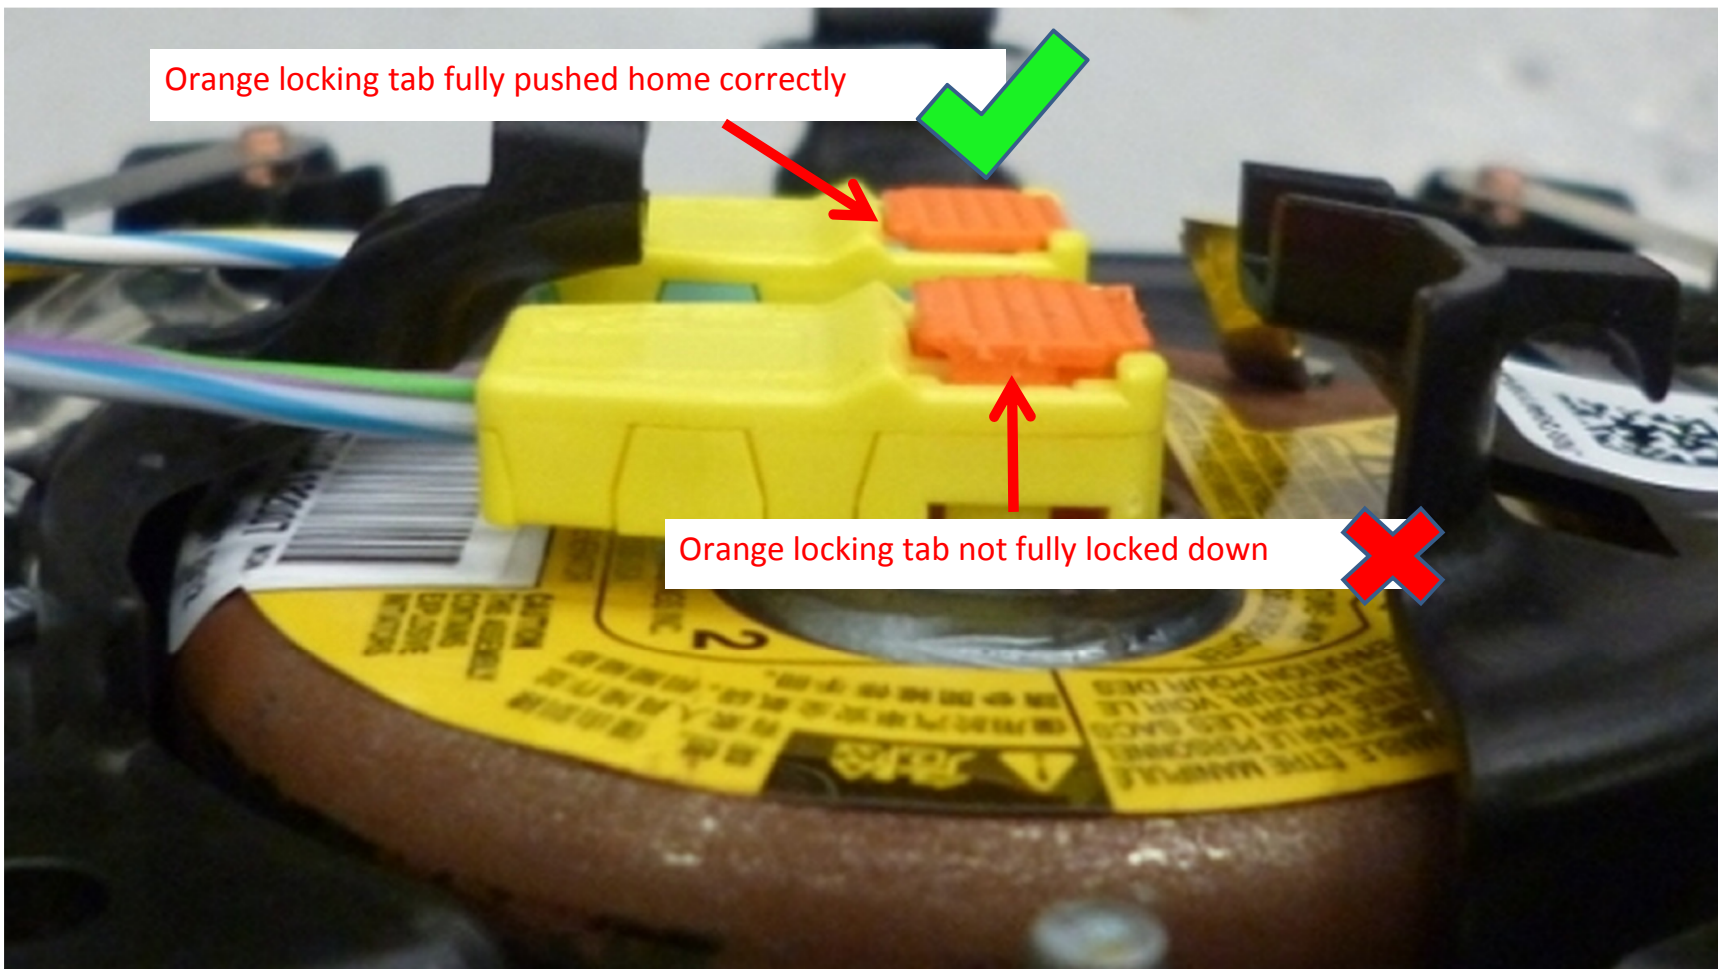
The clock spring connectors have not been latched correctly. See attachment

Orange locking tab not fully locked down

The work shop manuals have been updated for the following Restraints Control Module (RCM) DTC codes to inspect the connectivity of the clock spring connector.
