Reference	SSM72132
Models	LR2 / L359 Range Rover Evoque / L538
Title	M66 manual transmission turret housing incorrect part - LR022071 LR072971
Category	Driveline
Last modified	23-Dec-2014 00:00:00
Symptom	503000 Automatic Transmission Engagement Concerns
Attachments	A1.pdf

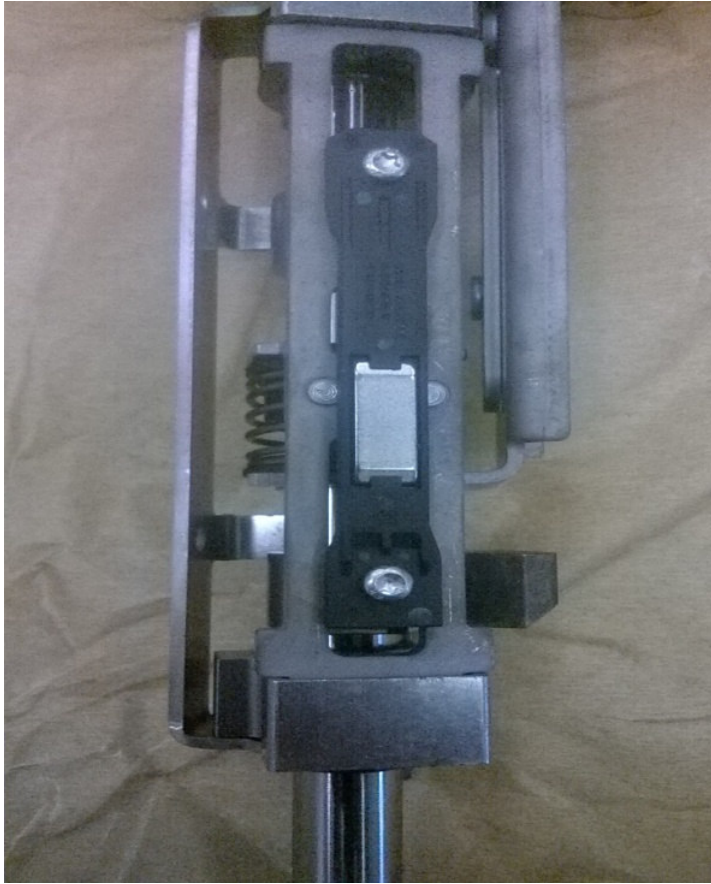
LR022071

- LR022071-Inductive sensor Turret
- LR072971-Hall effect sensor Turret.
