Reference	SSM71937
Models	Range Rover / L405 Range Rover Evoque / L538 Range Rover Sport / L494
Title	Steering Rack / Tie Rod Damage Identification
Category	Chassis
Last modified	04-Dec-2014 00:00:00
Symptom	303000 Steering/Handling
Attachments	1Tie Rod and Seat Material Damage Identifcation.pdf (1Tie Rod and Seat Material Damage Identifcation.pdf)

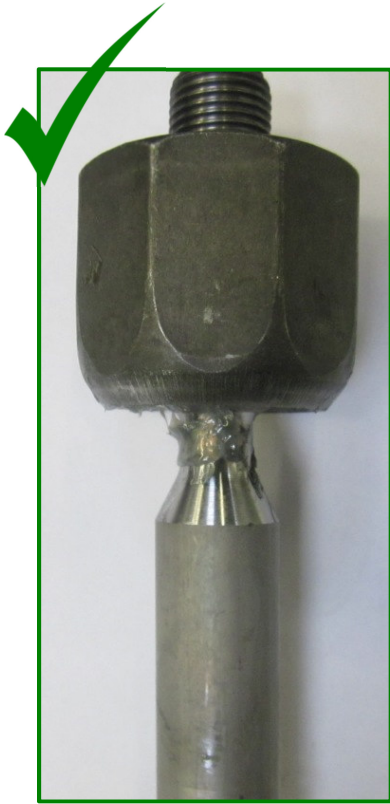
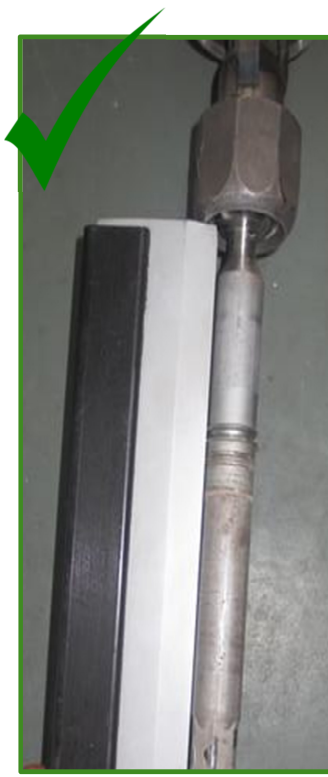
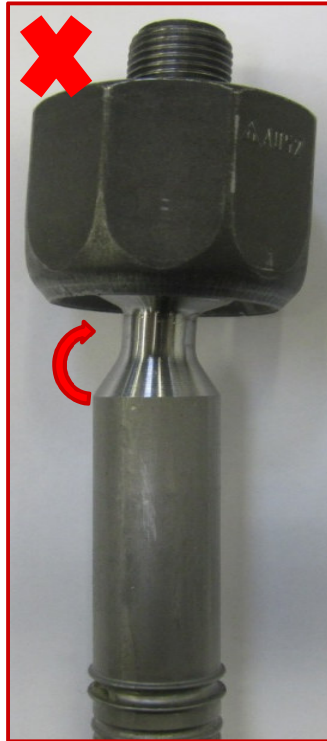
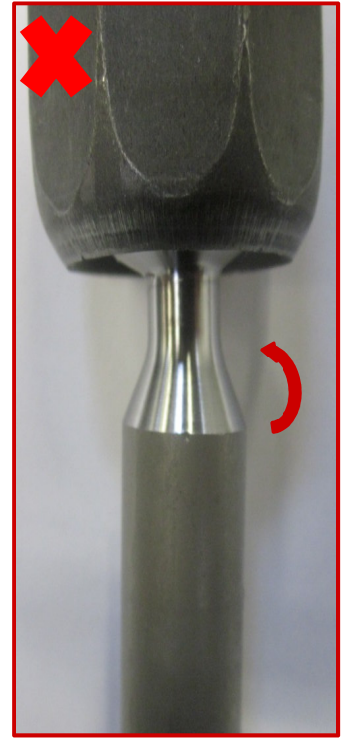
Tie Rod Bending:

Issue: Customer reports vehicle steering is stiff or a noise is coming from the steering gear internals. There may be no fault codes or warning lights present.

Cause: Side impact to the vehicle wheels.

Tie-rod bending (see pictorial help)

Action: If there is a steering fault (Stiff or internally Noisy), and it is suspected this may have come from accident damage inspect the steering gear and vehicle for signs of impact damage paying particular attention to the following:(These external symptoms correlate to internal damage, but both may not always be present, due to the type of impact)

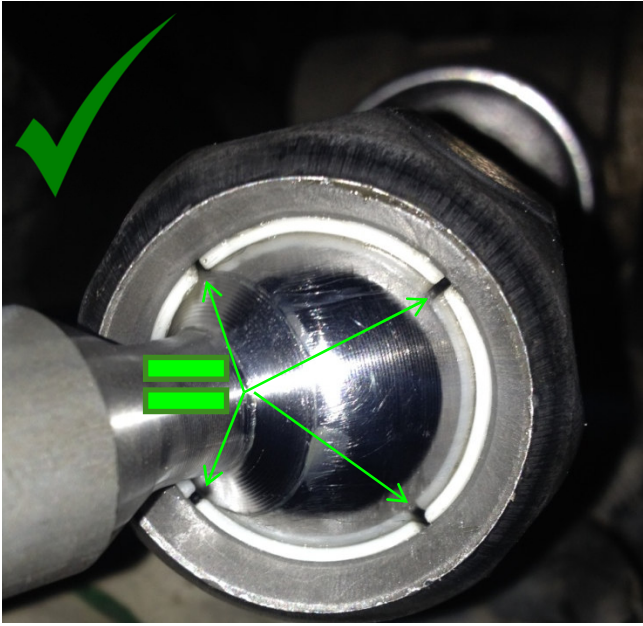
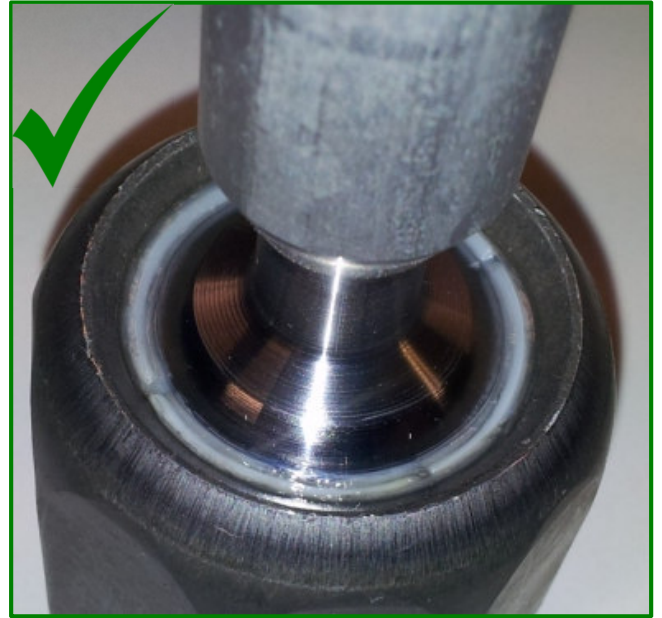
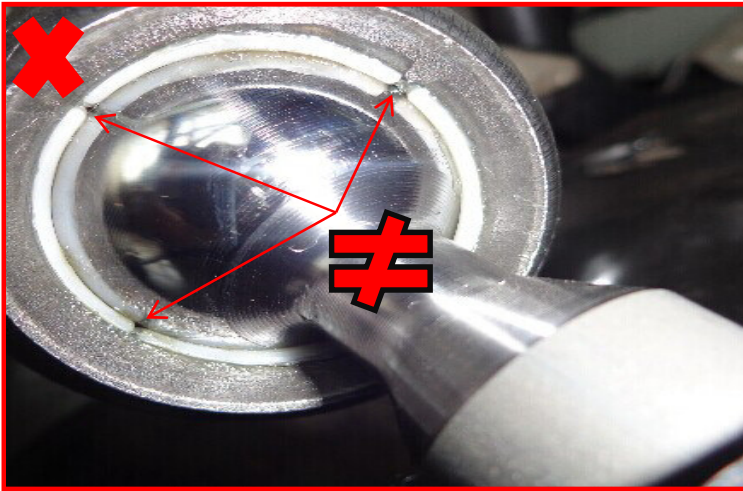
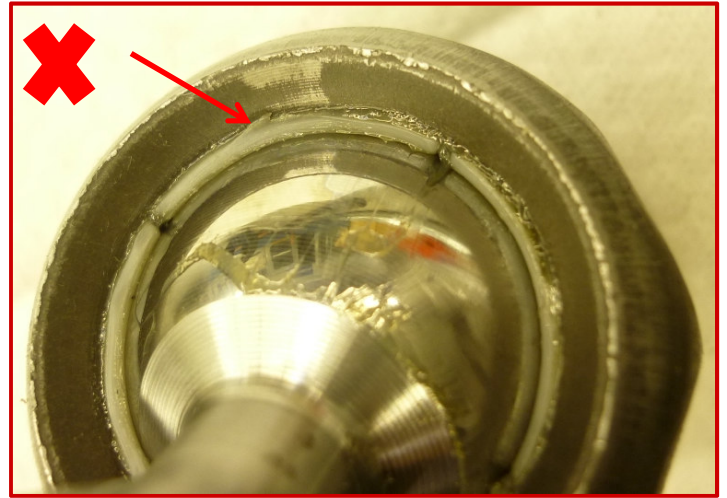
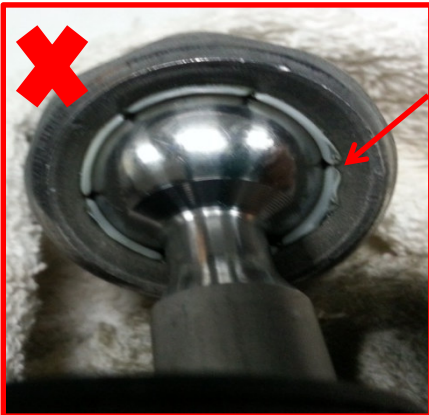
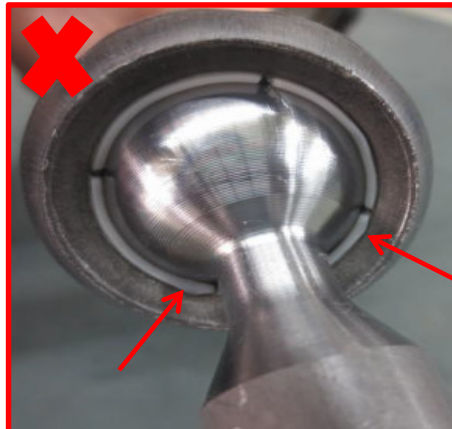
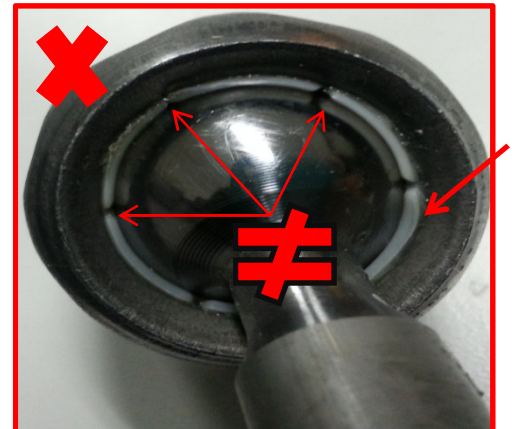
- Damage of seat material at inner tie-rod joint (see pictorial help)
