Secondary Air Injection System - MIL "ON" DTC P2440 and/or P2442

Service Category Engine/Hybrid System

Section Emission Control

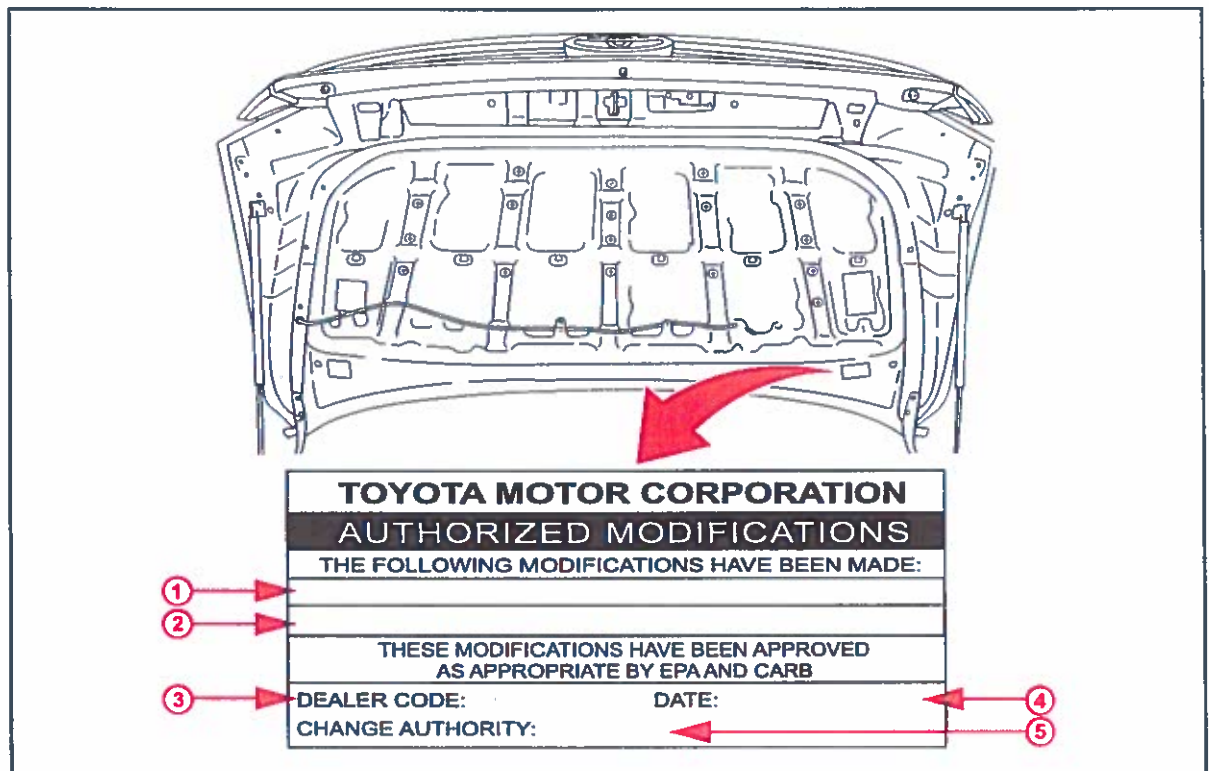
Figure 1. Location of Authorized Modifications Label on 2014 – 2015 Sequoia and Tundra

1	Replacement ECM (PCM) Part Number (i.e., 89661-0CN82)
2	New Calibration ID(s) (i.e., 30CJ4200)
3	Dealer Code

4	Date Completed
5	This SB Number

B. Affix the Authorized Modifications Label to the vehicle at the location shown in Figure 1. The Authorized Modifications Label is available through the MDC, P/N 00451-00001-LBL.
