Spark Knock Noise

Service Category Engine/Hybrid System

YEAR(S)	MODEL(S)	ADDITIONAL INFORMATION
2012 – 2014	Tacoma

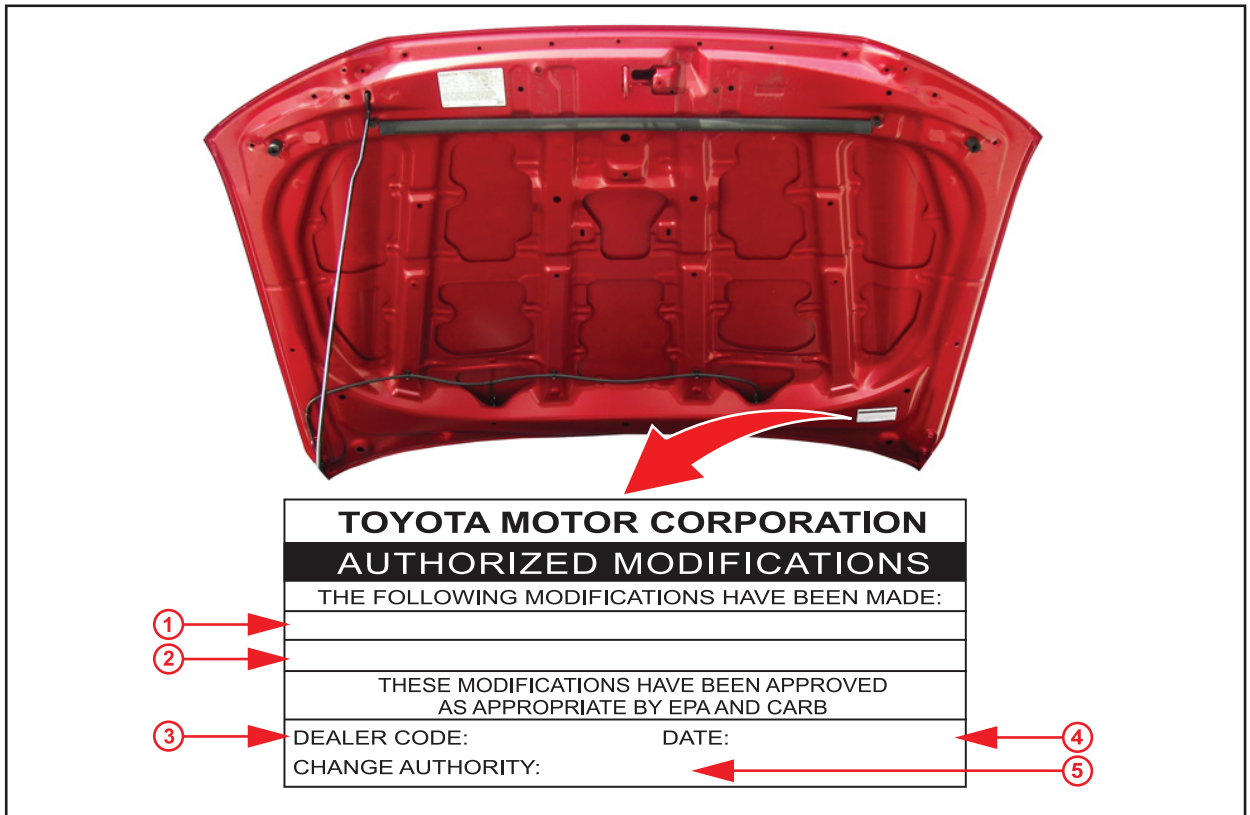
Figure 1. Location of Authorized Modifications Label on 2012 – 2014 Tacoma

2. Check for the Authorized Modifications Label affixed to the vehicle in the location shown in Figure 1. Confirm if the ECM (PCM) calibration has been updated. If the calibration ID listed is NOT the latest ECM (PCM) calibration — go to step 3. If the calibration ID is the latest, go to step 5.

- Install the Authorized Modifications Label.
 - Using a permanent marker, enter the following information on the label:
 - ECM part number [*Refer to the **Parts Information** section for the **NEW PART NUMBER***]
 - Calibration ID(s) [*Refer to the **Calibration Information** section for the **NEW CALIBRATION ID***]
 - Dealer Code
 - Repair Date
 - Change Authority [***This bulletin number***]
 - Affix the Authorized Modifications Label to the vehicle at the location shown in Figure 1. The Authorized Modifications Label is available through the MDC, P/N 00451-00001-LBL.
- Test drive to confirm the repair.
