MIL "ON" DTC P0011 – Advanced Camshaft Timing

Service Category Engine/Hybrid System

Section Engine Mechanical

Market USA

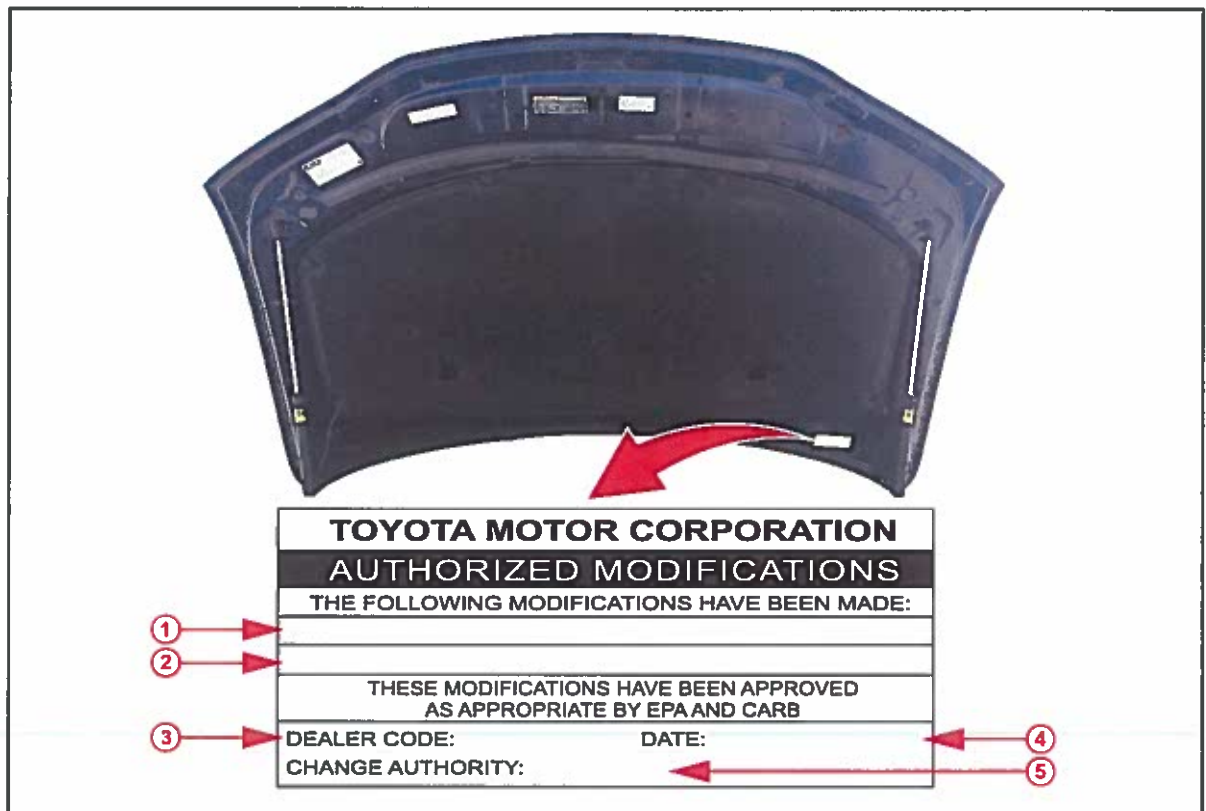
Figure 1. Location of Authorized Modifications Label on 2013 – 2014 ES 300h

2. Check for the Authorized Modifications Label affixed to the vehicle in the location shown in Figure 1 below. Confirm if the ECM (PCM) calibration has been updated. If the calibration ID listed is NOT the latest ECM (PCM) calibration — go to step 3.

B. Affix the Authorized Modifications Label to the vehicle at the location shown in Figure 1.
The Authorized Modifications Label is available through the MDC, P/N 00451-00001-LBL.
