# **Short Pin Installation During PDS**

YEAR(S)	MODEL(S)	ADDITIONAL INFORMATION
2015	Camry, Camry HV

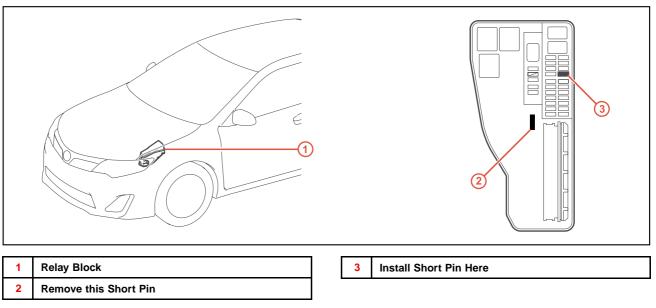
Figure 1.

To minimize battery discharge during transportation and storage, the Short Pin has been removed at the assembly plant and temporarily stored in the engine compartment Relay Block. Reinstall the Short Pin into its original location and confirm all related DTCs are cleared during Pre-Delivery Service (PDS).

Remove the Short Pin from the blank space of the Relay Block in the engine compartment and install the Short Pin in the Relay Block as shown.

- The Short Pin does NOT function as a fuse, so install it only in the position shown.
- If the vehicle is stored in the dealership after PDS, disconnect the negative (–) battery terminal to prevent battery discharge. Refer to Service Bulletin No. <u>PG001-06</u>, "Battery Maintenance for In-Stock Vehicles & Pre-Delivery".
