3rd Row Seat May Not Fold Flat

YEAR(S)	MODEL(S)	ADDITIONAL INFORMATION
2012 – 2013	Highlander

T-SB-0132-14

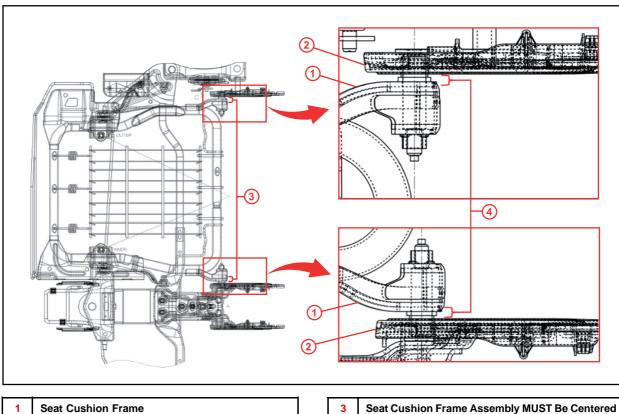
Figure 2.

1	Seat Cushion Frame		3	Seat Cushion Frame Assembly MUST Be Centered in Banana Brackets	
2	2 Banana Bracket				
	Danana Brasilet	J	4	These Distances MUST Be Equal

- A. Loosen the seat cushion frame mounting bolts to allow for the seat cushion frame to be shifted.
- B. With the seat cushion frame mounting bolts loosened, shift the seat cushion frame to create an equal gap dimension between the seat frame and the banana brackets.
- C. When the equal gap dimension is achieved, torque the seat frame mounting bolts per the Repair Manual specifications.
- 3. Reassemble the vehicle in reverse order and confirm normal operation.
